**Docket No. 272 – Development and Management Plan Inspection**

**Segment 2a Inspection**

**Date:** October 31, 2006

**Location:** Segment 2a – Beseck Switching Station to Cheshire/Hamden Town Line

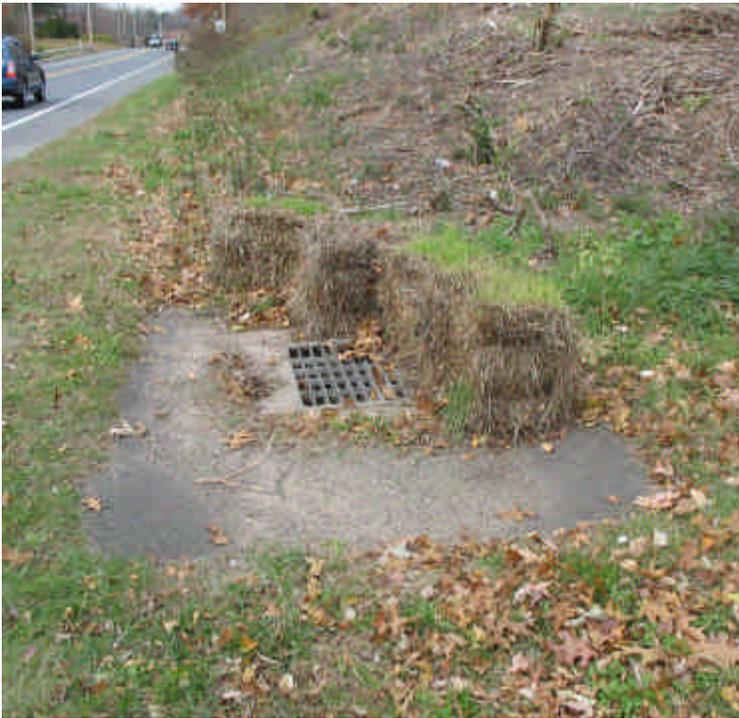
**Catch basin protection off Rt. 68.**

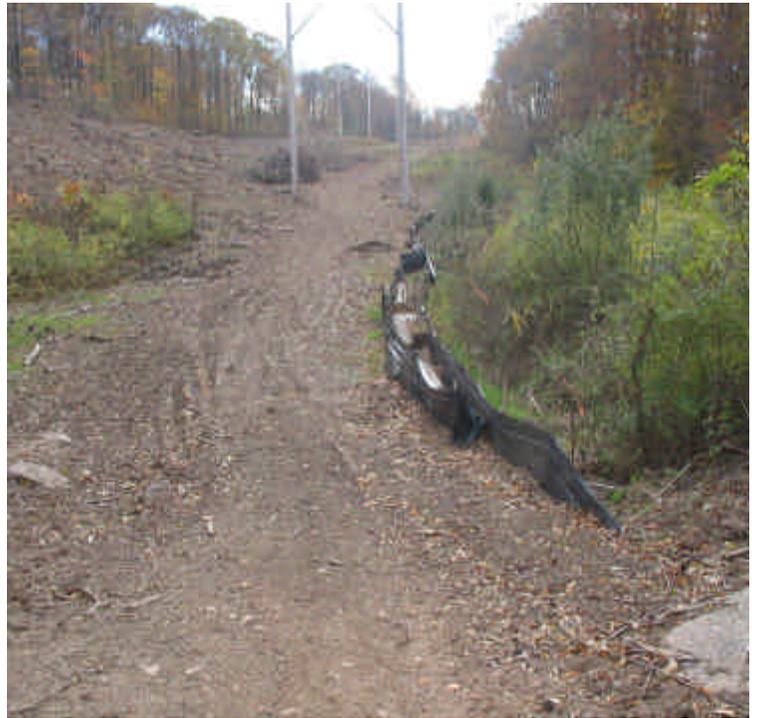
**Silt fence above wetland off High Hill Rd.**

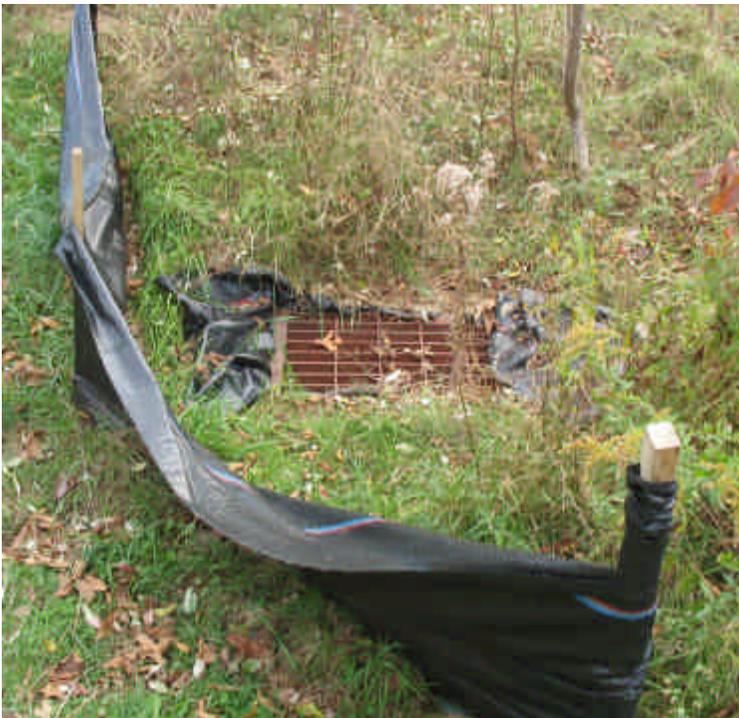
**Catch basin controls in place off Stony Brook Rd.**

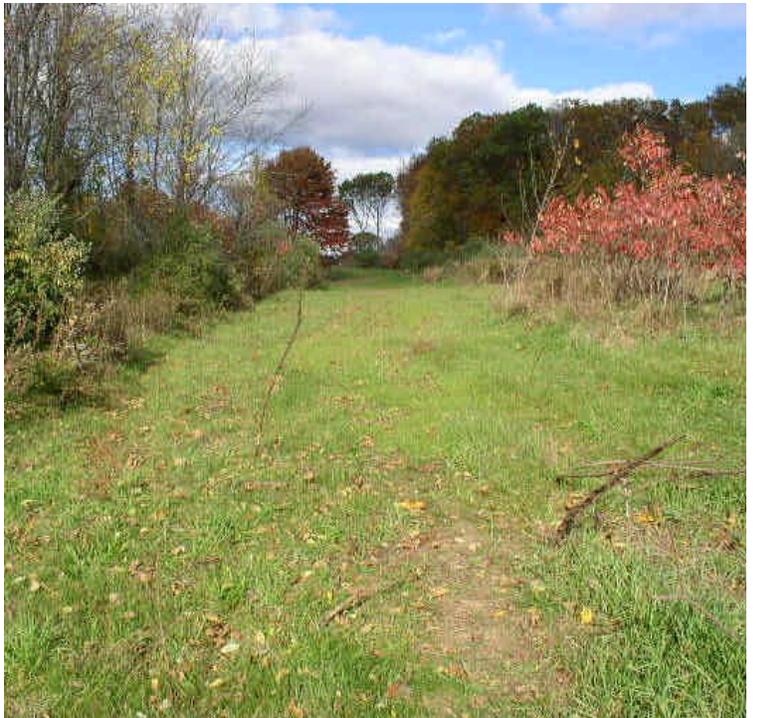
**Site entrance off Stony Brook Rd. with well established grass cover.**

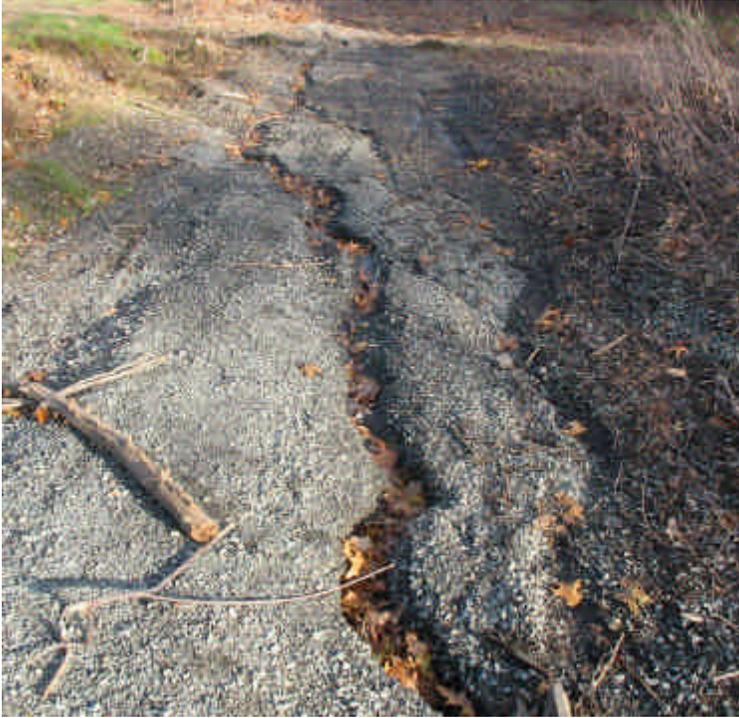
<b>S. Turnpike + Merritt Parkway Area</b>	<b>No sediment tracking noted on S. Turnpike. No new work performed in this area. Some washouts/erosive gullies were noted along the access road slope after the heavy rains. 10/31/06</b>	<b>Continue to monitor the entrances and sweep as needed. Slope will need to be regraded and stabilized. Stormwater diversion may be needed 10/31/06</b>	<b>Needs attention when feasible.</b>
<b>Mansion Rd</b>	<b>No sediment tracking noted on Mansion Rd. No new work performed</b>	<b>Continue to monitor and sweep entrance as needed. 10/31/06</b>	<b>Good grass cover is in place.</b>

**Washouts/erosive gullies noted in access road off of South Turnpike. Area will need some grading and stabilization/stormwater control.**

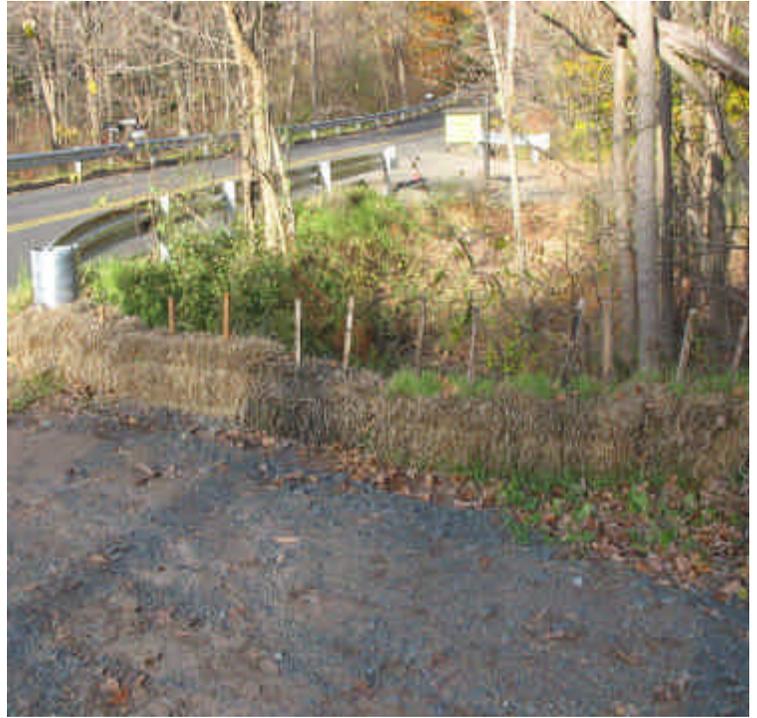
**Extra haybales added to prevent runoff at Mansion Rd. entrance.**

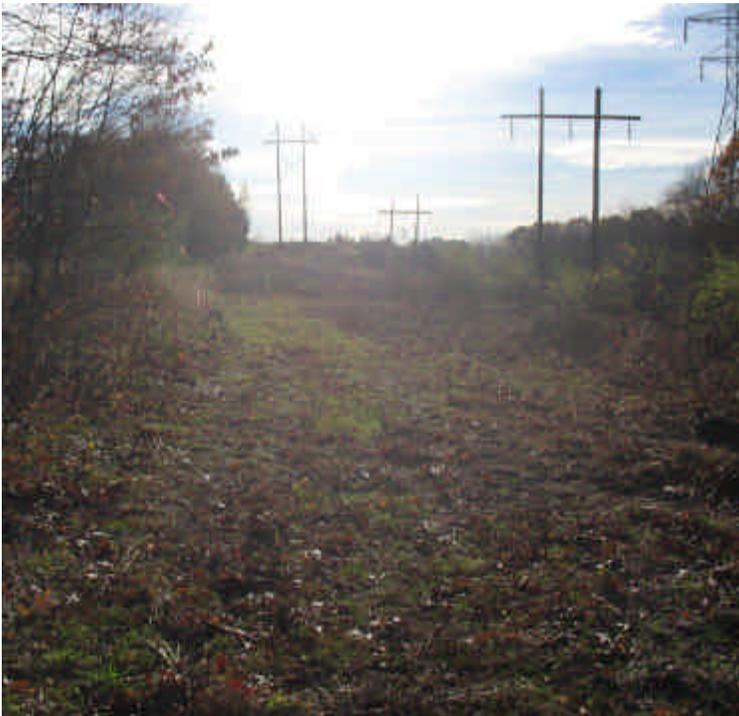
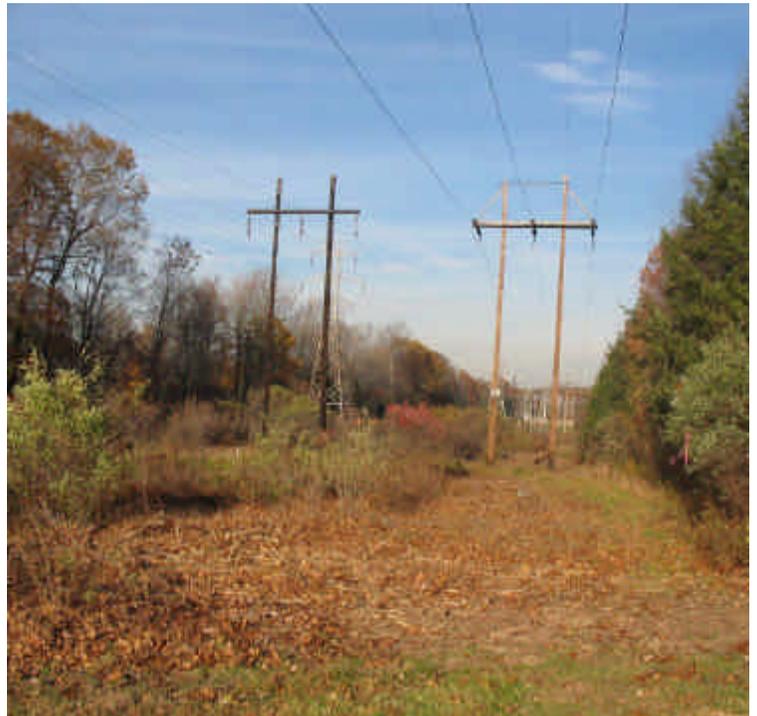
Old Farm Rd.	<p>The majority of the vegetation remains intact here. Very little potential for erosion exists in this area. 10/31/06</p>	<p>Continue to selectively cut vegetation in accordance with the D&amp;M plan if needed. 10/31/06</p>	NA.
Inland Wetland and Watercourse encroachment and mitigation	<p>Jurisdictional wetlands and buffers will not be accessed until the ACOE permit is in hand. 8/24-10/31/06</p> <p>Wetlands were flagged at the 100' buffer prior to work starting in each area. These buffers have been retained. 10/31/06</p>	<p>Continue to monitor wetlands and erosion controls. 10/31/06</p> <p>Continue to maintain buffer zone until ACOE permits allow access. 10/31/06</p>	<p>NA</p> <p>Buffer zones are established and retained.</p>
State species of concern, threatened and endangered species.	<p>According to the D&amp;M plan, state-listed species are not located in the current work areas. 10/31/06</p>	<p>None 10/31/06</p>	NA

**Vegetation left in place for stabilization off Old Farm Rd.**
