Docket No. 272 – Development and Management Plan Inspection

Segment 4a Underground Line

Date: August 30, 2006

Location: Singer Substation to Fairfield/Westport Town Line

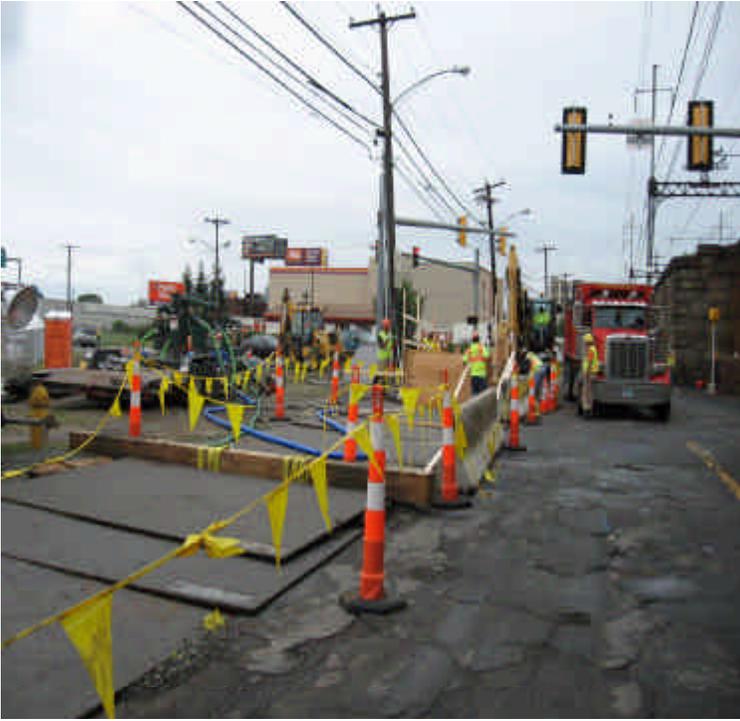
Bridgeport: Photo of trenching activities on the shoulder of Railroad Ave. near the intersection with Warden Ave.

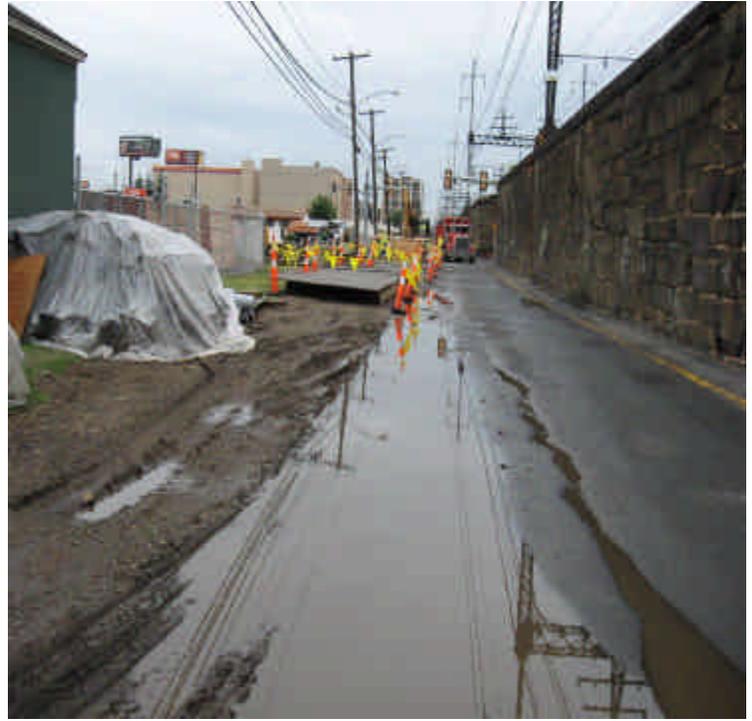
Photo of work along Railroad Ave. between Warden Ave. and Iranistan Ave.

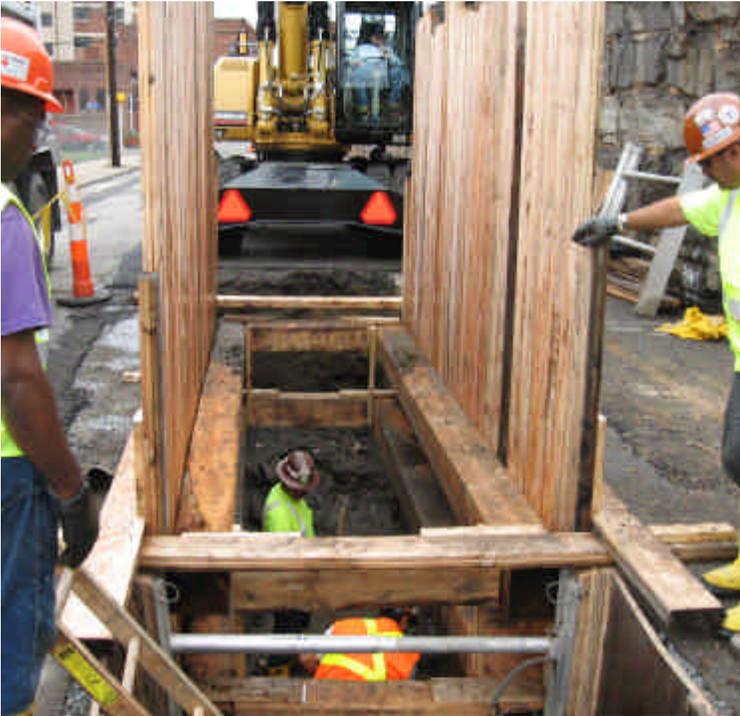
Trench excavation activities on Railroad Ave. between Lafayette St. and Warren St.

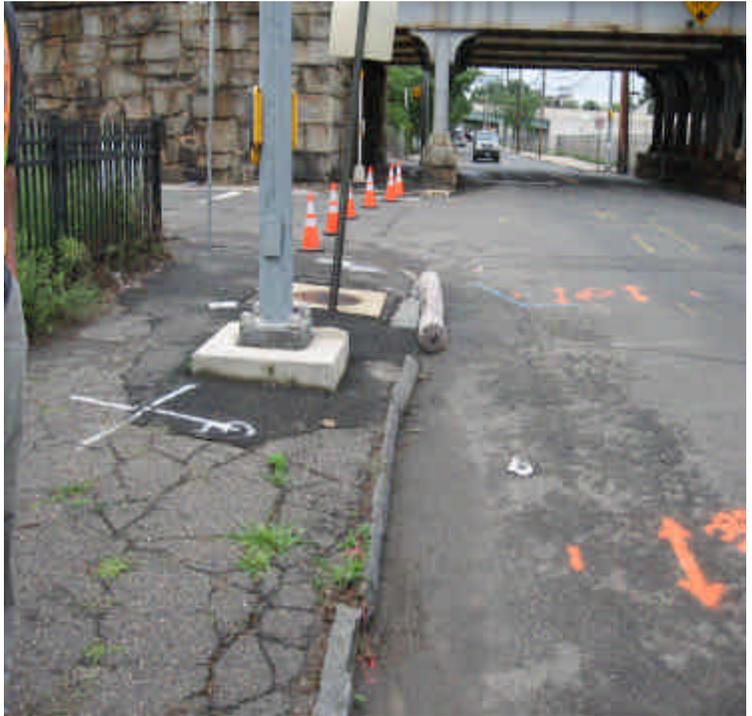
Gutter buddy installed to protect curb drop inlet on Lafayette St. at the intersection with Railroad Ave.

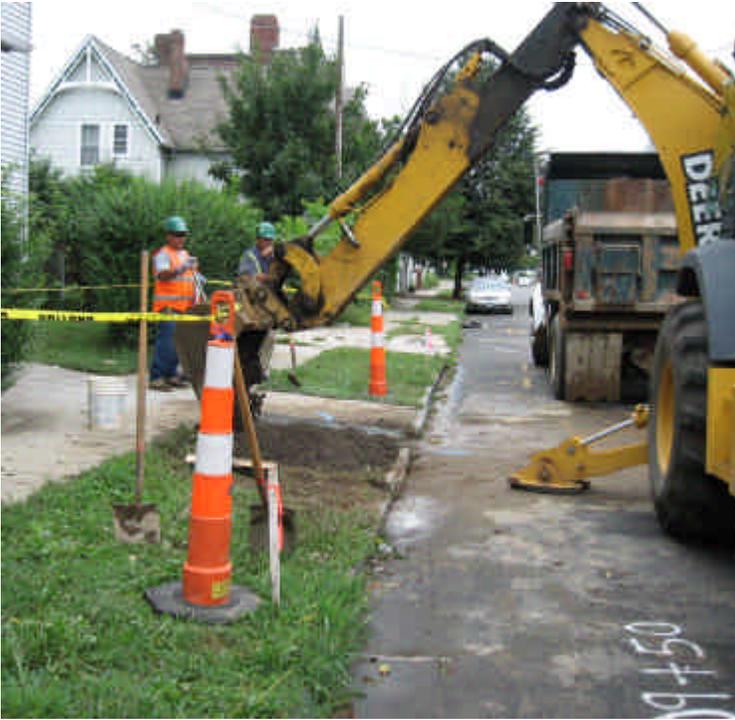
Utility work being conducted within the shoulder of Broad St. at the intersection of Atlantic St. Work includes an approximately 6 x 6 foot area. Disturbed soils should be permanently stabilized/revegetated if no further work is required in area.

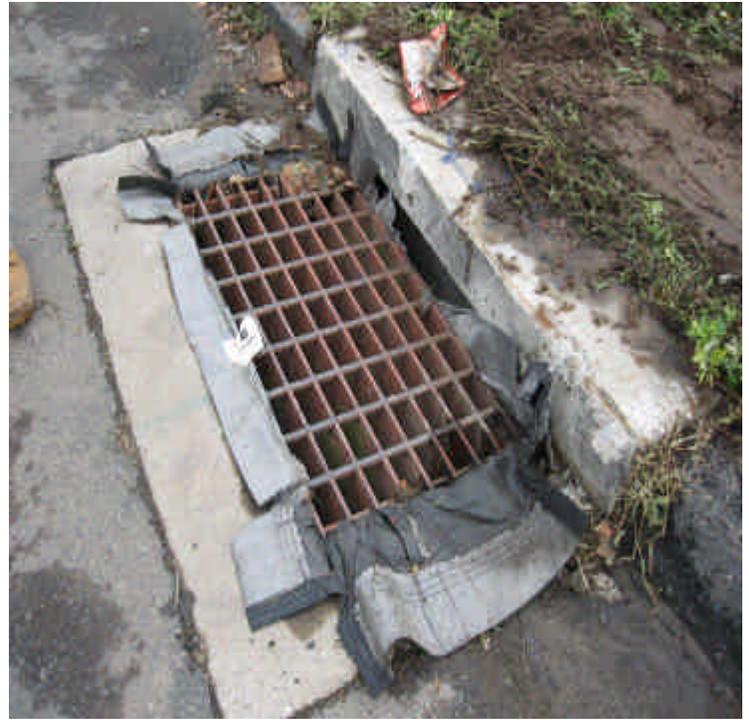
Catch basin near utility work. A gutter buddy (or similar) should be installed along the curb drop inlet of the catch basin to prevent sediment from entering the stormwater drainage system.

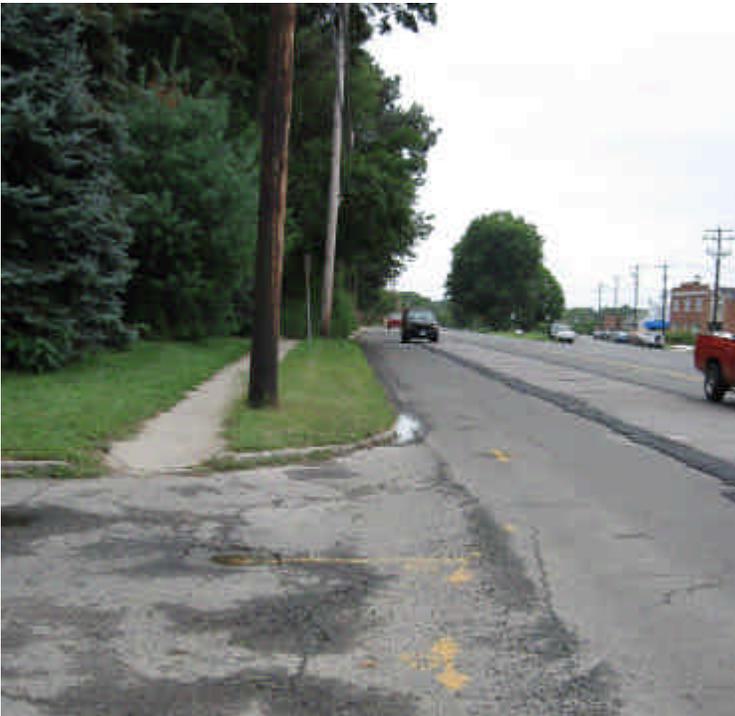
Fairfield: Photo of the intersection of Rt. 130 (Post Road) and Shoreham Village Dr. looking southwest at Rt. 130. The slurry of fine sediments created by saw-cutting and noted during the last inspection had been removed from along the gutter of Rt 130.

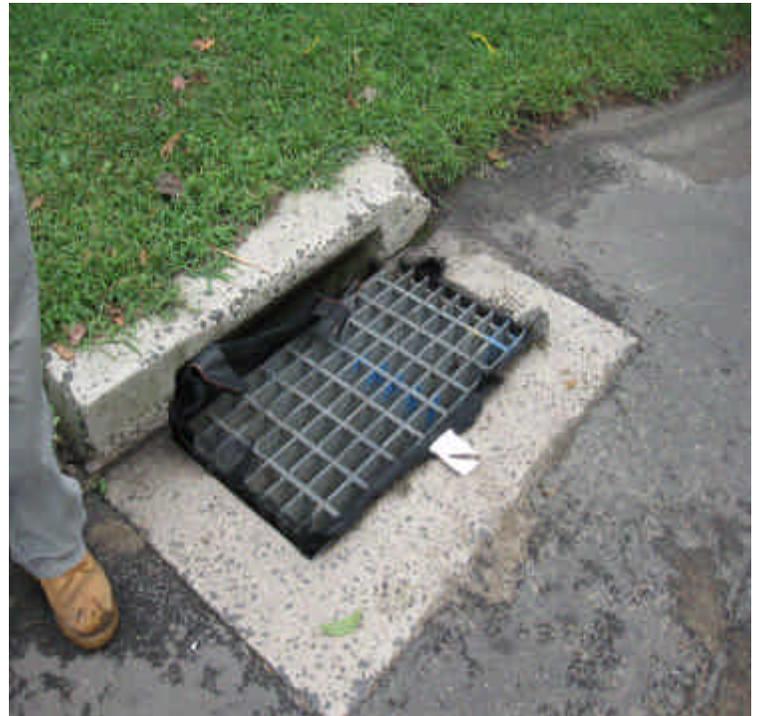
Catch basin located on Old Post Road. This basin receives most stormwater associated with the vault #7537 construction. BSC recommends that a more stable fabric and a gutter buddy* be installed to protect the curb drop inlet portion of the basin.

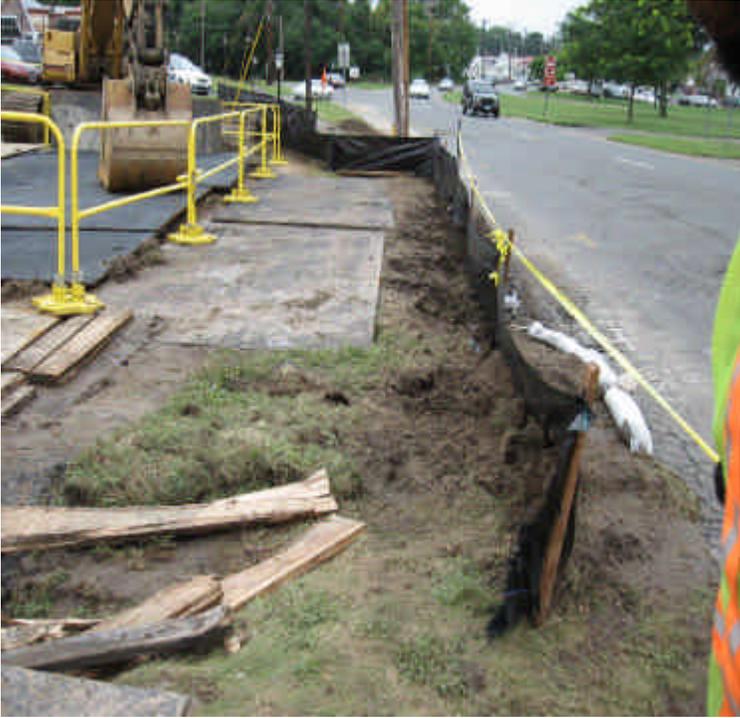
Vault #7537 construction area on the shoulder of Rt. 1. Additional controls should be placed between the disturbed soils and Rt. 1.

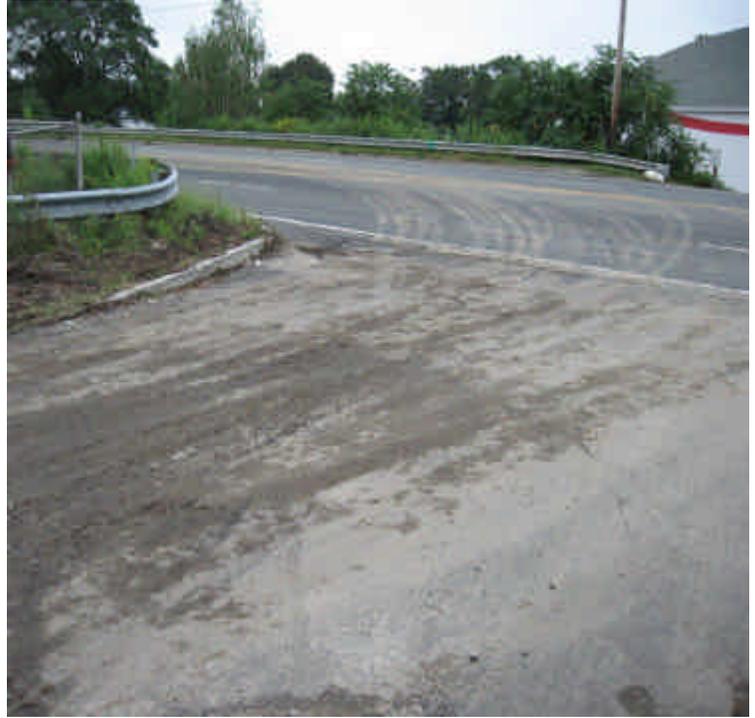
<p>Sediment tracking was noted on Kings Highway from the yard. A stone construction entrance was recently installed and new material was being spread to reduce mud in yard. 8/30/06</p>	<p>Roadway should be swept. If tracking continues, additional control methods should be implemented. 8/30/06</p>	<p>Stone construction tracking pad has been constructed</p>
	<p>Storage yard is bordered on the east by a perimeter chain link fence. However, potentially jurisdictional wetlands and a concrete lined swale are located immediately adjacent. No controls are in place to contain yard. 8/30/06</p>	<p>Controls should be installed to contain yard and prevent sedimentation to sensitive areas. 8/30/06</p>	<p>Needs attention</p>
<p>A stockpile is located adjacent to perimeter fence with no controls containing it from potential resource areas.</p>	<p>Erosion controls should encircle soil stockpile and/or soil pile should be stored away from adjacent wet</p>	<p>Needs attention</p>

Tracked sediment from storage yard located off Kings Highway near the Rt 1 rotary in Fairfield. Sediment should be swept off the roadway on a regular basis.

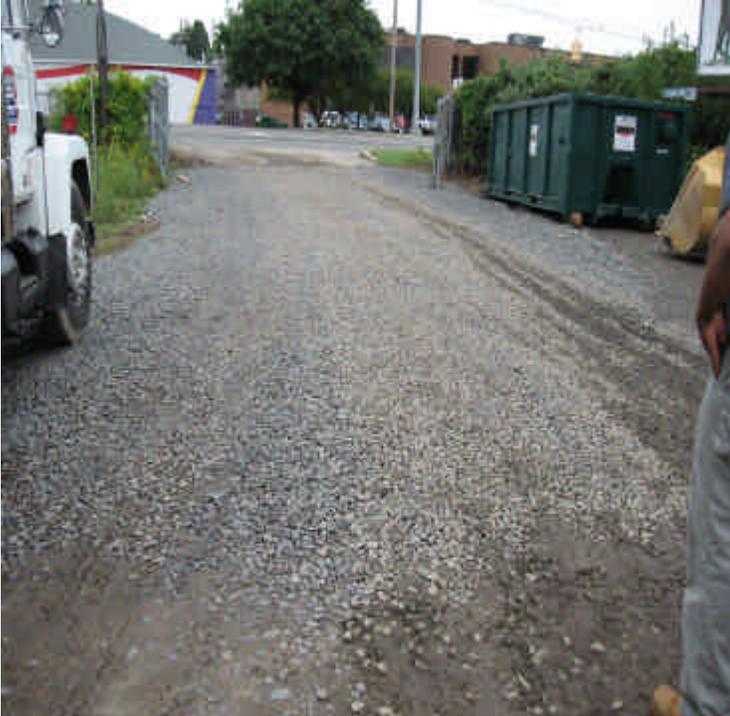
Photo taken facing Kings Highway at the newly installed construction entrance within the storage yard.

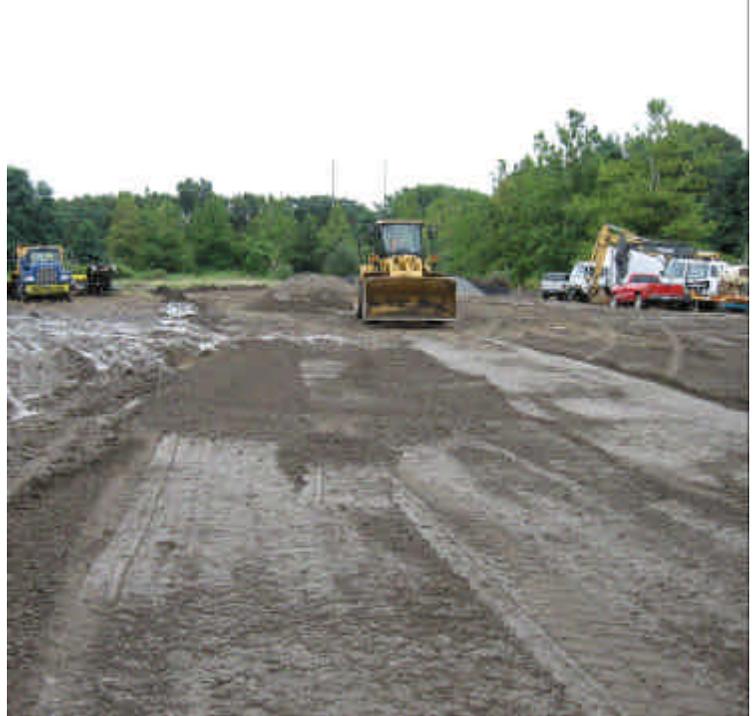
Photo taken facing north at the Kings Highway storage yard. Crews were spreading new loan material to reduce mud in the yard. Potentially jurisdictional resource areas are located to the east.

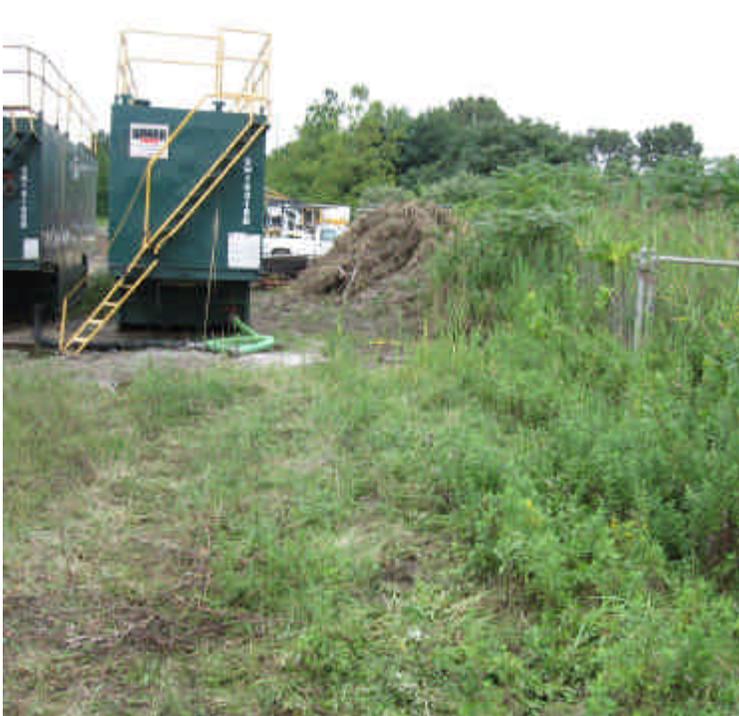
Photo taken facing northeast at the Kings Highway storage yard. The soil stockpile does not have erosion controls and no controls are present at the perimeter fence to contain the yard from the adjacent wet areas and armored swale.

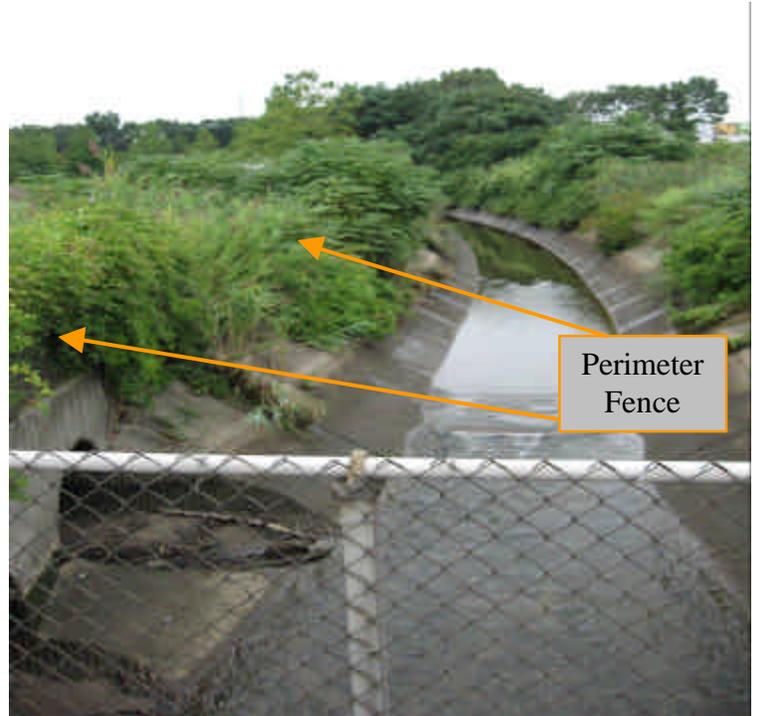
Photo taken facing northeast at concrete lined waterway/swale and adjacent wet areas. Kings Highway storage yard is located immediately to the west of the perimeter fence.

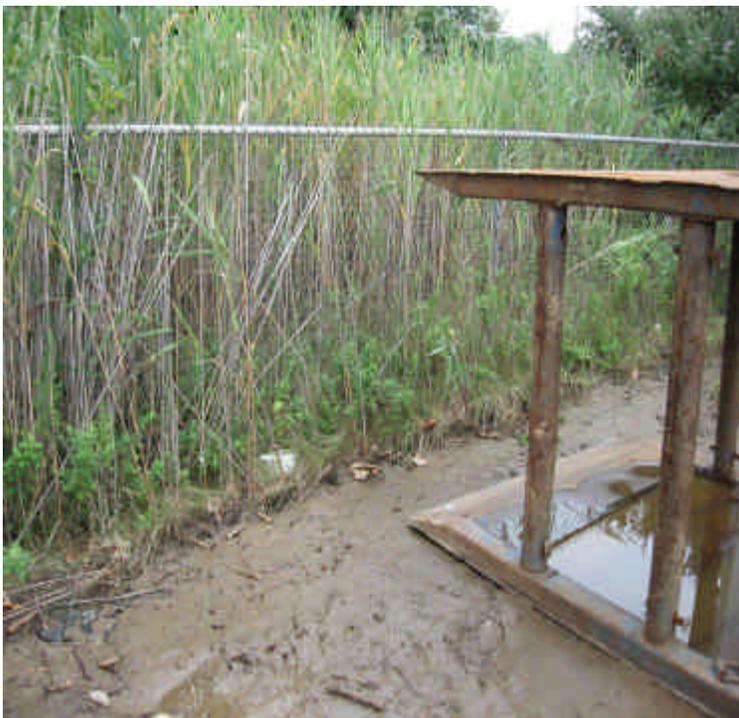
Photograph of Kings Highway storage yard immediately adjacent to perimeter fence. Erosion controls should be installed to contain the yard from the waterway/swale and wet areas on the other side of the fence.

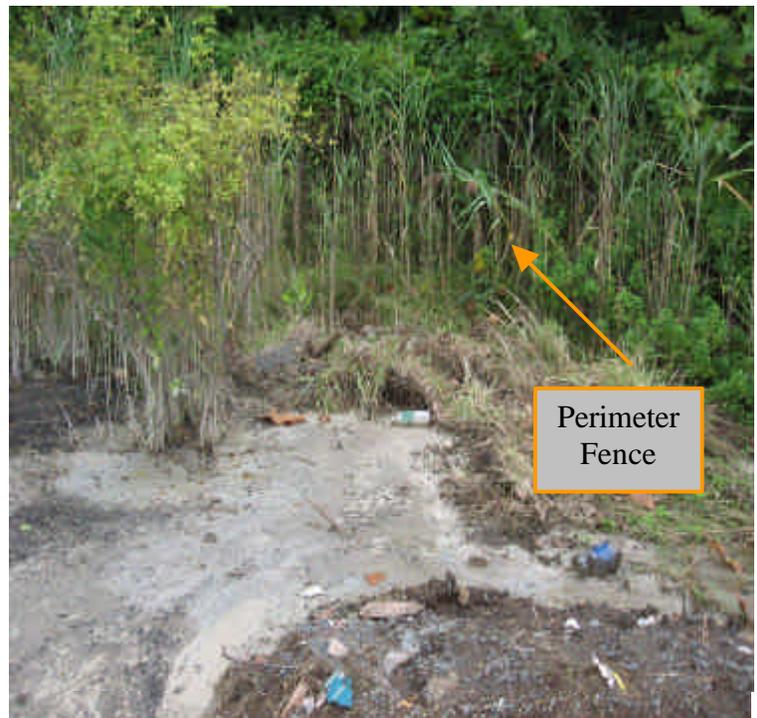
Areas of Inspection	Observation	Recommended Action	Corrected Action
	<p>8/30/06</p> <p>A concrete washout was noted immediately adjacent to perimeter fence with no controls established to prevent concrete from entering potential resource areas. 8/30/06</p>	<p>areas. 8/30/06</p> <p>A designated concrete washout area should be located away from sensitive areas and contained. 8/30/06</p>	Needs attention
Inland Wetland and Watercourse encroachment and mitigation	The Kings Highway storage yard is located adjacent to potential resource areas and a concrete lined swale/waterway and requires controls. 8/30/06	See erosion control section. 8/30/06	Needs attention
Staging, Storage, and Parking Areas	<p>A contractor storage yard on Bostwick Ave contains frac tanks, trailers, and available parking. Reserve spill kits are located in the equipment trailers. 8/30/06</p> <p>A contractor storage yard is located off of Kings Highway near the Rt. 1 rotary. 8/30/06</p>	<p>None 8/30/06</p> <p>See erosion control section for recommendations. 8/30/06</p>	<p>NA</p> <p>NA</p>

Photo of a concrete washout noted immediately adjacent to perimeter fence. A designated, contained washout area should be established and located away from the edge of the yard.
