**Docket No. 272 – Development and Management Plan Inspection**

**Segment 4a Underground Line**

**Date:** September 20, 2006 (night inspection)

**Location:** Singer Substation to Fairfield/Westport Town Line

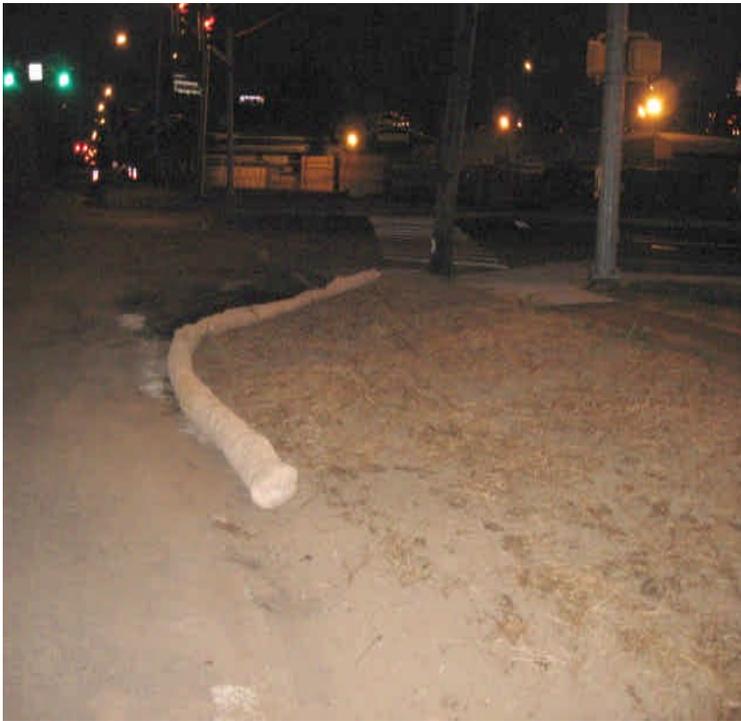
**Photo taken on Railroad Ave. looking towards its intersection with Wordin Ave. Exposed soils that are no longer being worked have been seeded and mulched with hay. This area also has a gutter buddy installed to help stabilize the soil.**

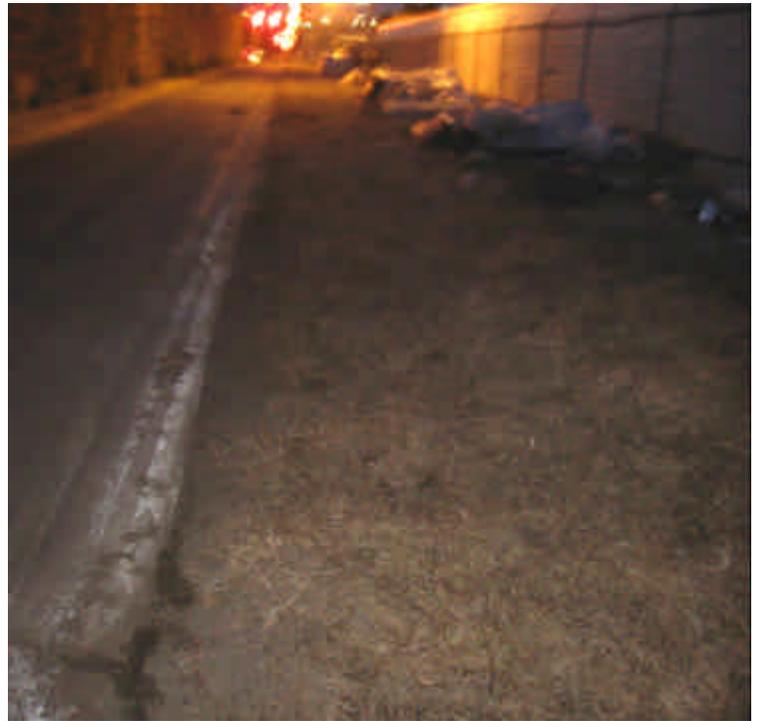
**Photo taken on Railroad Ave. between Wordin Ave. and Howard Ave. Exposed soils that are no longer being worked have been seeded and mulched with hay.**

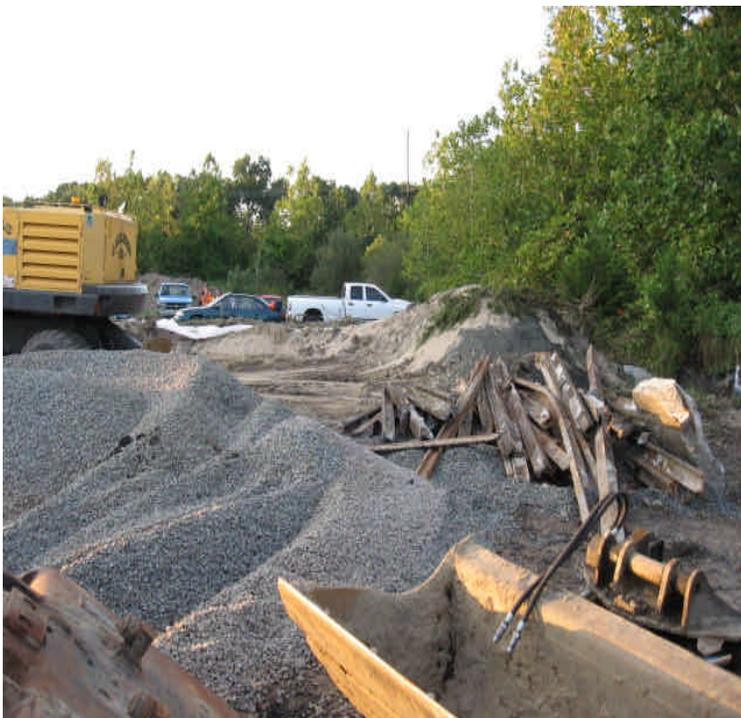
**Photo of Kings Highway laydown yard taken facing northeast. The perimeter fence is located in the far right of the photo. Soil pile in the background will be relocated when original concrete basin is removed.**

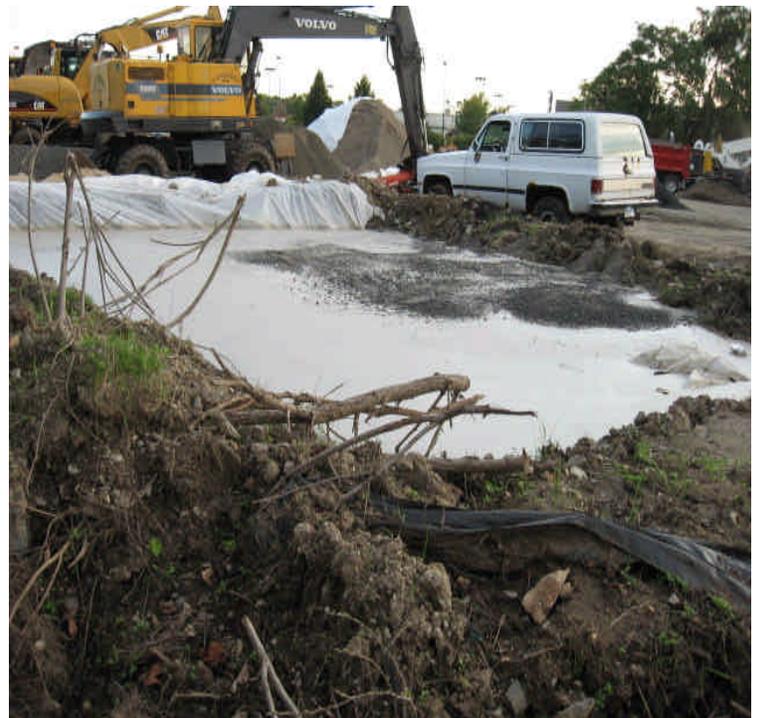
**Original concrete washout basin located in the Kings Highway laydown yard. Concrete will be removed from basin when material has hardened, and the basin will be removed.**

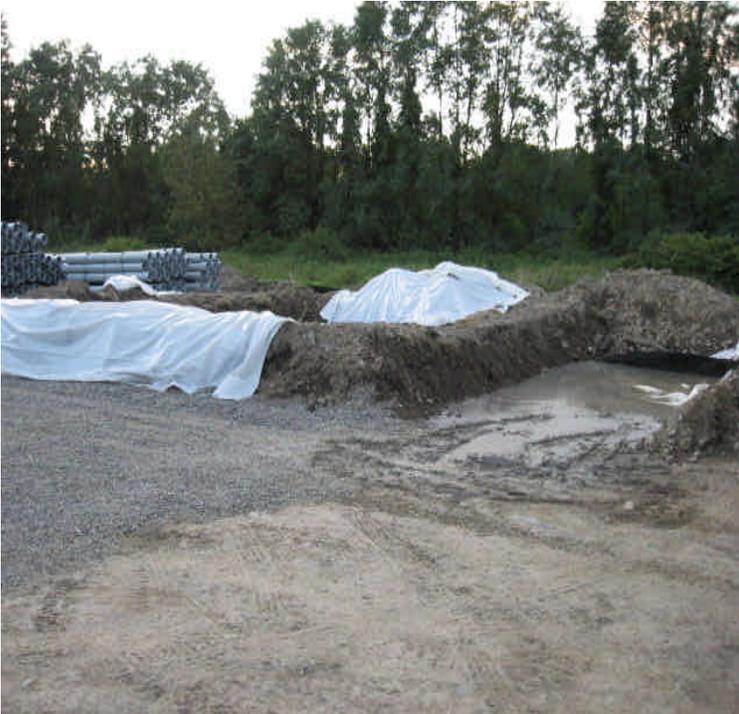
**New concrete and sweeper wash-out area located away from the perimeter. Additional controls are needed in this area.**

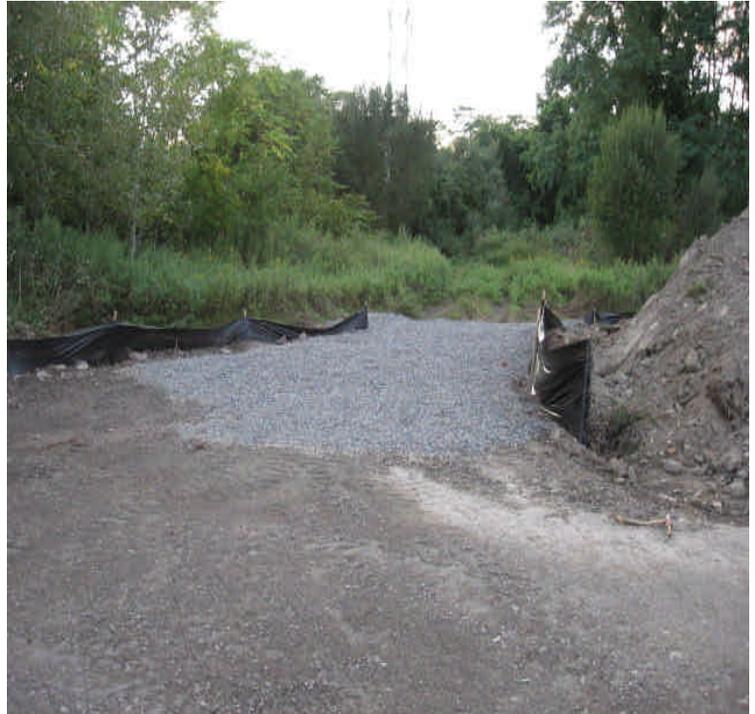
**Access way need within the Kings Highway laydown yard for the Fairfield Sewer Department. A stone berm is to be added between the yard and the vegetated area.**

Areas of Inspection	Observation	Recommended Action	Corrected Action
	<p>One area requires regular access by the Town of Fairfield and silt fence cannot be installed. New stone was placed here. 9/20/06</p>	<p>9/13/06 – 9/20/06            Stone berms or similar will be installed across the access-way to filter run-off. 9/13/06 – 9/20/06</p>	<p>Stone has been installed but not berm.</p>
<p>Inland Wetland and Watercourse encroachment and mitigation</p>	<p>The Kings Highway lay-down yard is located adjacent to potential resource areas and a concrete lined waterway but is well controlled at this time. 9/20/06</p>	<p>See erosion control section. 8/30- 9/20/06</p>	<p>NA</p>
<p>Staging, Storage, and Parking Areas</p>	<p>A contractor storage yard on Bostwick Ave contains frac tanks, trailers, and available parking. Reserve spill kits are located in the equipment trailers. 9/20/06</p> <p>A contractor lay-down yard is located off of Kings Highway near the Rt. 1 rotary. 9/20/06</p>	<p>None 9/20/06</p> <p>See erosion control section for recommendations. 9/20/06</p>	<p>NA</p> <p>NA</p>

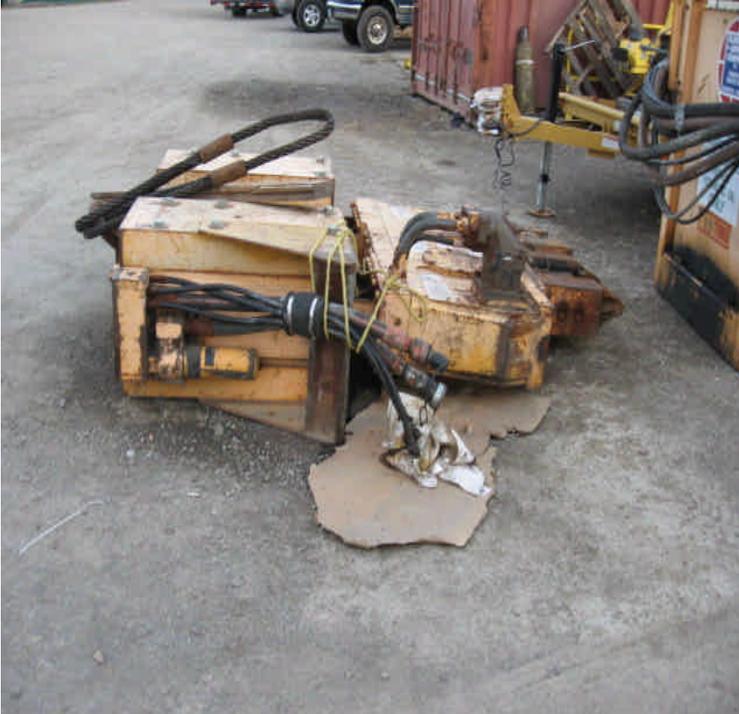
**A piece of equipment located in the Kings Highway laydown Yard has been proactively controlled from potential leaks from fluid filled hoses coming in direct contact with the ground.**

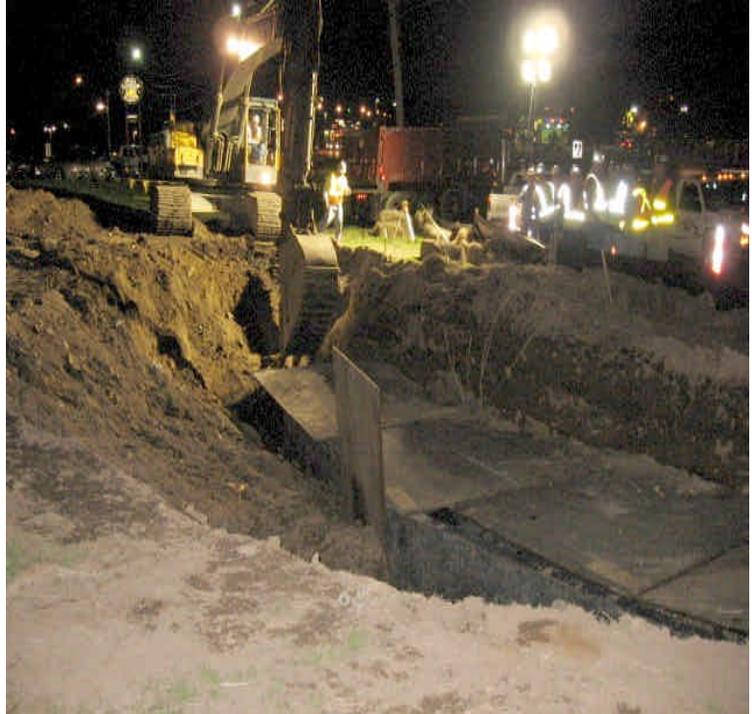
**Excavation activities for the trench that connects to Vault #7537. Excavator is located immediately above vault.**

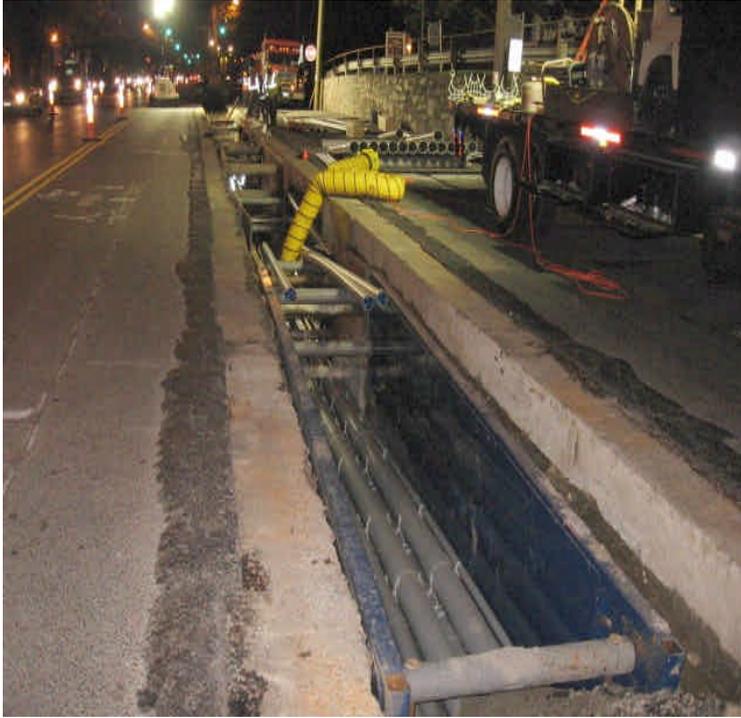
**Photograph taken on Rt. 1 facing southwest of trench activities between Round Hill Rd. and Unquowa Rd.**

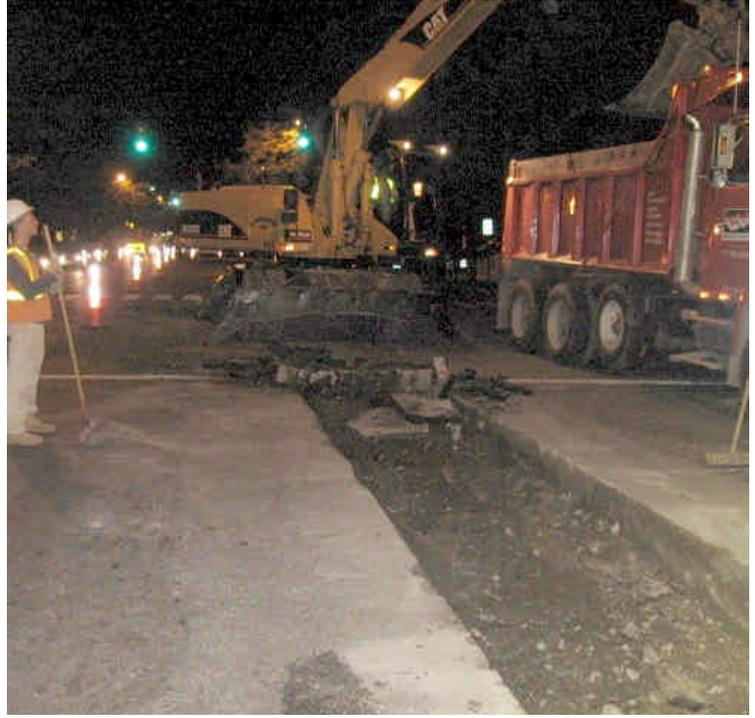
**Photo of trenching activities in same location as photo to the left. Crews were proactively sweeping pavement of soil as the trench was being excavated.**

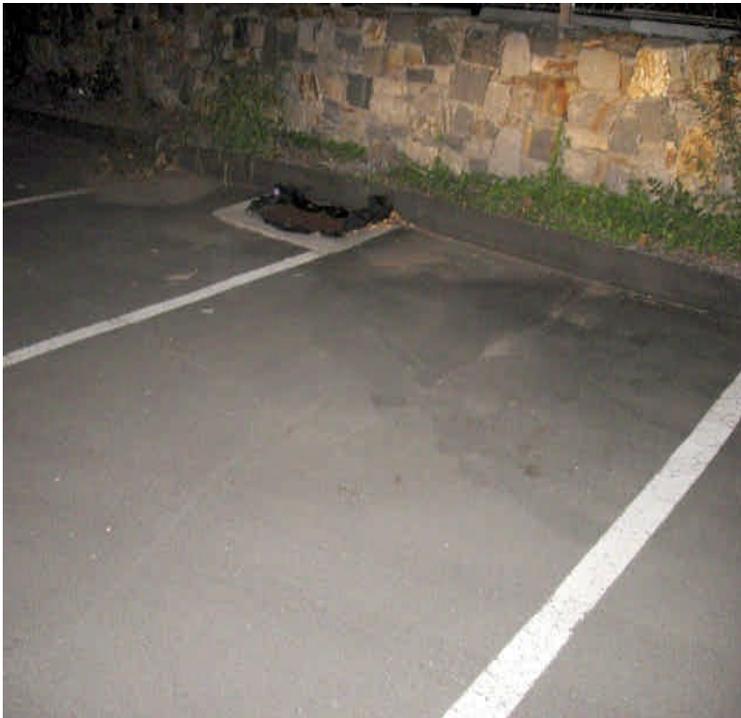
**Photograph of parking area and catch basin located adjacent Vault #6428. Stain on pavement from spill last week has been cleaned and soiled silt sack has been replaced.**

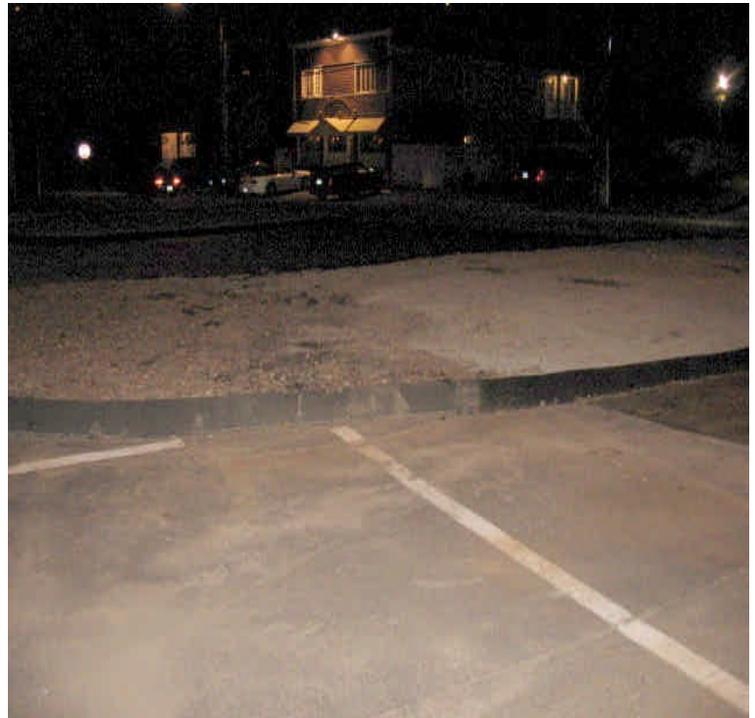
<b>Kings Highway Lay-down Yard (Off Kings Highway, near Rt. 1 rotary)</b>	<p>Work on vault #6428 is complete in the parking area. The “islands” in the parking area still have disturbed soils. There is accumulated sediment around two of the three catch basins in the parking area but controls are in place. 9/20/06</p> <p>The abandoned concrete wash-out basin contains hardening concrete. 9/20/06</p> <p>An area for the sweeper truck to wash-out has been added to the new basin. 9/20/06</p>	<p>Stabilize any exposed soils if appropriate. Remove all accumulated sediment located near the catch basins. When soils are stabilized and sediment is removed from parking area, silt sacks could be removed if work is complete in the area. 9/20/06</p> <p>The concrete in the abandoned basin should be properly disposed of when dried and the basin removed. 9/20/06</p> <p>Additional geofabric should be added to the new concrete wash-out basin so that it covers the entire bottom of the basin, including the sweeper washout area.</p>	<p>Needs attention when feasible</p> <p>Needs attention when feasible</p> <p>Needs attention when feasible</p>

**Photograph of the location of Vault #6428. Vault work is complete and curb has been re-paved. Exposed soil on island should be stabilized if appropriate.**

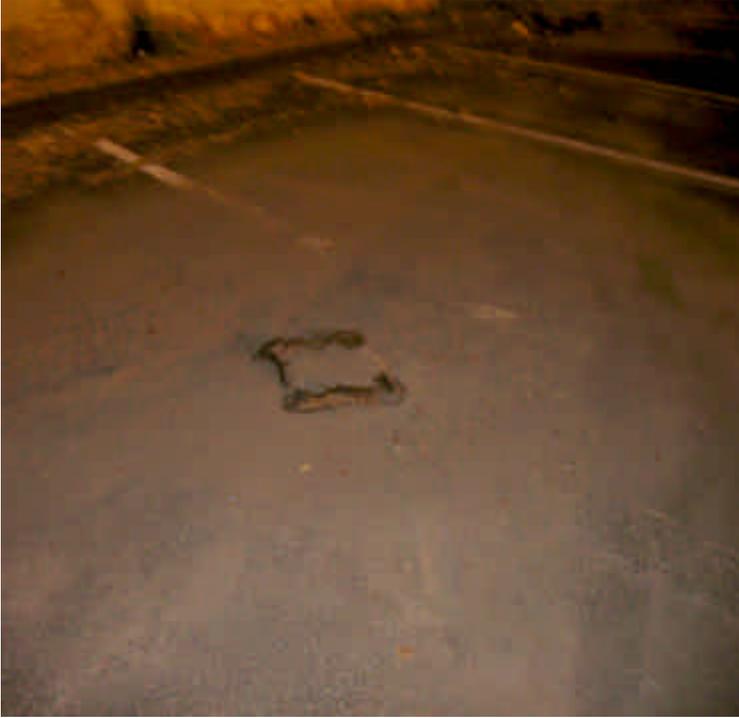
**Photograph of parking area and catch basin located adjacent to Vault #6428. Accumulated sediment should be removed on a regular basis.**

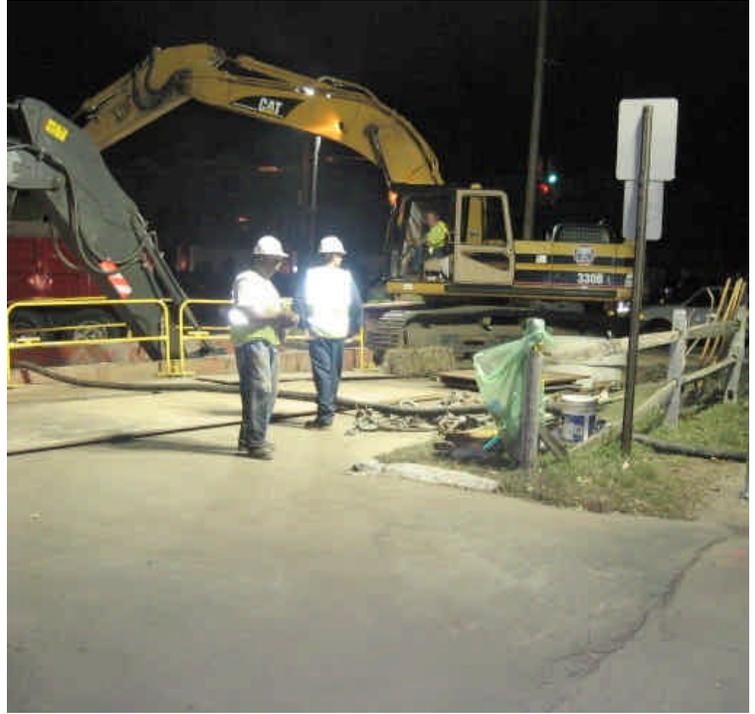
**Vault #7527 excavation activities consisted of removing bedrock.**

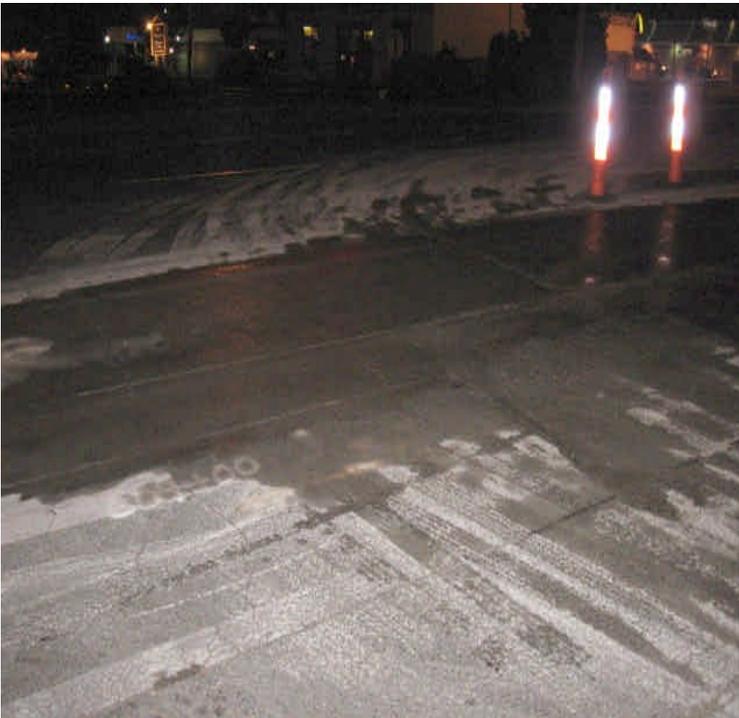
<b>Areas of Inspection</b>	<b>Observation</b>	<b>Recommended Action</b>	<b>Corrected Action</b>
<b>Access Roads and Adjacent Roadways</b>	All work is within or adjacent to existing paved roadways at this time.	See erosion control section.	NA
	Slurry tracking from sawcutting southwest of vault #7537 was occurring as the area could not be isolated from traffic. 9/20/06	See erosion control section for more details. 9/20/06	NA
<b>Vault Openings and Trench Construction Bridgeport</b>	The majority of the excavated trench has been backfilled on Railroad Ave. between Wordin Ave. and Iranistan Ave. 9/20/06	None 9/20/06	NA
	Trench excavation continues east on Railroad Ave, between Wordin Ave. and Howard Ave, and between Howard Ave. and Hancock Ave. Sediment on roadways from construction activities is swept off of roadway upon completion of work in the area or at the close of the workday. 9/20/06	Continue to monitor and be proactive. Dust control has been an issue in other areas. Continue to sweep as soon as feasible. 9/20/06	Roadway was swept regularly. (Proactively)  Catch basins are protected. (Proactively)

**Saw cutting area on Rt. 1 to the southwest of Vault #7537. The area could not be isolated from traffic due to the access to Dunkin Donuts being located in this area. This area and future areas like this need continuous attention to avoid tracking the slurry and the resulting airborne dust production.**

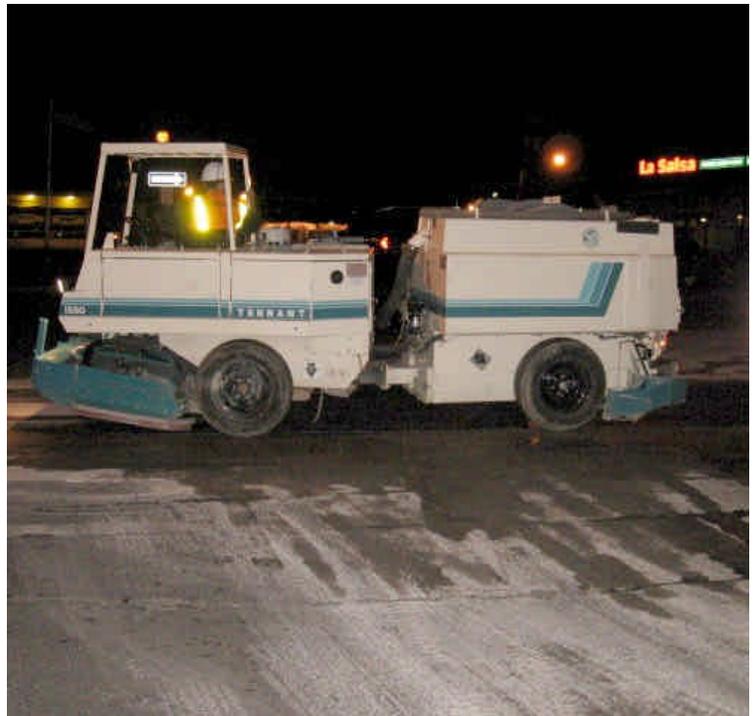
**Street sweeper cleaning slurry from the roadway that was created during saw cutting activities.**
