**Docket No. 272 – Development and Management Plan Inspection**

**Segment 4a Underground Line**

**Date:** October 13, 2006

**Location:** Singer Substation to Fairfield/Westport Town Line

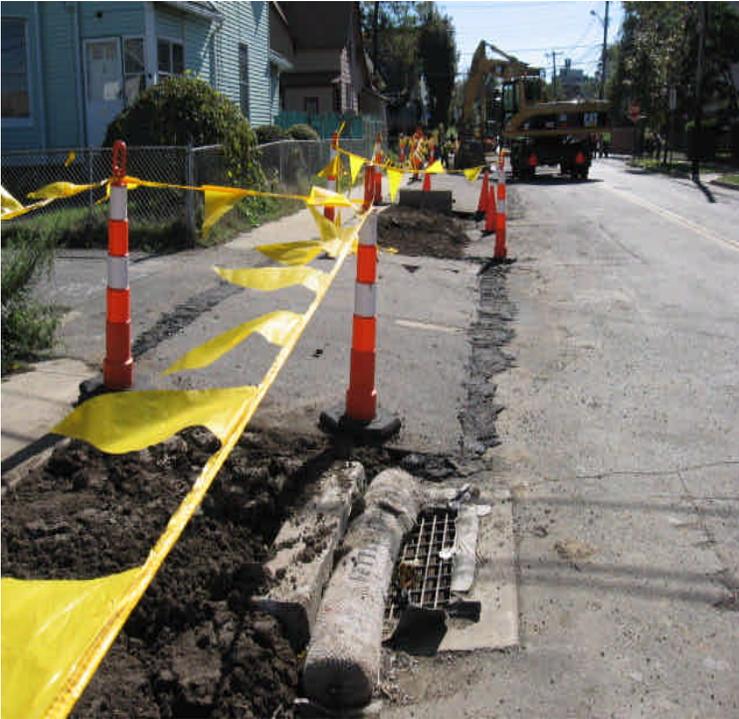
**Trenching activities near the intersection of Atlantic Ave. and Broad St. Please note that controls are in place in the catch basin.**

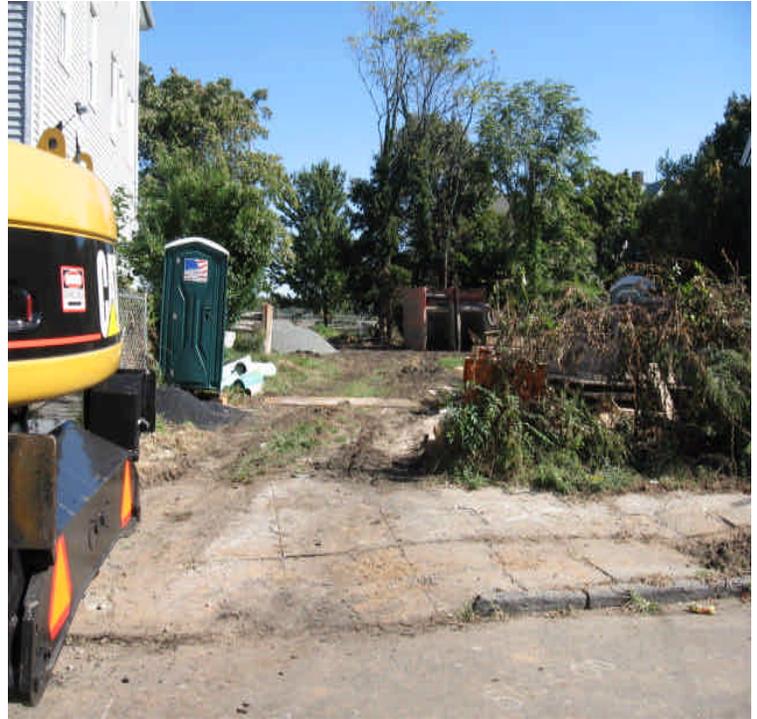
**Former location of garage/shed on Broad St. that has been removed for utility installation.**

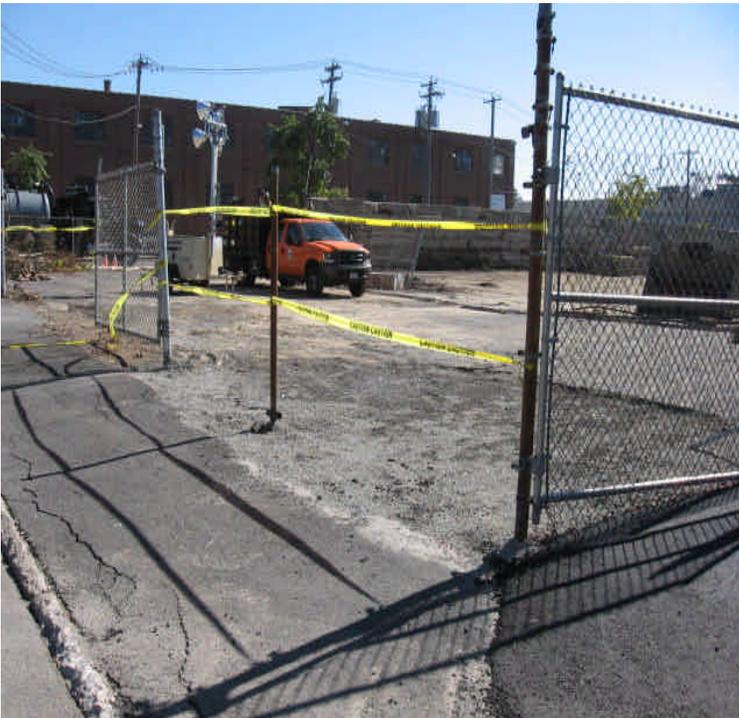
**Location of Vault #7546 that has been installed adjacent to Railroad Ave.**

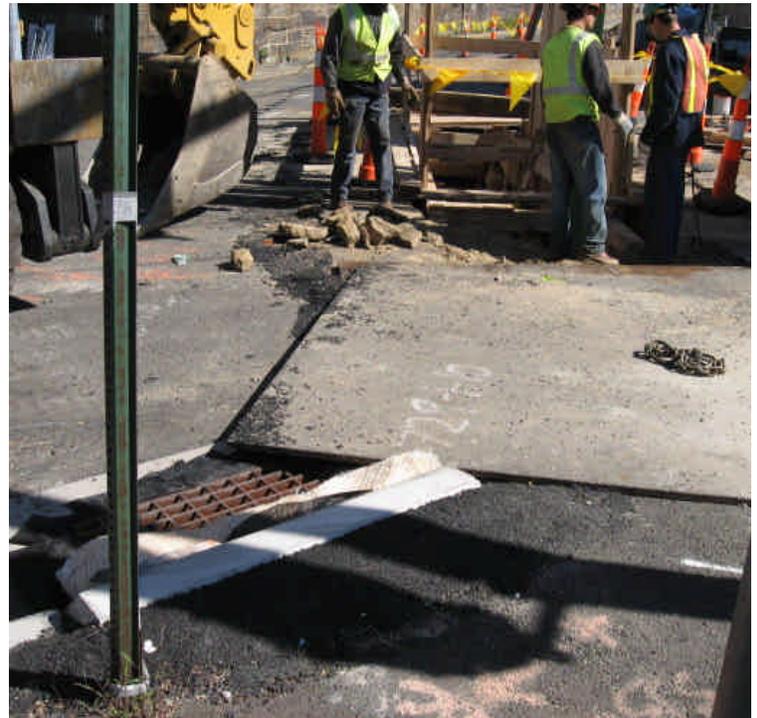
**Utility work on at the intersection of Bostwick Ave. and Railroad Ave.**

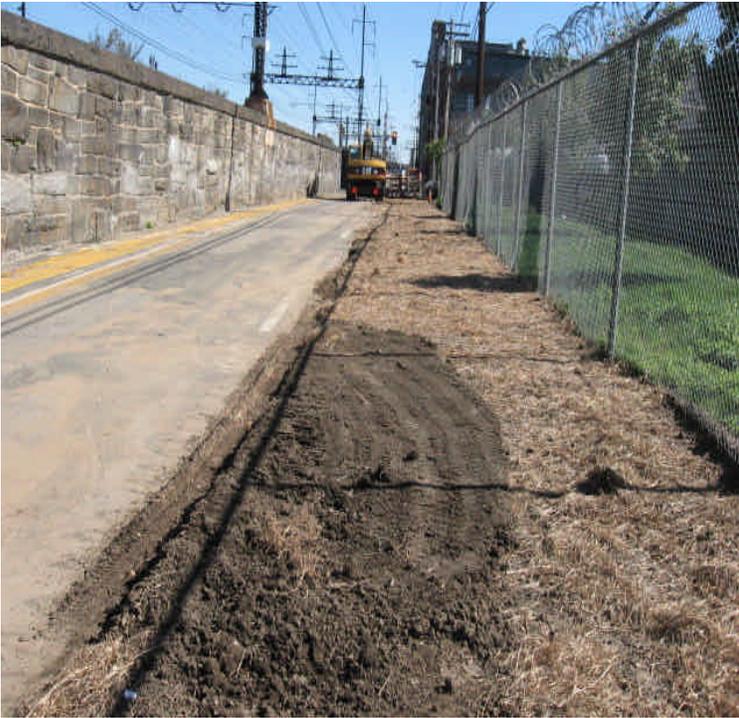
Photo of exposed soils stabilized with seed and hay mulch. The area that is not mulched was recently re-graded to remove gullies that had formed along the roadway from the recent rainfall.

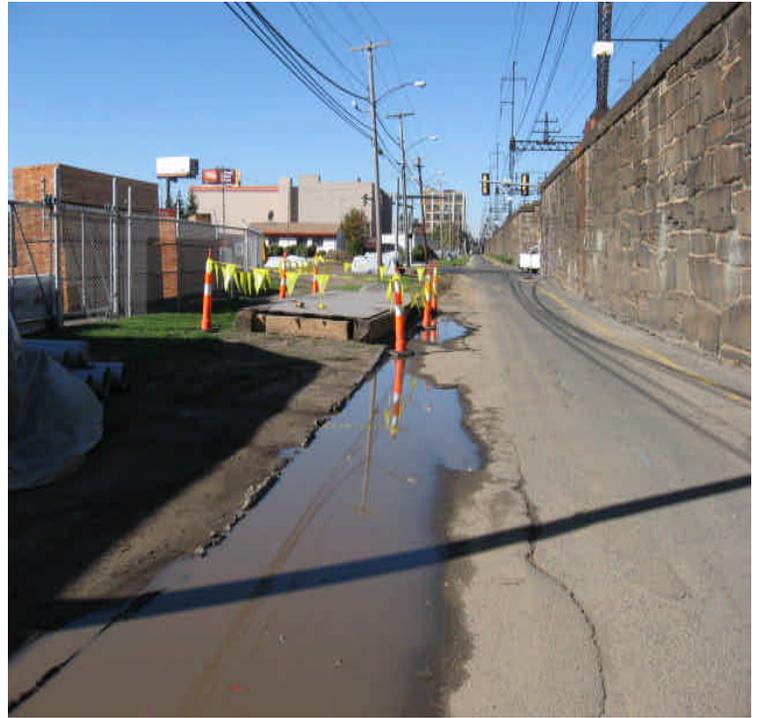
Photo taken on Railroad Ave. facing the intersection of Wordin and Railroad Ave.

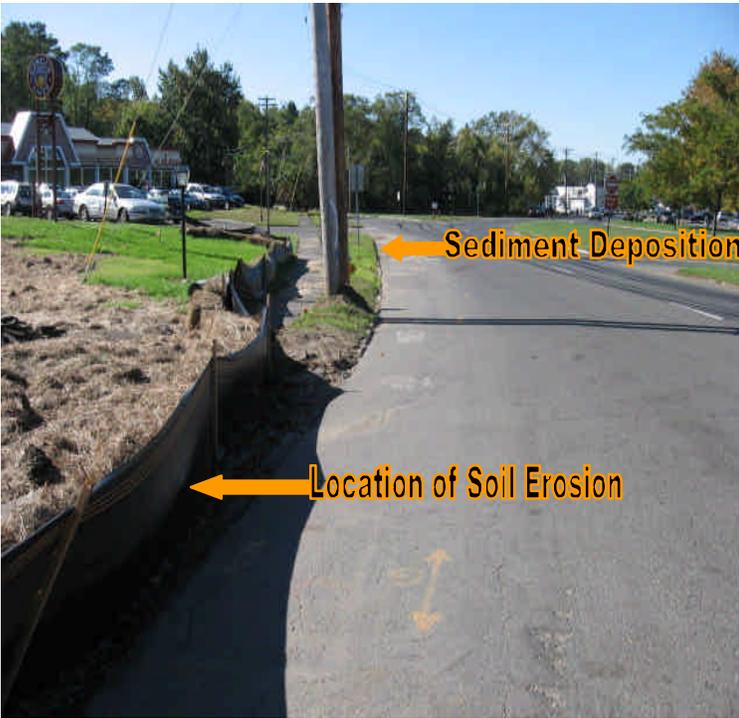
<b>Fairfield</b>	<b>At Vault #7537, a line of</b>	<b>Remove all sediment</b>	<b>Needs attention</b>

Photo of Vault # 7537 adjacent to Rt. 1. The majority of exposed soils have been stabilized with hay mulch but exposed soil between the silt fence and Rt 1 has eroded resulting in sedimentation along the roadway to the catch basin.

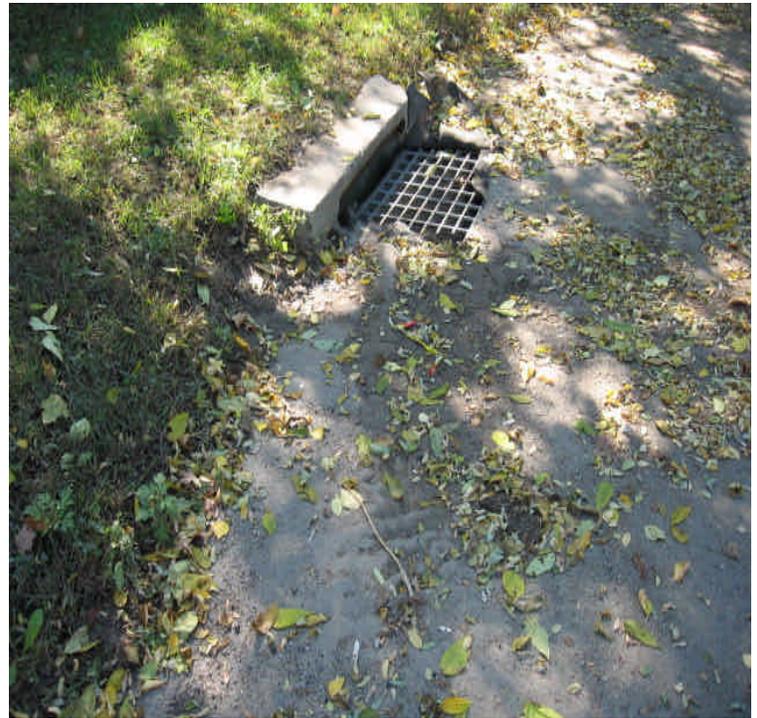
Catch basin located on Old Post Rd. that receives runoff from the Vault # 7537 area. Sediment has accumulated in this area. The gutter buddy was removed during the rain event due to ponding of water in this area.

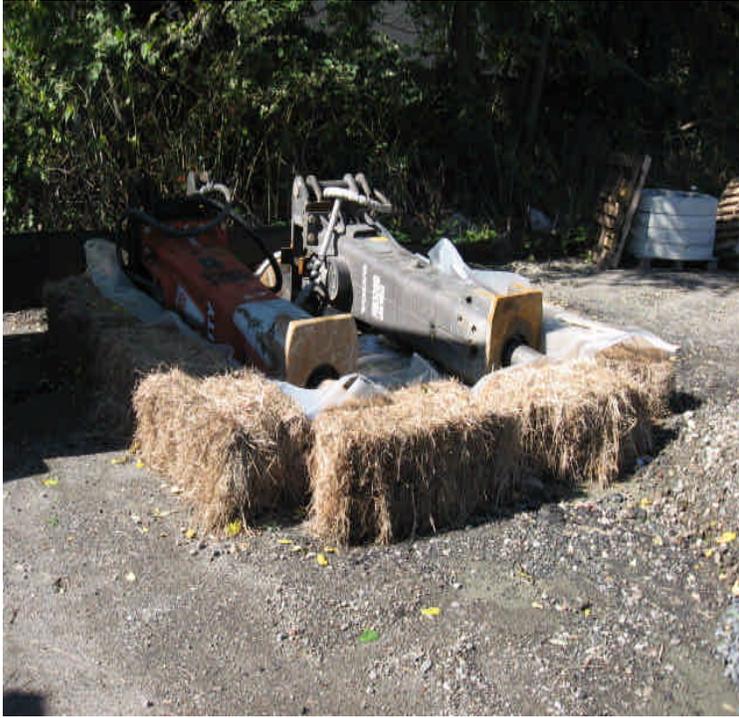
**Attachments with fluid-filled hoses are being appropriately stored in the yard with proactive spill controls in place.**

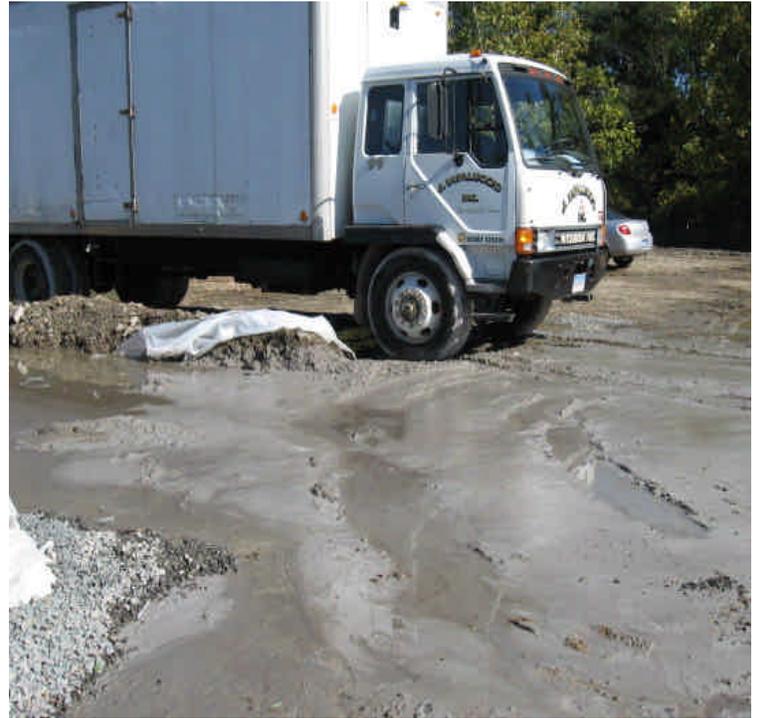
<p><b>The sweeper truck wash-out area is not contained within the designated area but remains well contained within the yard. 10/04-10/13/06</b></p>	<p><b>Implement methods to contain all truck wash-out material to the basin. 10/04-10/13/06 This was exacerbated by the recent rain.</b></p>	<p><b>Needs attention.</b></p>
	<p><b>The concrete washout basin is almost to capacity. 10/13/06</b></p>	<p><b>Remove concrete from basin to restore capacity if feasible. If not, an additional basin may need to be constructed. 10/13/06</b></p>	<p><b>Needs regular attention.</b></p>
	<p><b>The soil piles located in the westerly portion of the yard were hydro-mulched per erosion control guidelines. 10/13/06</b></p>	<p><b>Soil piles that are inactive for 30 days should be stabilized with a fast growing seed mix. 10/13/06</b></p>	<p><b>Hydro-mulch has been applied to soil piles.</b></p>
	<p><b>Equipment attachments with fluid-filled hoses were contained appropriately with proactive spill controls. 10/13/06</b></p>	<p><b>None. 10/13/06</b></p>	<p><b>Containment for attachments has been provided proactively</b></p>

**Sweeper washout area is not containing all of the washout run-off to the basin. The recent rainfall has exacerbated the situation but run-off remains contained to the yard.**

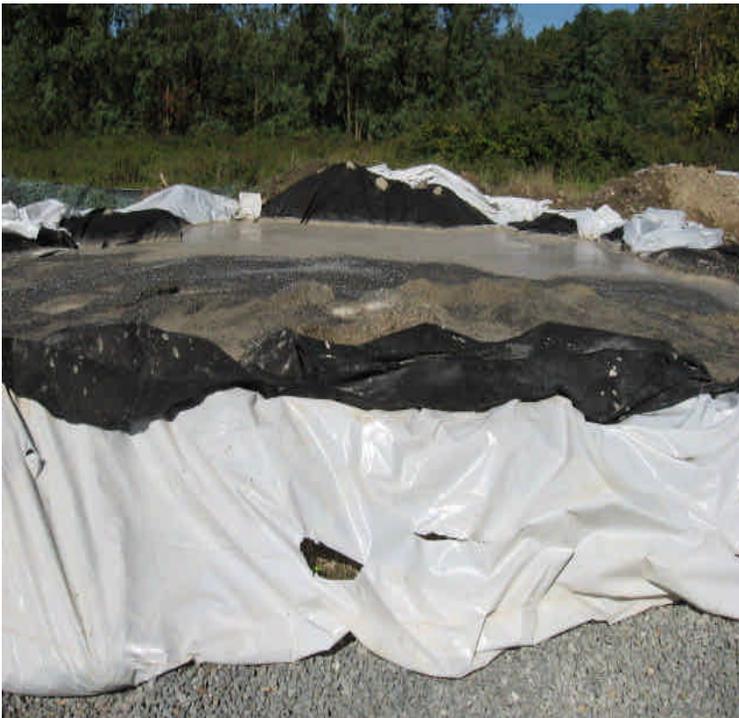
**Concrete washout basin is reaching capacity. Material should be removed in order to restore capacity or an additional basin could be created.**

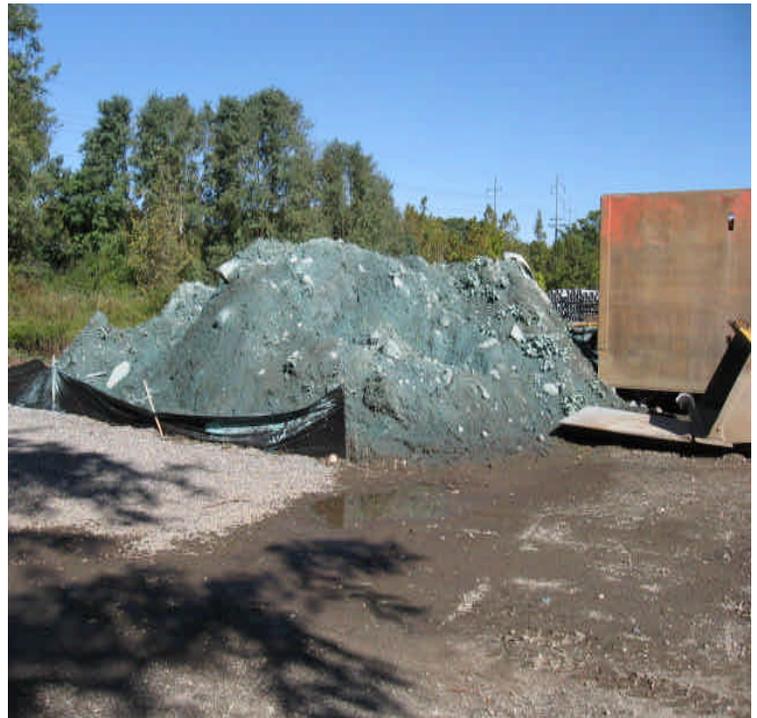
**Inactive soil piles within the yard have been seeded appropriately to control potential dust production, per the erosion control guidelines.**
