Docket No. 272 – Development and Management Plan Inspection

Beseck Switching Station Inspection

Date: December 12, 2006

Location: Beseck Switching Station

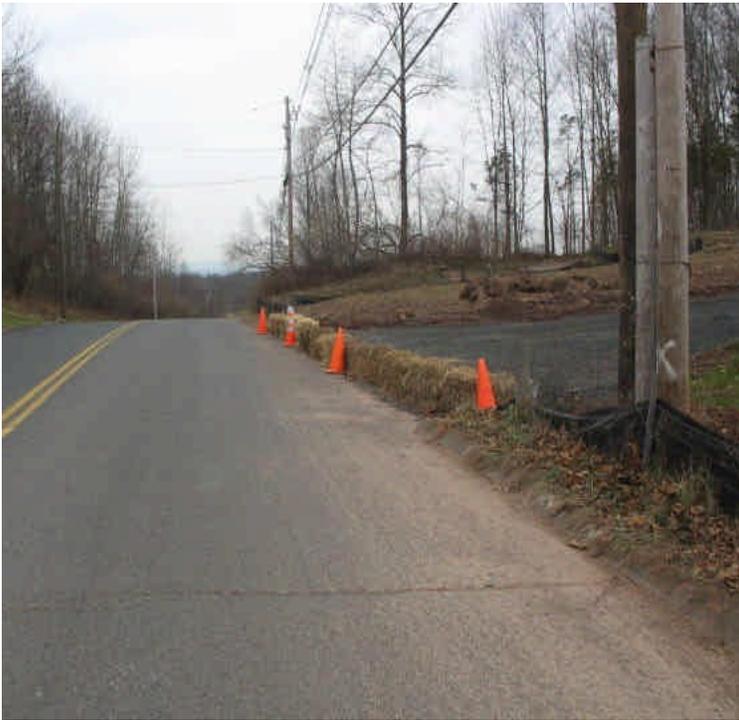
New entrance off Carpenter Lane at final grade with haybale barrier in place.

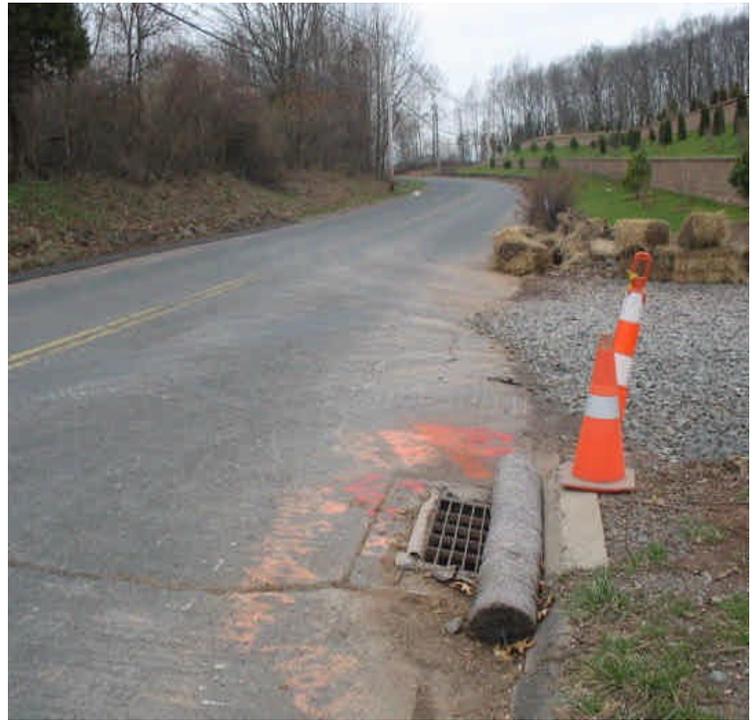
View of Carpenter Lane and retaining walls. Minor sediment accumulation was noted in the gutters on both sides of the roadway. This should be swept up by hand to prevent entry into the storm drain system.

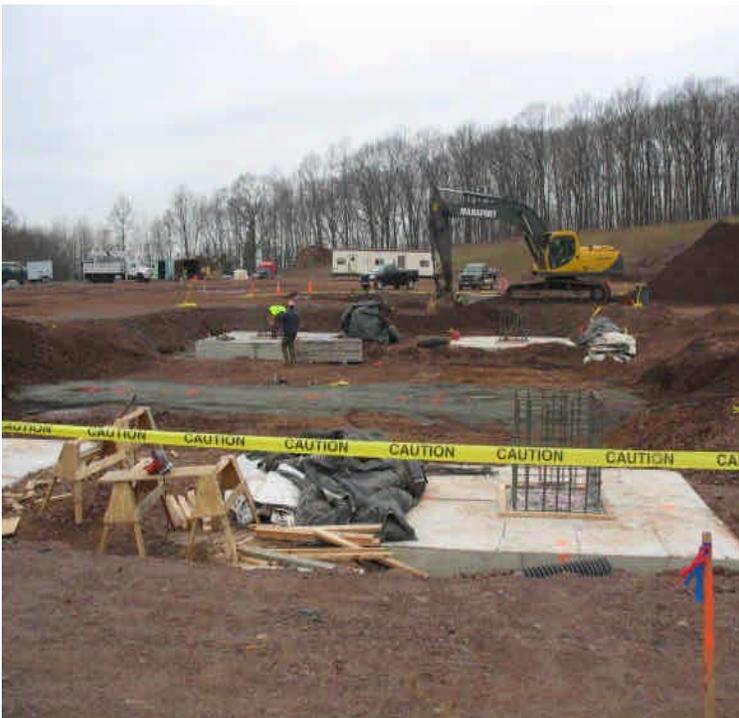
View of site looking from east to west. Foundation installation continues.

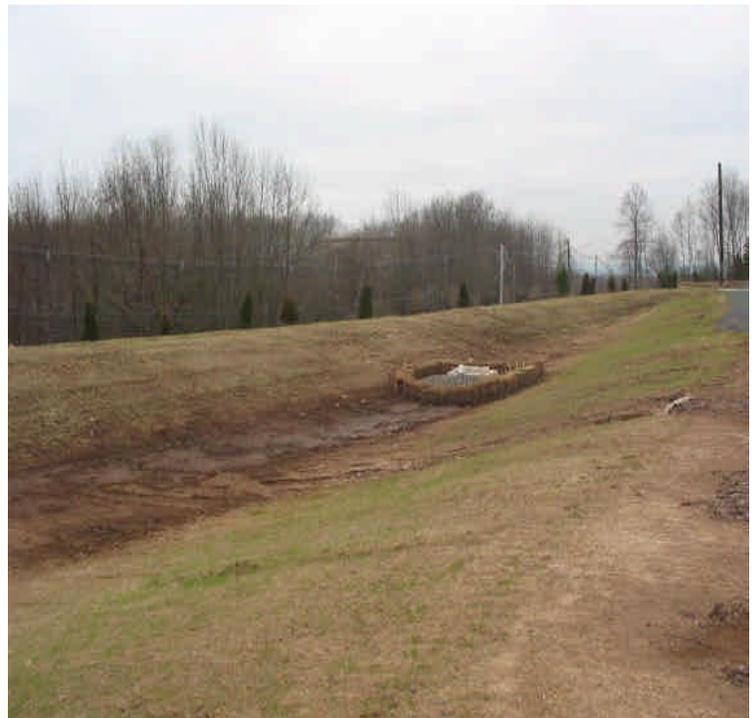
Some grass growth was observed on the seeded slopes of the detention basins. Additional/alternative controls are still recommended to prevent turbid water from pooling into the inlet.

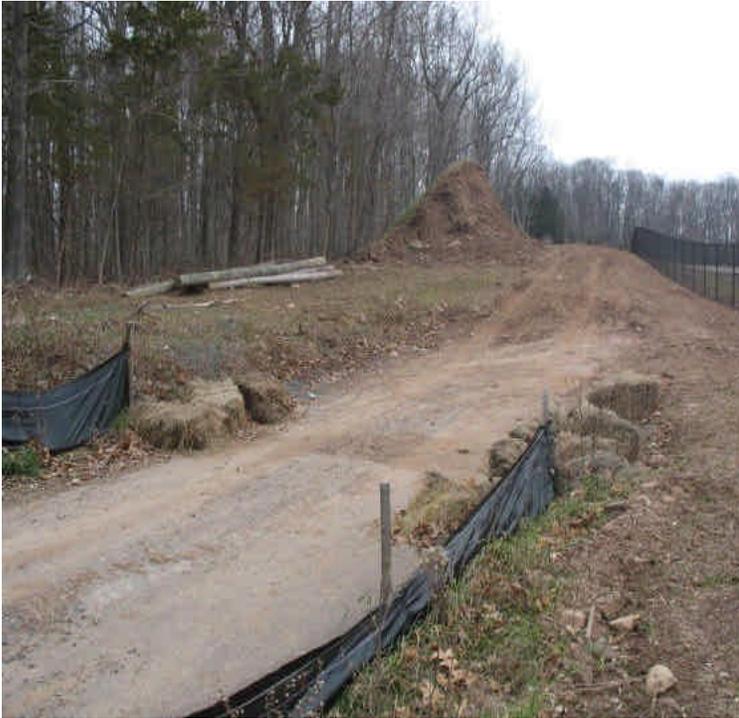
Replace haybales across the old Zolnik driveway (they had been moved for access). Soils have been graded and seeded.

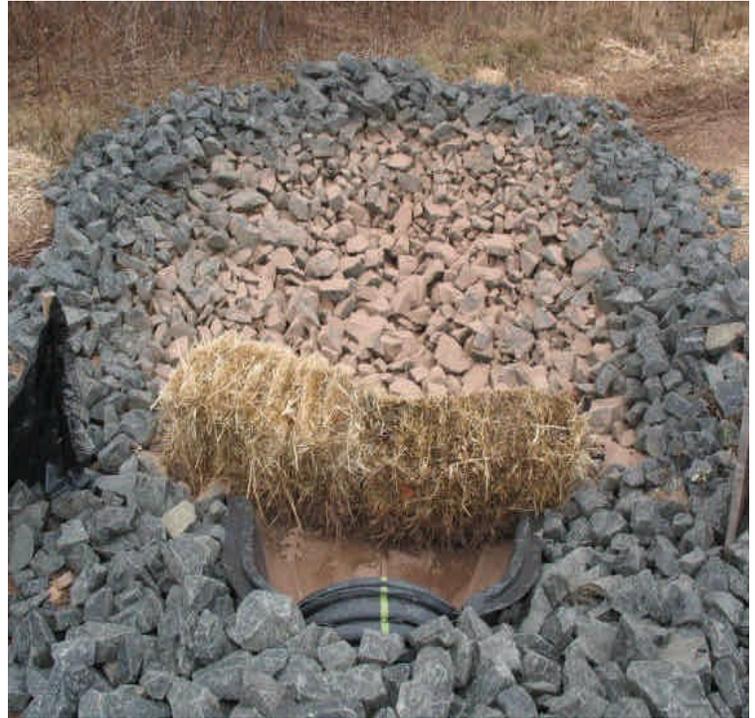
View of the culvert under the new access road. Some minor sediment was noted but was well contained in the trap. Beseck and Seg. 1A contractors are jointly sharing the access road.

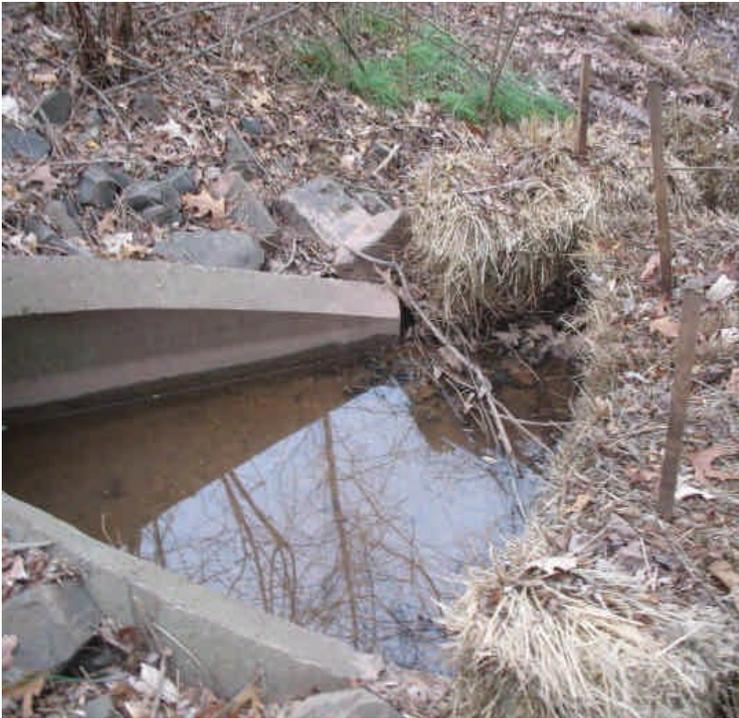
Storm drain outlet across Carpenter Lane contained settled sediment with clear standing water at the outlet pipe. The haybale configuration could still use some adjustment for better coverage.

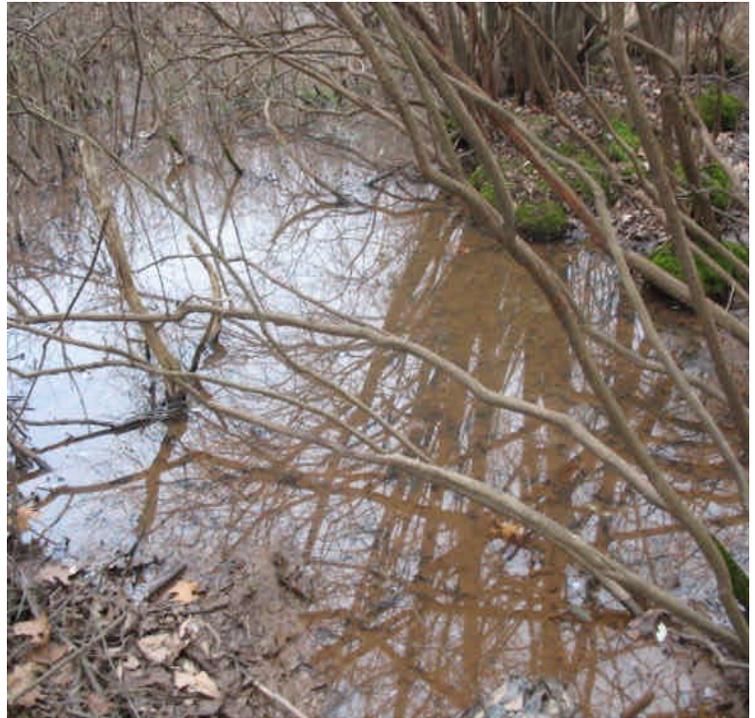
Sediment has settled out in the wetlands across Carpenter Lane, leaving a fine layer on the leaf litter. This may be difficult to remove while standing water is present but it may continue to get mixed into the water column during storms. Evaluate whether any can be removed without causing further harm to wetland.
