Docket No. 272 – Development and Management Plan Inspection

Scovill Rock Switching Station Inspection

Date: December 26, 2006

Location: Scovill Rock Switching Station

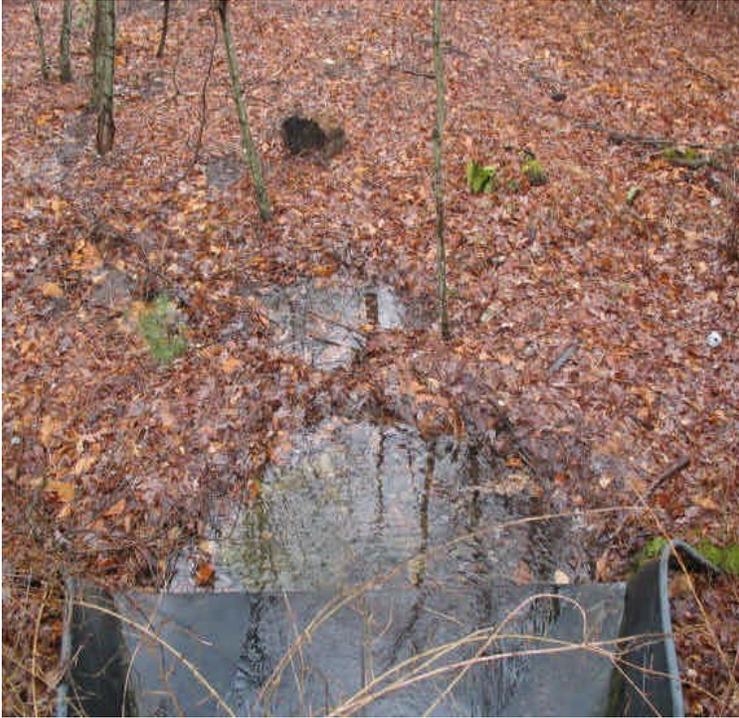
View of the culvert under the access drive. No sediment issues have been observed.

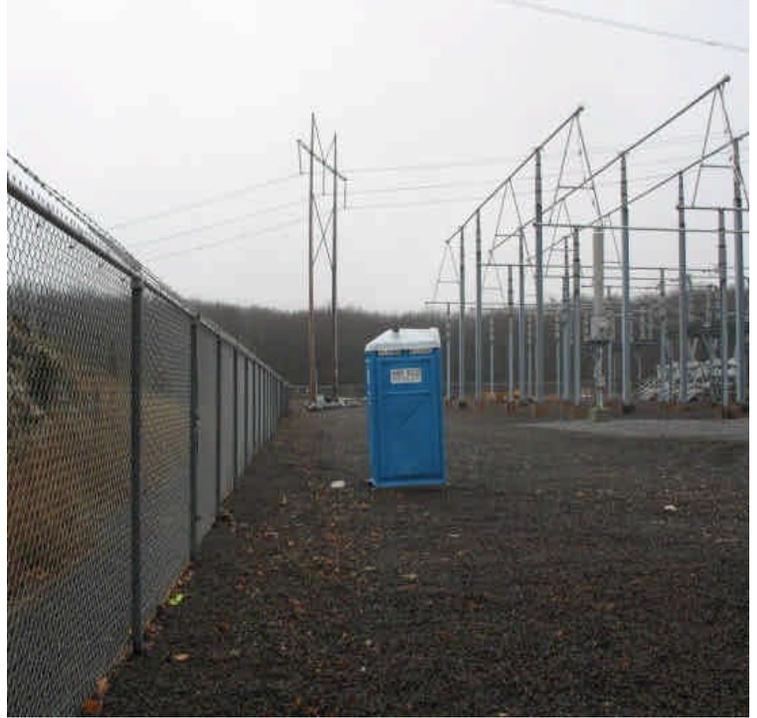
View of the perimeter of the yard. The site is stable and soil disturbing work is now complete.

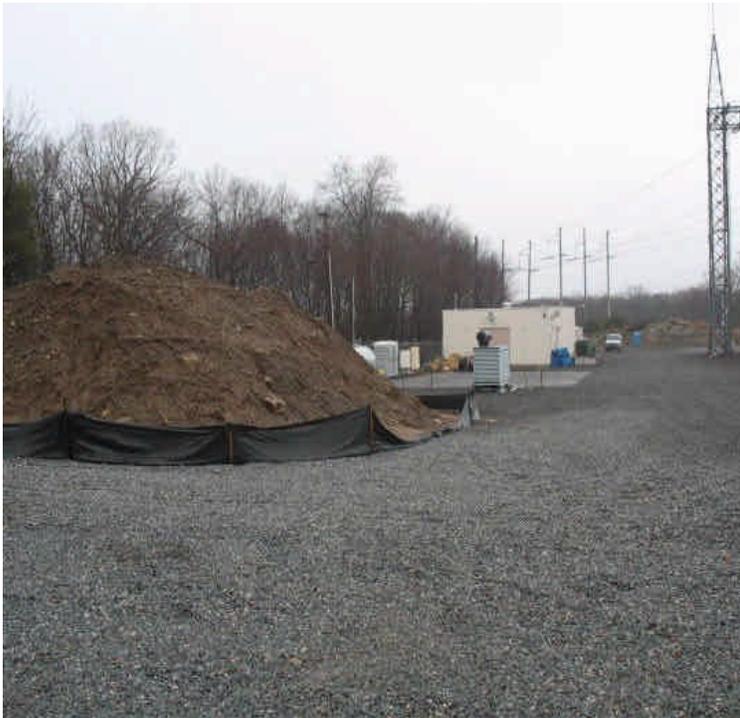
One stockpile remains in the yard, surrounded by silt fence and a flat crushed stone surface. It	Once soil analysis is complete, remove soil and dispose of properly. Soils are contained within	Silt fence needs attention when feasible

The remaining soil stockpile is surrounded by silt fence. Repair fallen section of silt fence and remove soil from site when feasible.

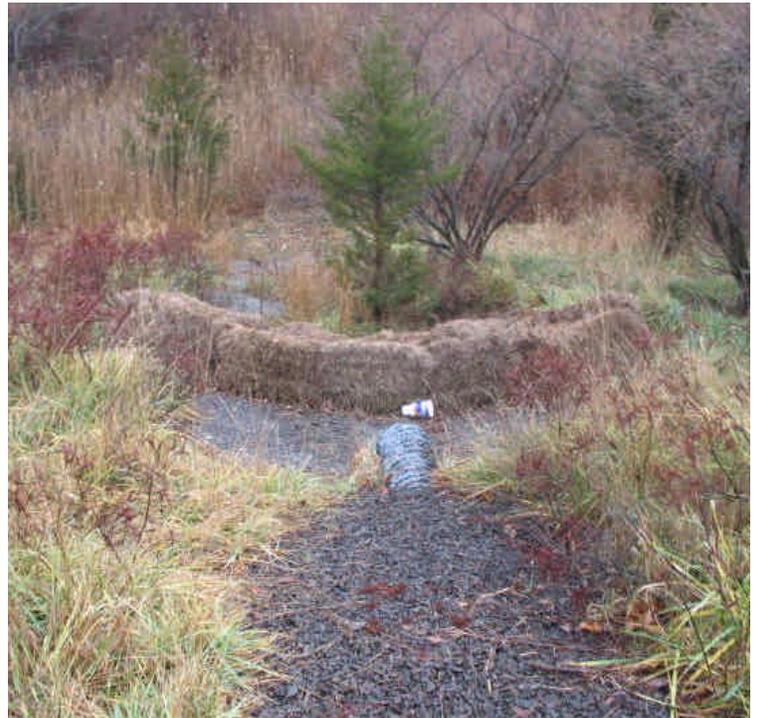
Remove degraded haybales when feasible. Site is stable.
