Docket No. 272 – Development and Management Plan Inspection

Segment 1a Inspection

Date: December 5, 2006

Location: Segment 1a – Scovill Rock Switching Station to Chestnut Junction, Oxbow Junction to Beseck Switching Station (excluding Royal Oak Bypass), Black Pond Junction to Beseck Switching Station

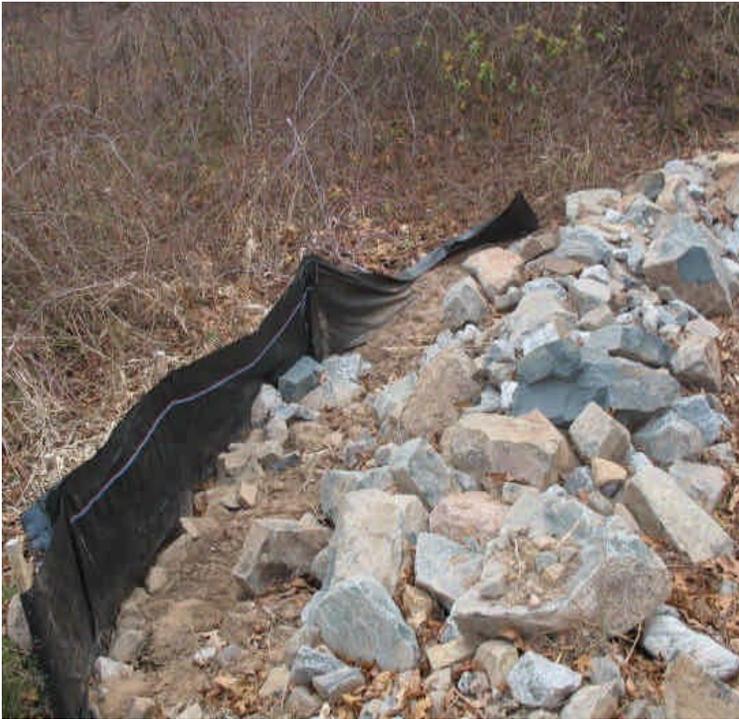
Riprap sediment trap and silt fence along the access road off Black Walnut Dr. Accumulated sediment should be removed and the silt fence repaired.

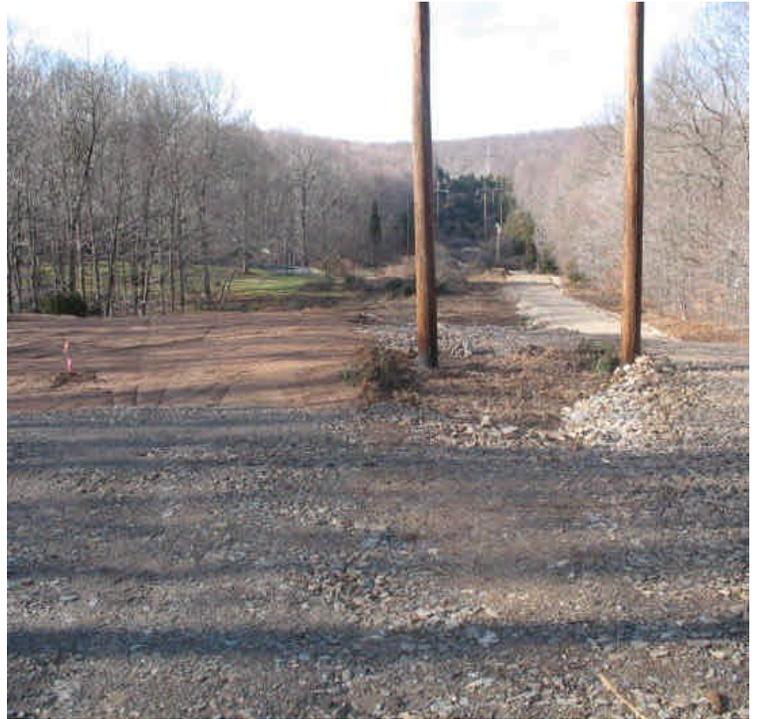
Silt fence, clearing grading, and access road off Arbutus Street.

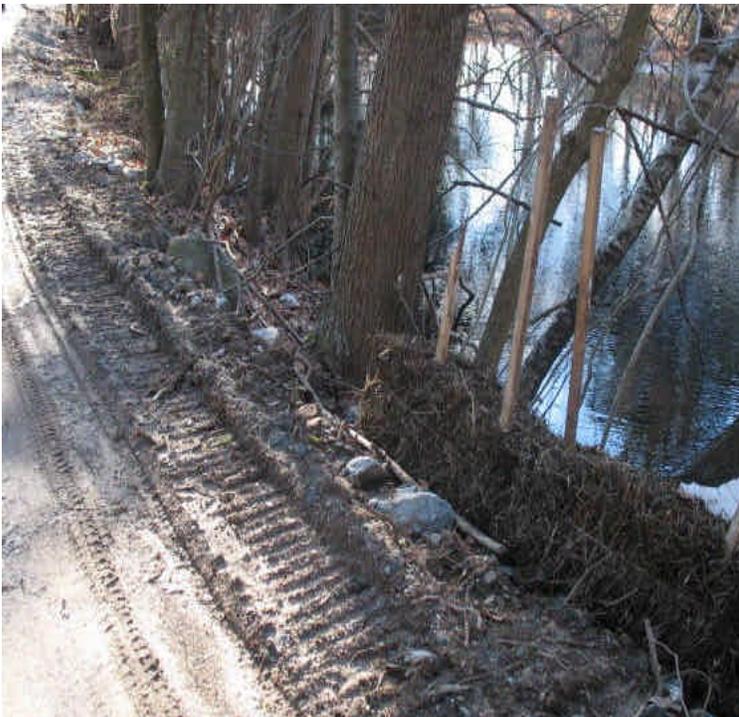
Erosion controls may need to be extended between the new access road and the pond off Haddam Quarter Rd. to prevent potential sedimentation, especially when work returns here.

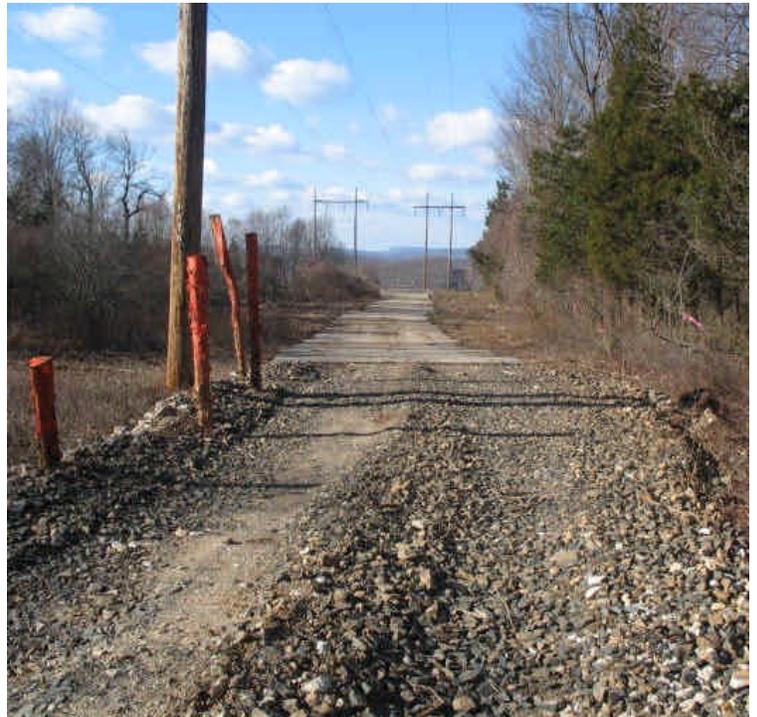
Non-jurisdictional wetland crossing area in the access ROW off Haddam Quarter Rd. Mats are in place and clean water was leaving the site.

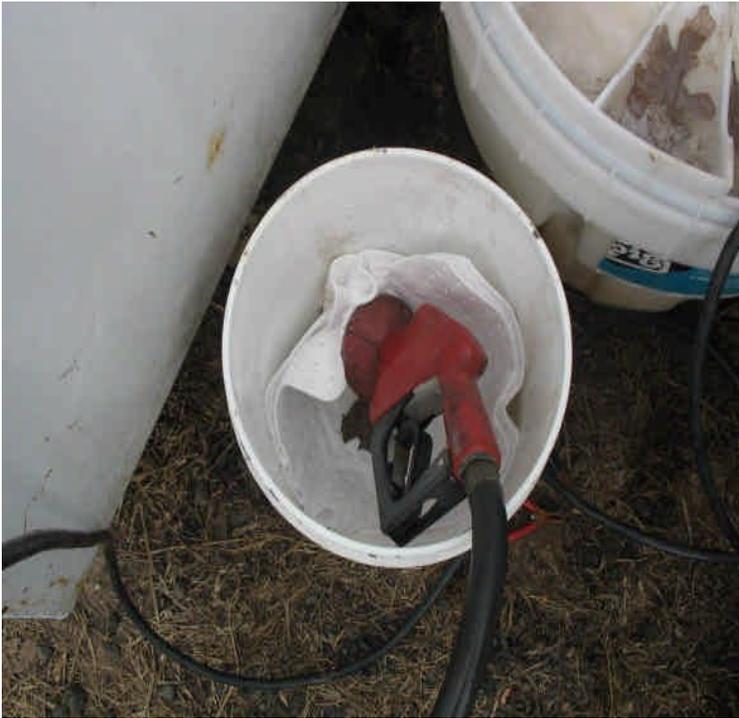
Nozzles for the fuel tank have been placed inside of 5-gallon buckets with spill controls at the contractor yard.

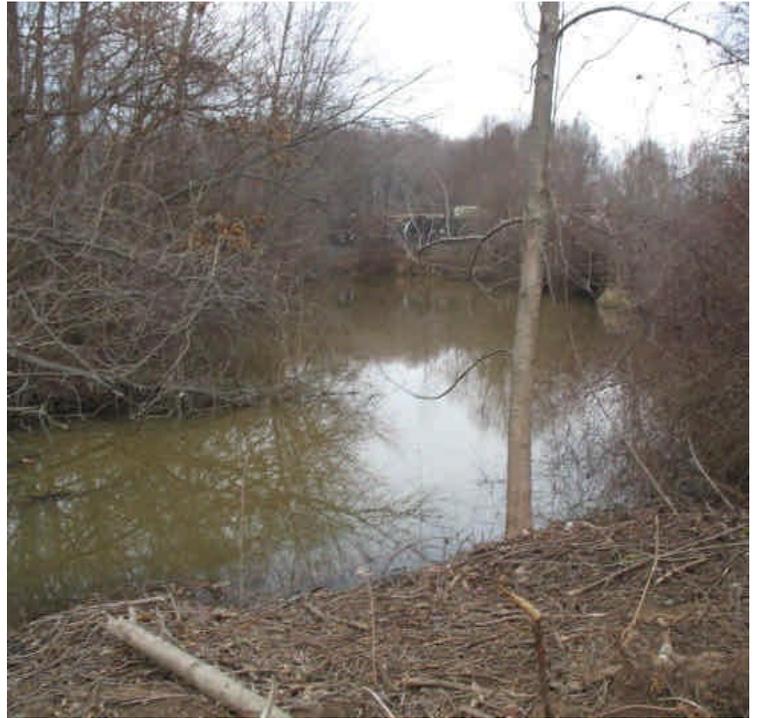
Pond west of the contractors receiving yard was noticeably turbid. This will be evaluated to determine whether this is an existing/natural condition or if sediment is entering from the yard. A source was not obvious.

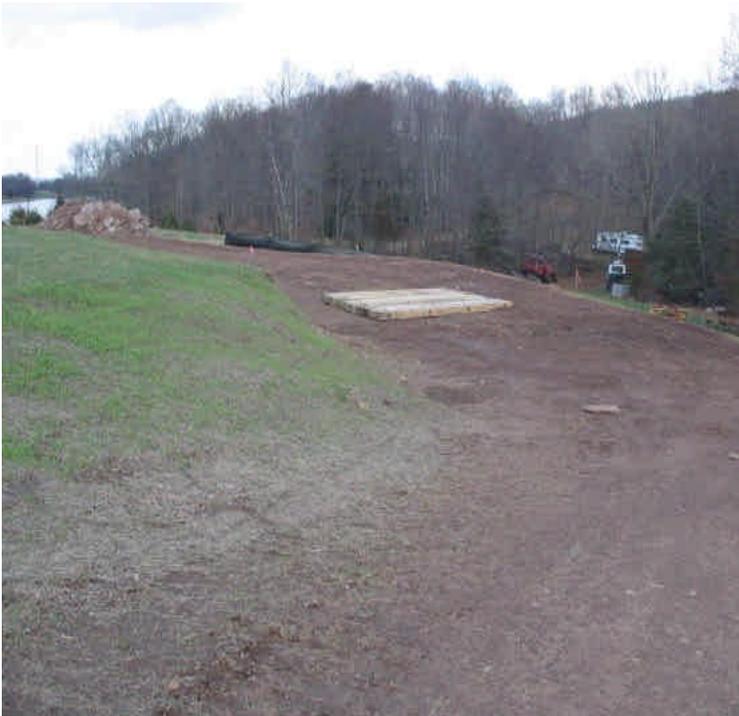
Recently drilled hole in preparation for foundation installation in the ROW north of Beseck SS.

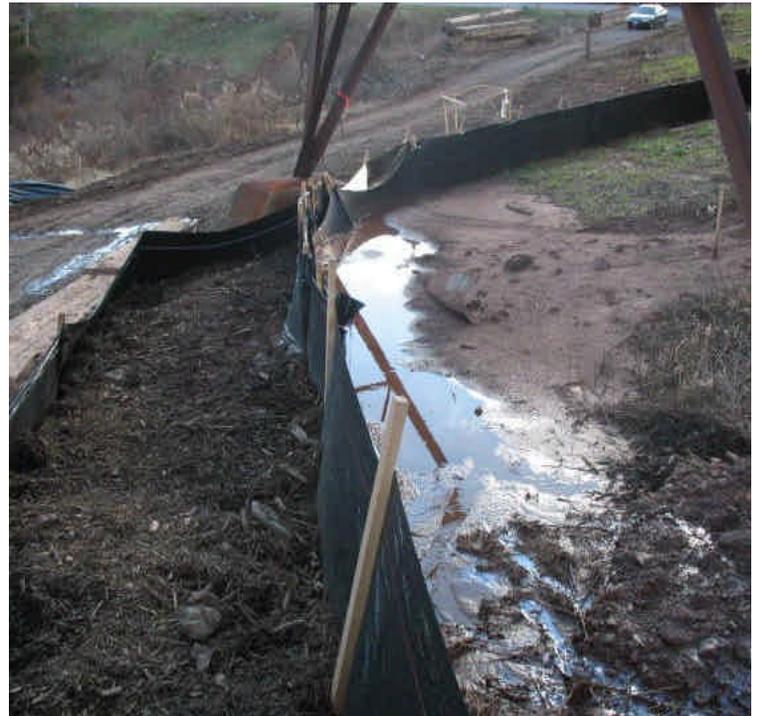
Silt fence/haybale barrier along the access road adjacent to Black Pond used for dewatering slurry. Slurry remains contained.

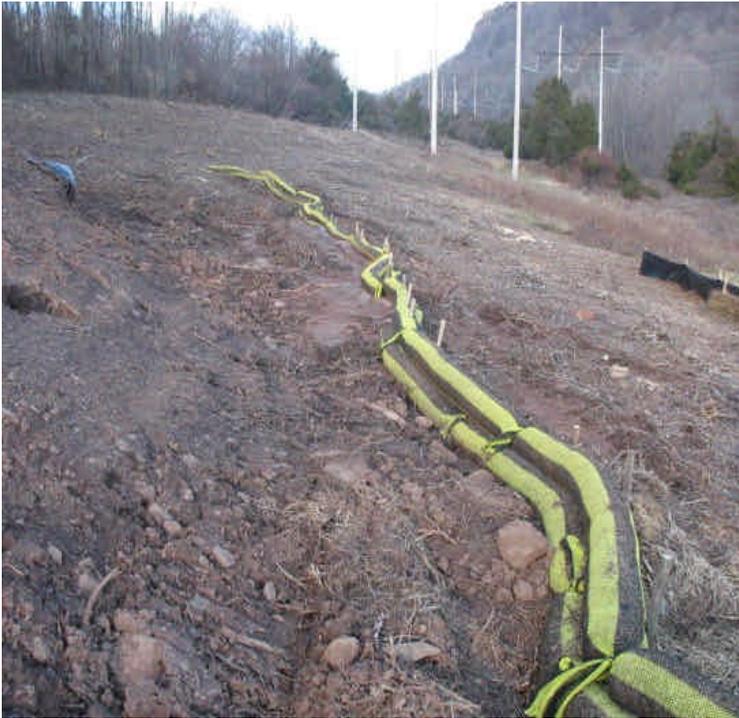
Bio-socks used to trap/filter slurry and sediment from dewatering efforts at Black Pond.

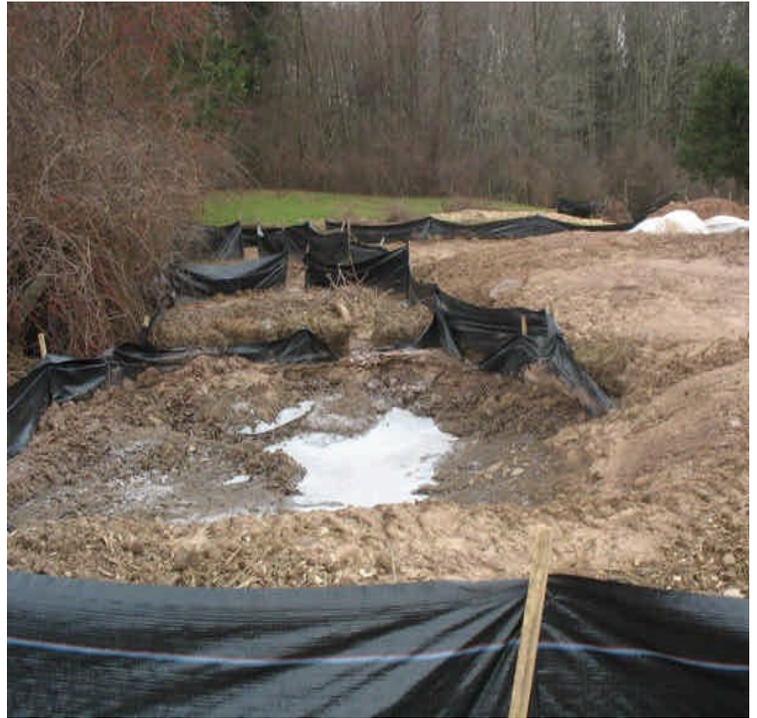
Slurry containment areas located in the ROW north of the contractor yard along Rte 17. Sediment is being removed and spread, and is mostly dry at this time.

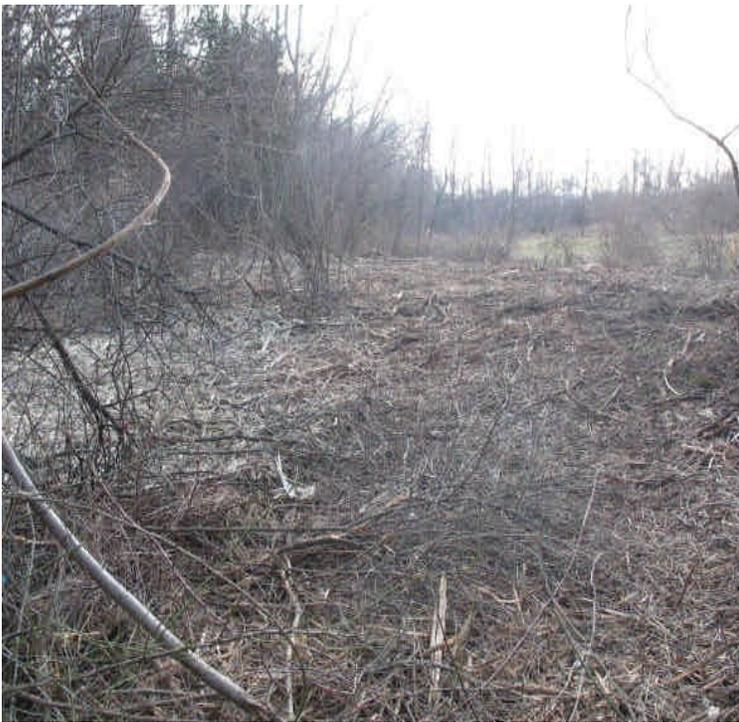
Buffer zone clearing off Little Lane, view from the wetland towards the upland. Monitor and add controls if needed, however, root stock appears to stabilize the soil.

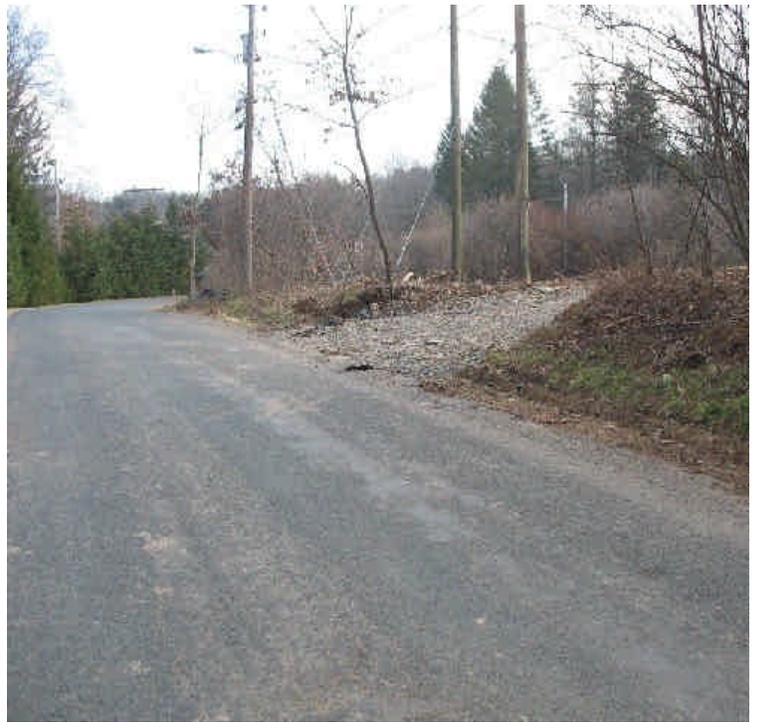
ROW entrance off Little Lane. No sediment tracking was noted.
