Docket No. 272 – Development and Management Plan Inspection

Segment 1a Inspection

Date: December 19, 2006

Location: Segment 1a – Scovill Rock Switching Station to Chestnut Junction, Oxbow Junction to Beseck Switching Station (excluding Royal Oak Bypass), Black Pond Junction to Beseck Switching Station

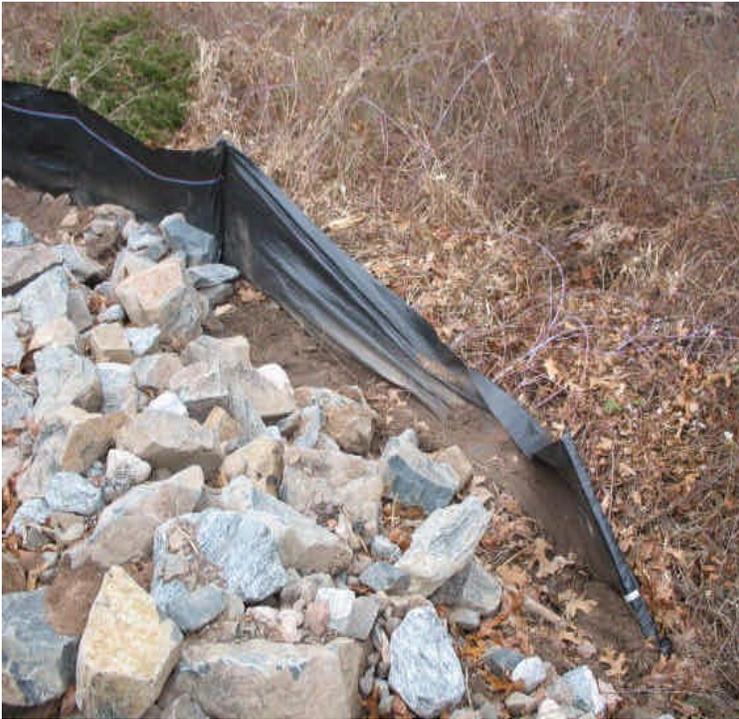
Areas of Inspection	Observation	Recommended Action	Corrected Action
Black Walnut Dr.	Accumulated sediment is putting stress on a section of silt fence. 11/21-12/19/06	Clean sediment and maintain silt fence as needed. 11/21-12/19/06	Needs attention when feasible.
Black Pond	More silt fence and filter socks were installed along the slope for containing/ filtering slurry from dewatering. However, the sediment has overwhelmed some controls and the accumulation is stressing the remaining areas. Some of the turbid water and sediment have flowed beyond the fence and into the adjacent wetland. 12/19/06	Less severe sediment accumulation was noted against the controls since 11/21/06 Additional/alternative controls are now needed. Sediment accumulation needs to be spread out to dry and completely contained. Sediment should be removed carefully from the wetland by hand. 12/19/06	Needs attention.
ROW North of Beseck SS	A small section of silt fence fallen along the access drive was repaired. 12/19/06 Silt fence was in place at work areas. No dewatering was required at this time. 12/19/06	Continue to monitor and maintain controls. 12/19/06 Monitor silt fence during drilling and dewatering, if needed. 12/19/06	Silt fence repaired. NA

Riprap sediment trap and silt fence along the access road off Black Walnut Dr. Accumulated sediment should be removed and the silt fence repaired.

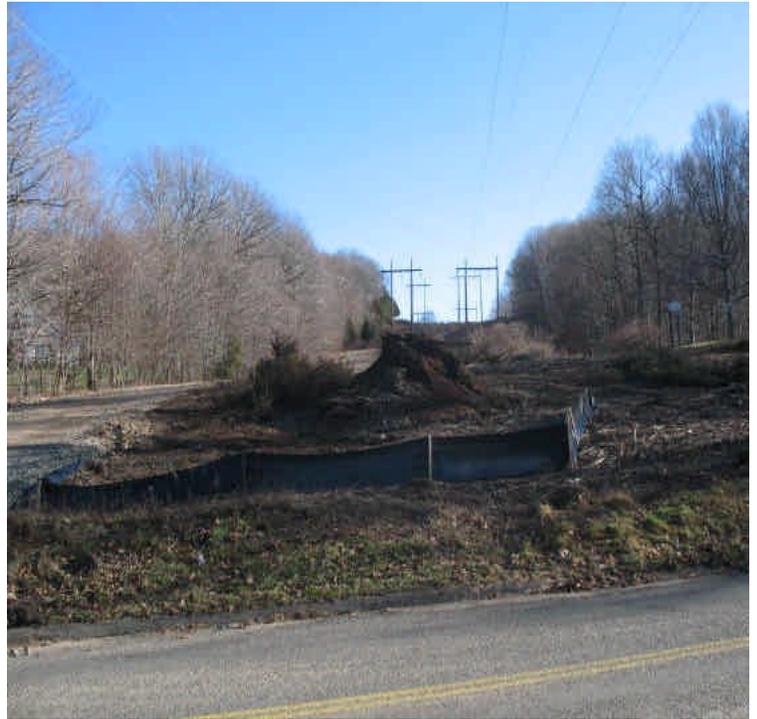
Silt fence, clearing, grading, and access road off Arbutus Street. Pull back stone from the roadway as needed.

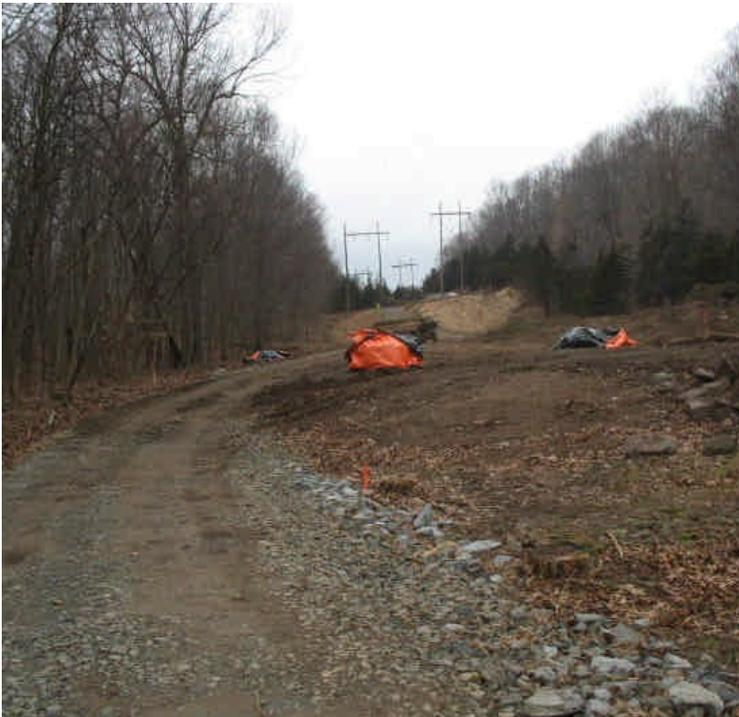
ROW access road off Black Walnut Dr.

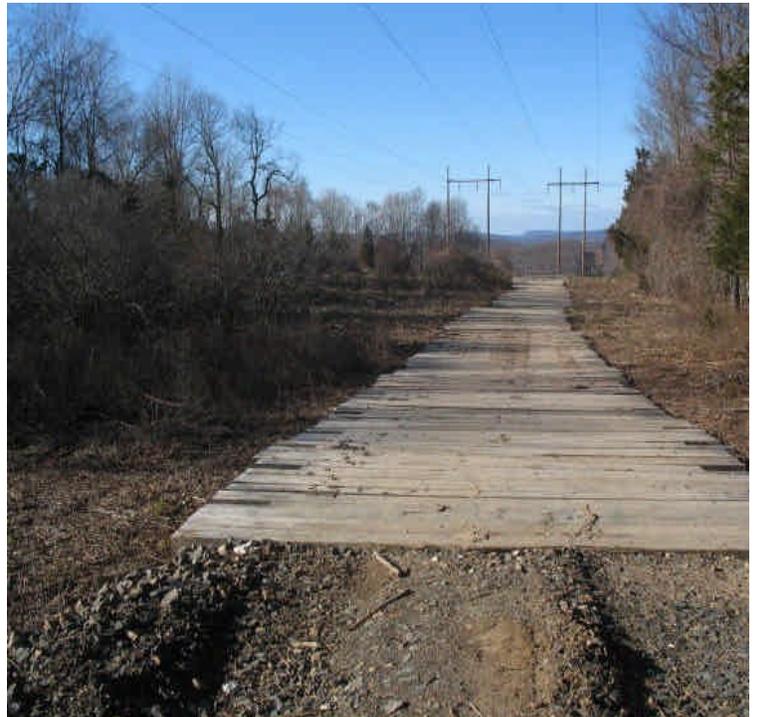
Non-jurisdictional wetland crossing area in the access ROW off Haddam Quarter Rd. Mats are in place and clean water was leaving the site.

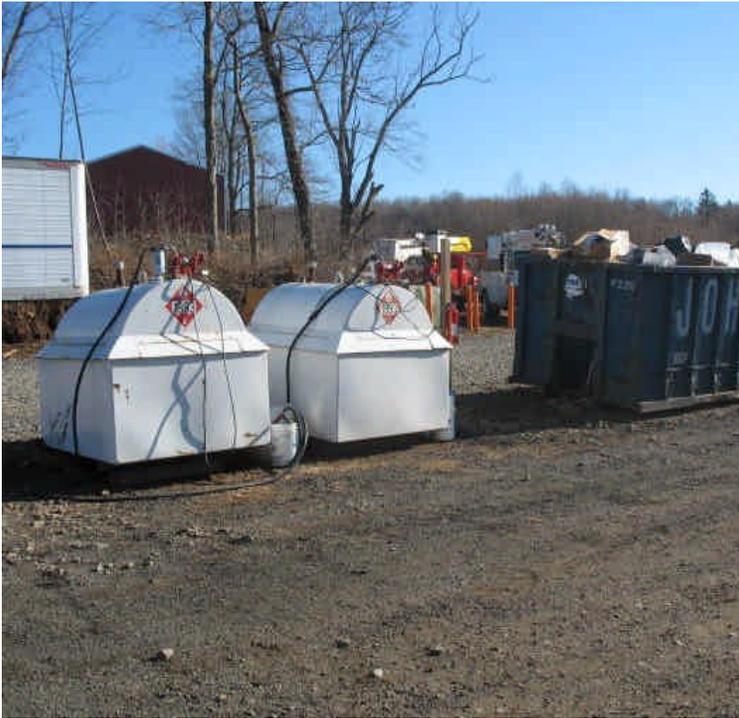
Nozzles for the fuel tank remain inside of 5-gallon buckets with spill controls at the contractor yard.

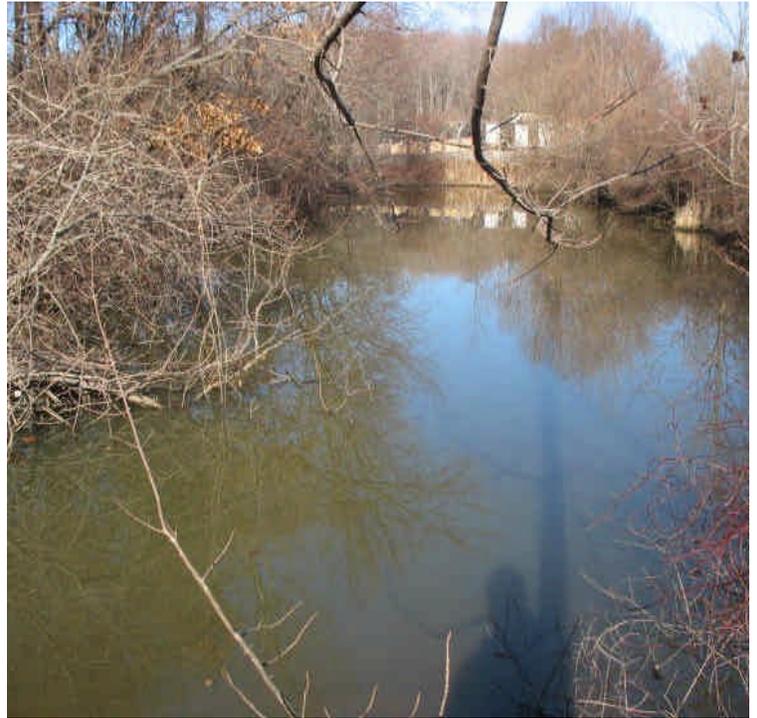
Slightly turbid pond adjacent to the PAR shipping and receiving yard. It is still unclear whether the turbidity here was a pre-existing condition.

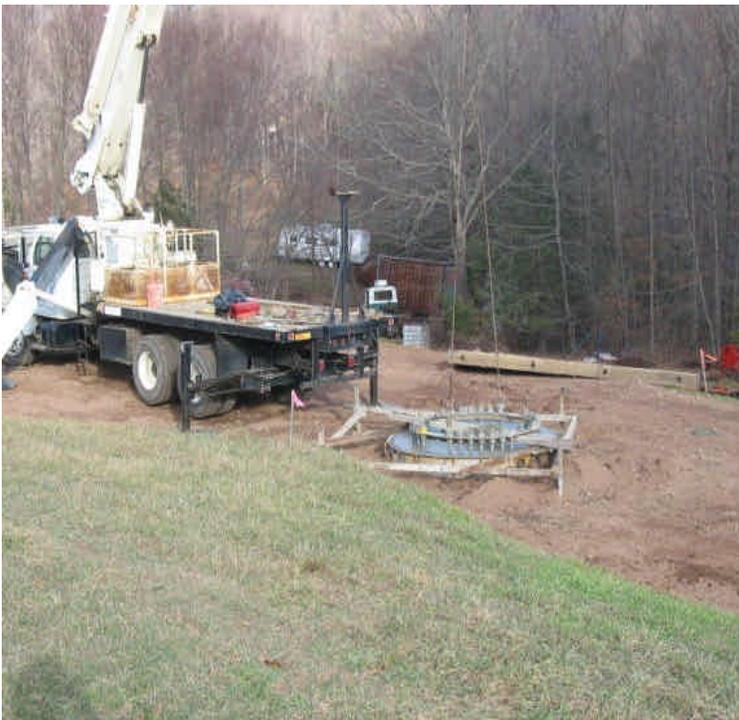
View of foundation installation occurring in the ROW north of of Beseck SS.

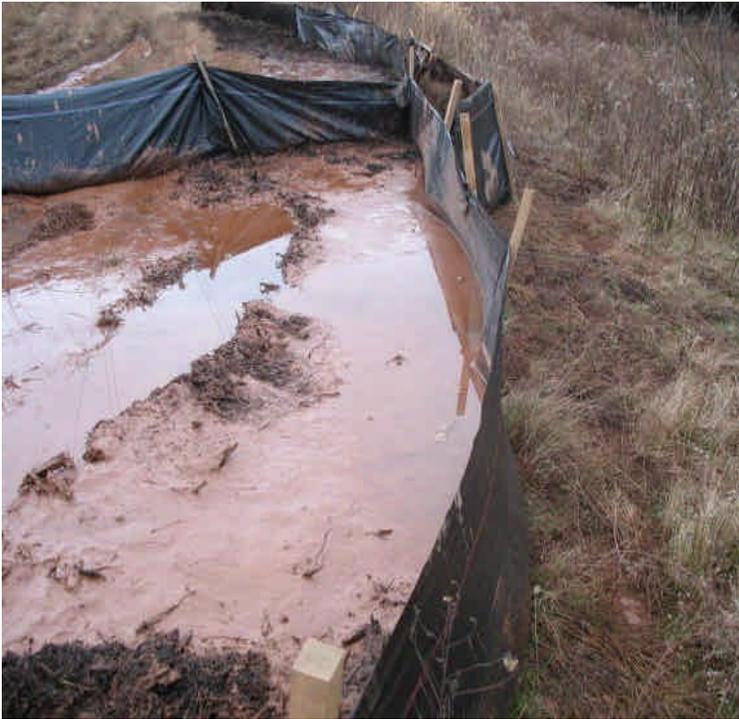
Turbid water and sediment flowed beyond the silt fence and into the adjacent wetland at Black Pond.

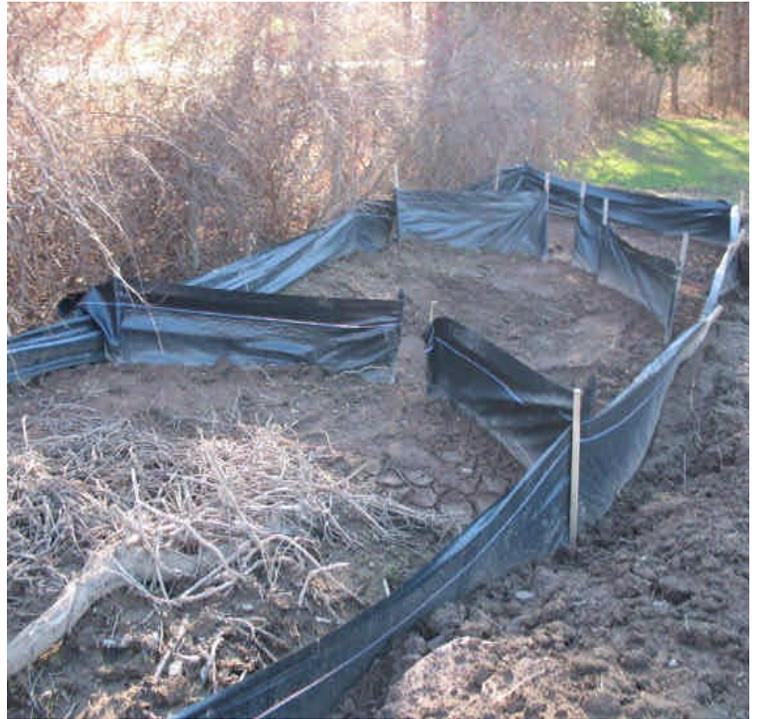
Old slurry containment areas located in the ROW north of the contractor yard along Rte 17. Sediment is being removed, spread, and dried.

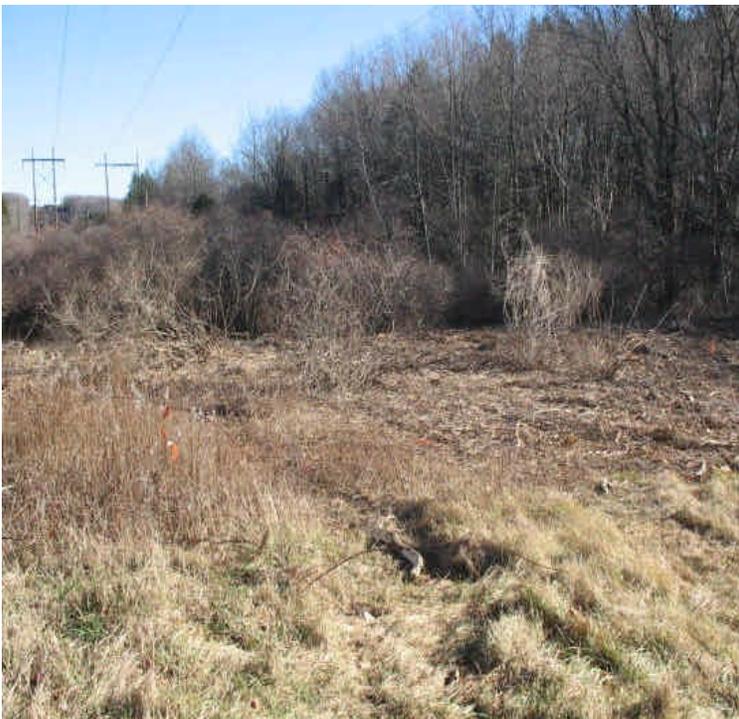
Previous clearing off Little Lane, view from the wetland towards the upland. Monitor and add controls if needed; however, roots appear to be keeping soil stable.

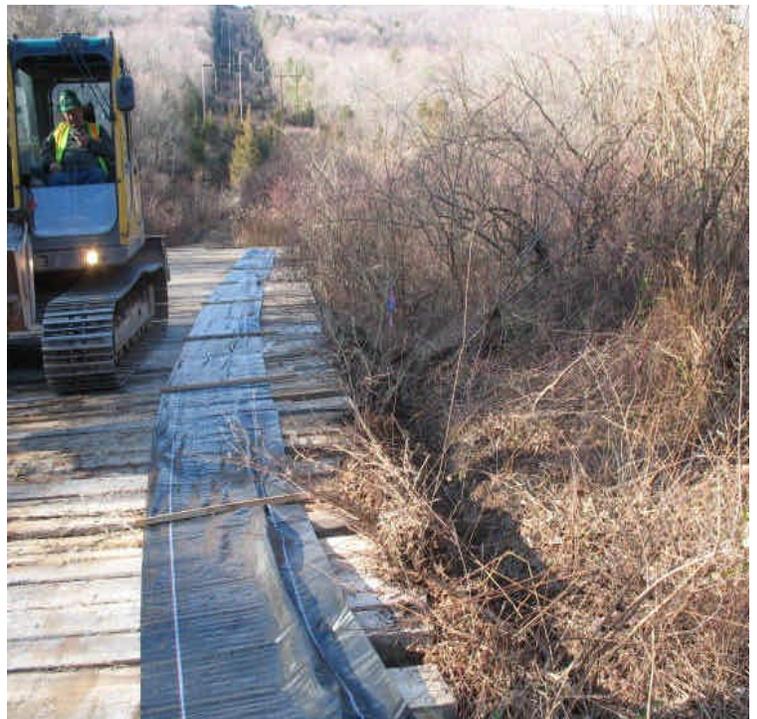
Silt fence and timber mat installation along the new access road off Powder Hill Rd.
