Docket No. 272 – Development and Management Plan Inspection

Segment 4a Underground Line

Date: December 13, 2006 (Evening Inspection)

Location: Singer Substation to Fairfield/Westport Town Line

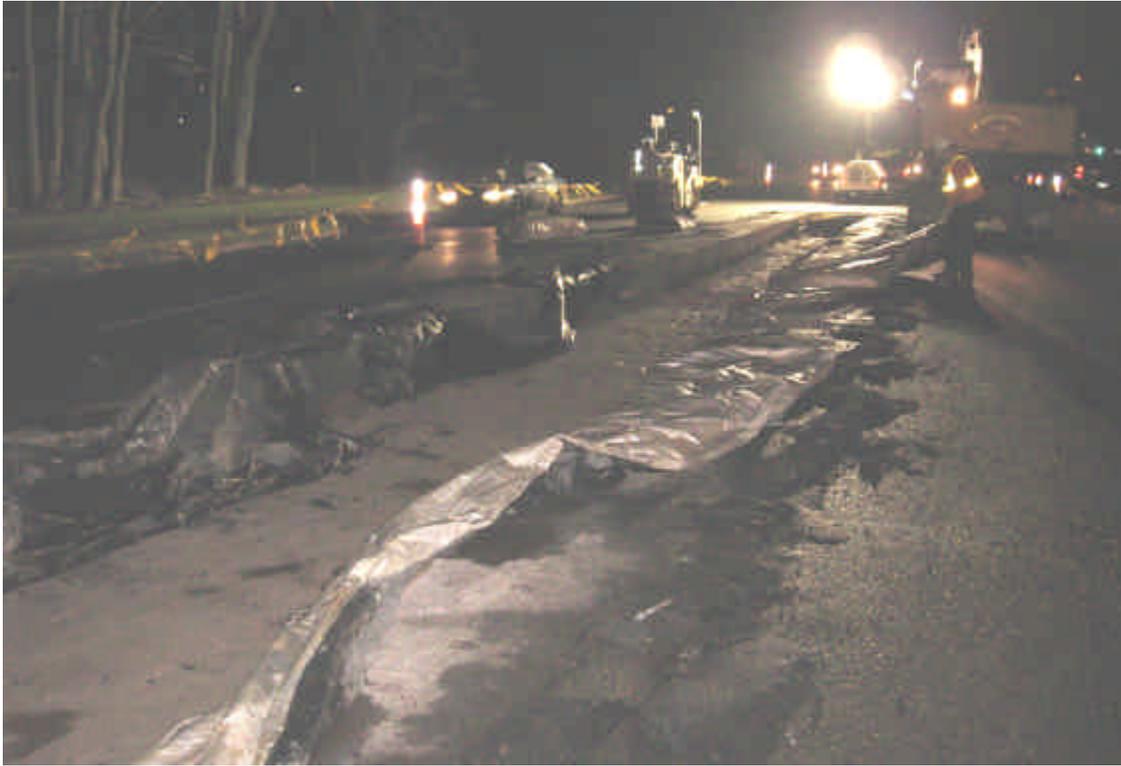
Photo shows a view of the trench work in the Rt. 1 roadway, south of Benson Road. The excavation was being backfilled with flowable fill.
