Docket No. 272 – Development and Management Plan Inspection

Segment 4a Underground Line

Date: December 20, 2006

Location: Singer Substation to Fairfield/Westport Town Line

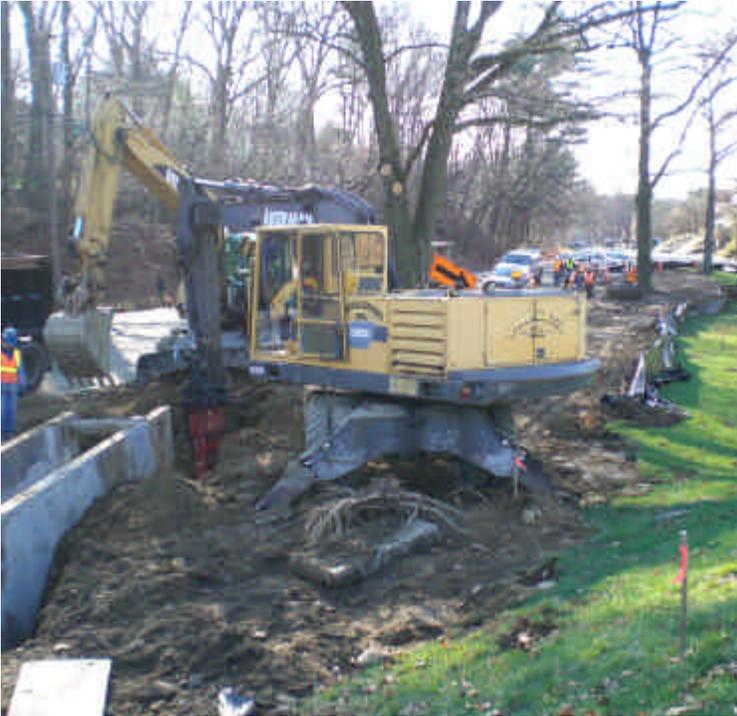
Trenching activities along the shoulder of Pequot Ave. at station 495+00. Five trees had been removed in this location. Erosion controls have been installed downgradient of disturbed soils.

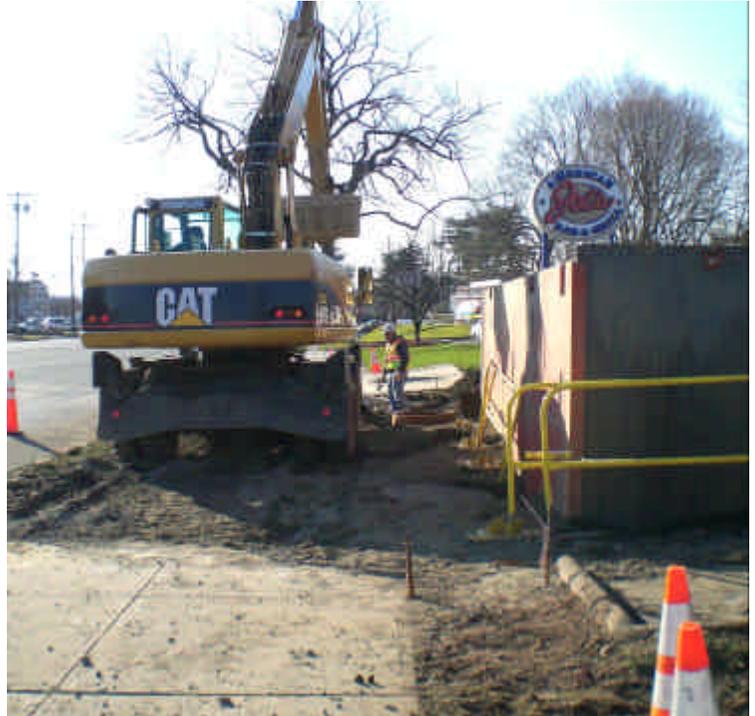
Work at Vault #7536 to install manholes. Nearby catch basins were protected with silt sacks. One additional tree was removed.

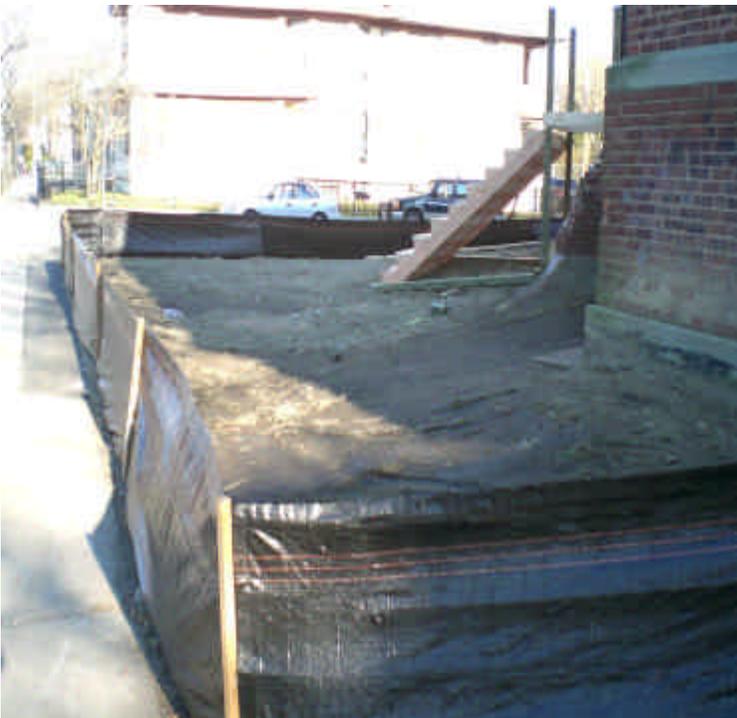
Location of Vault #7541 construction activities are complete. Silt fence has been installed to contain disturbed soils.

Vault #7541 installation activities are complete.	Restore disturbed area when appropriate.	NA

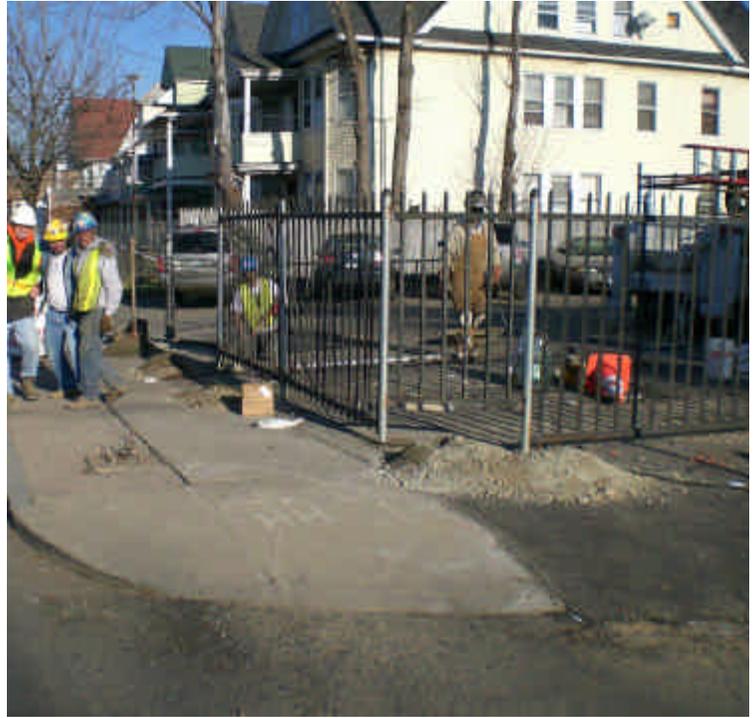
Location of Vault #7542 construction activities. Crews were installing fence at the time of the inspection.

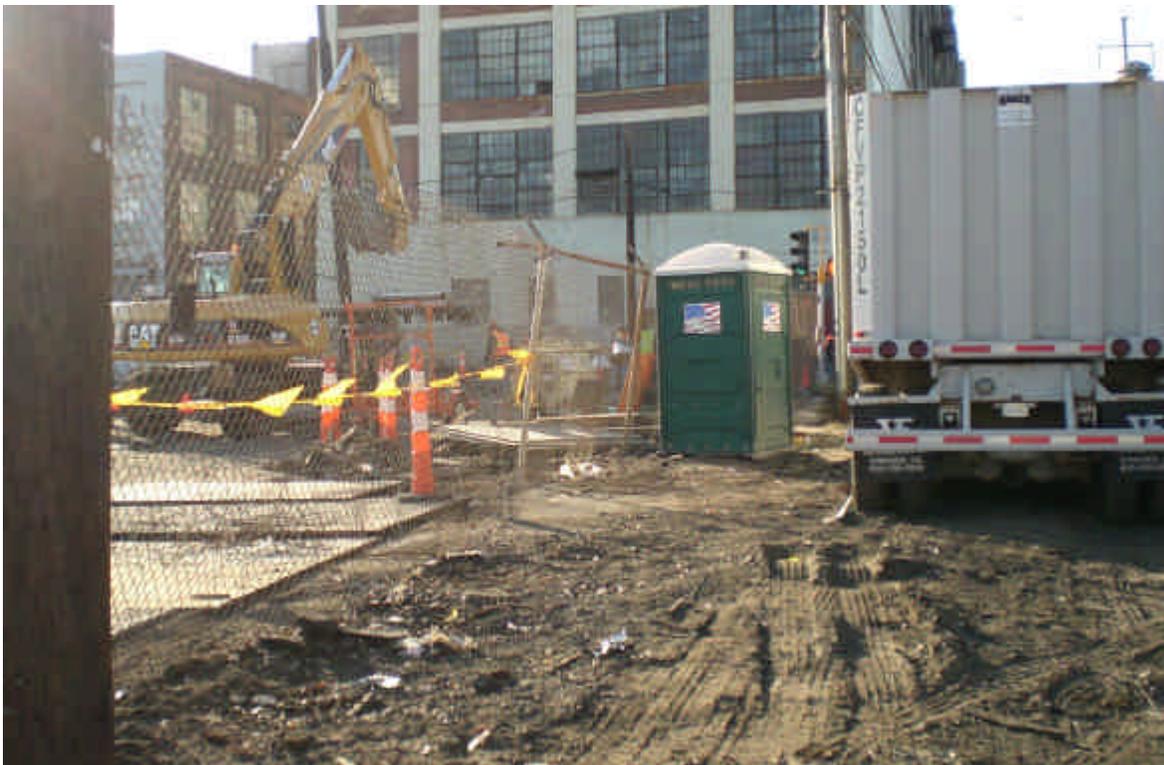
Trenching activities at the corner of Howard Ave. and Railroad Ave. Exposed soils from the activities were not observed migrating from the construction area. Disturbed areas should be restored/temporarily stabilized when appropriate.

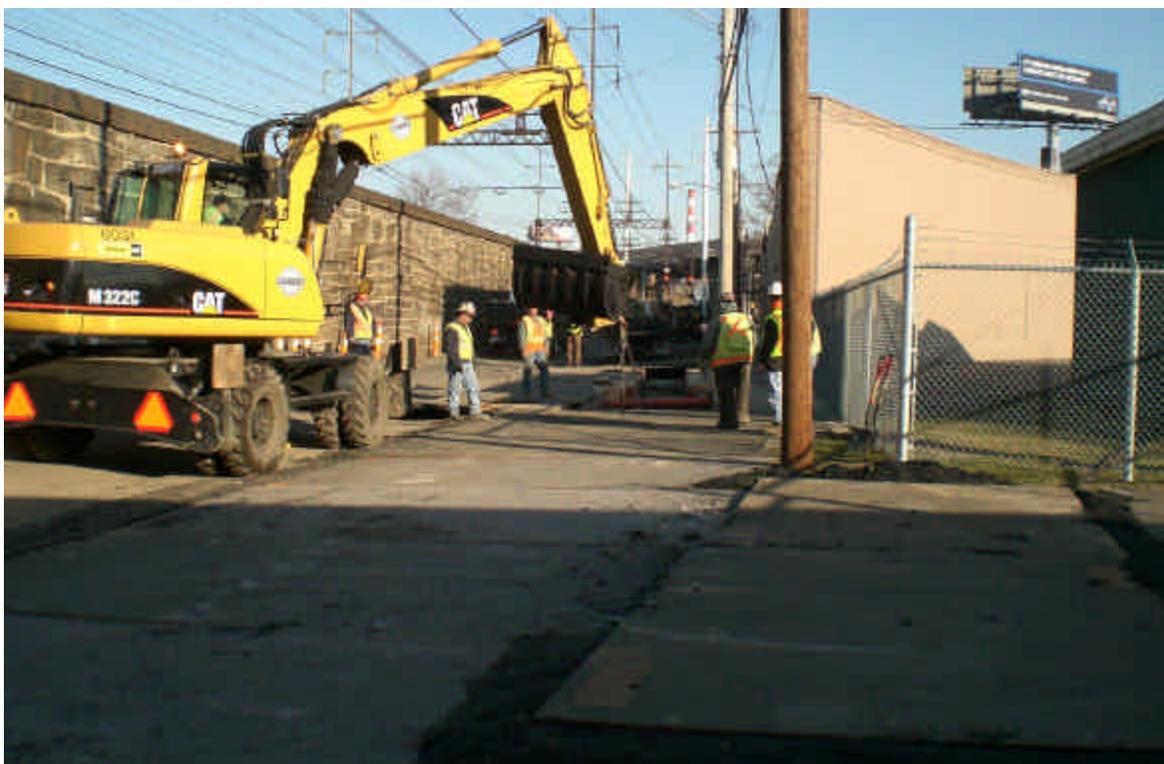
Photo of trenching activities on Railroad Ave. between Wordin Ave. and Iranistan Ave.
