Docket No. 272 – Development and Management Plan Inspection

Scovill Rock Switching Station Inspection

Date: February 5, 2007

Location: Scovill Rock Switching Station

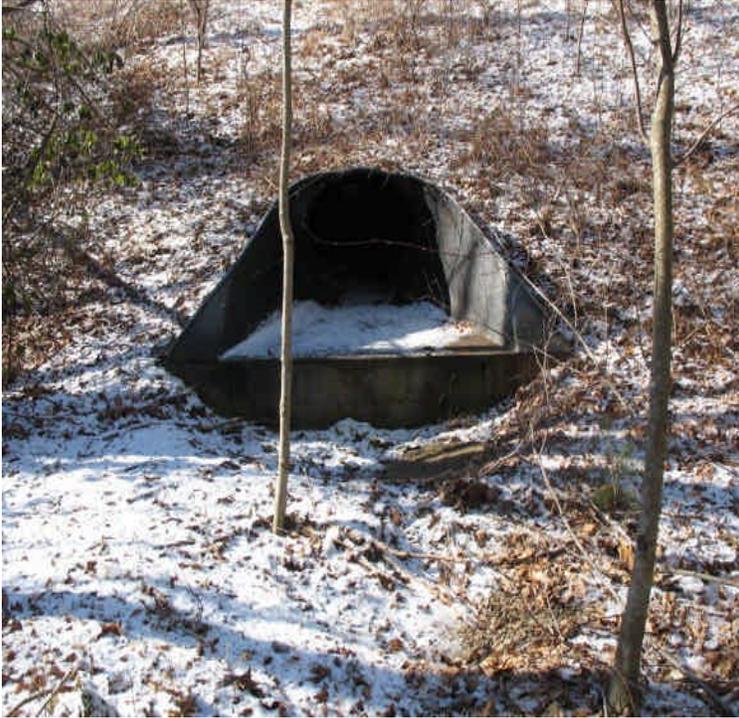
View of the culvert under the access drive. No sediment issues have been observed.

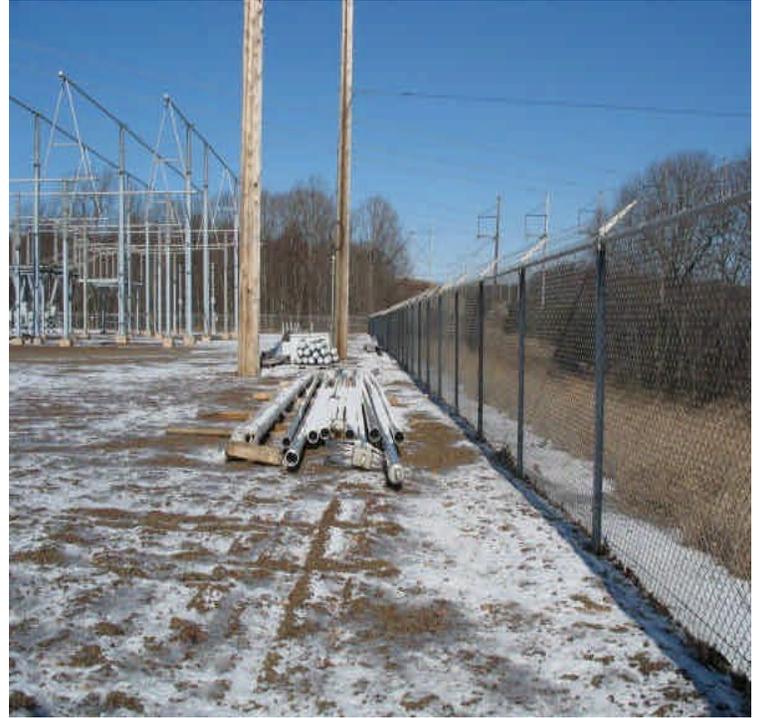
Wind blown debris/trash within the yard has been removed. The site is stable and soil disturbing work is complete.

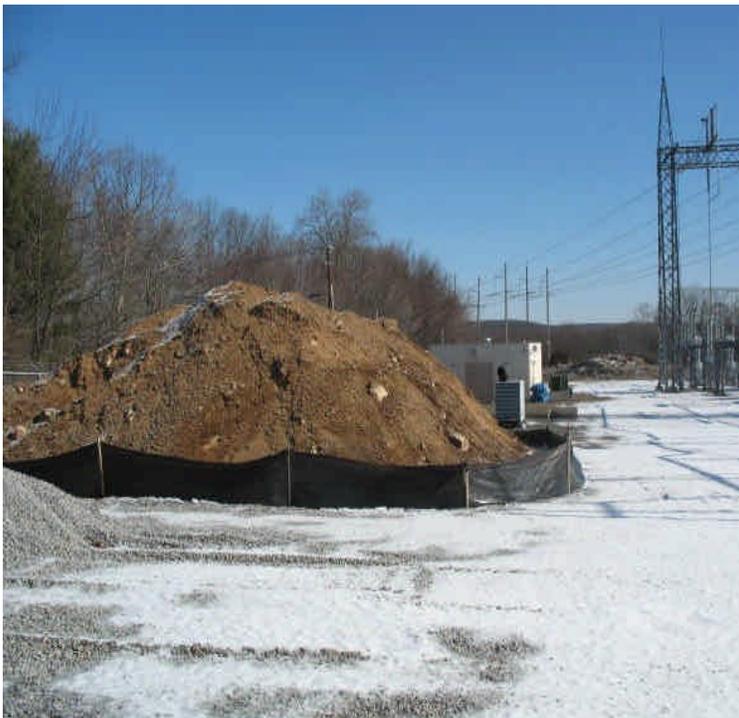
Silt fence surrounding the remaining soil stockpile remains intact. All soils are well contained to the site.

One stockpile remains in the yard, surrounded by intact silt fence and a flat crushed stone surface. It	Once soil analysis is complete, remove soil and dispose of properly. Soils are contained within	NA

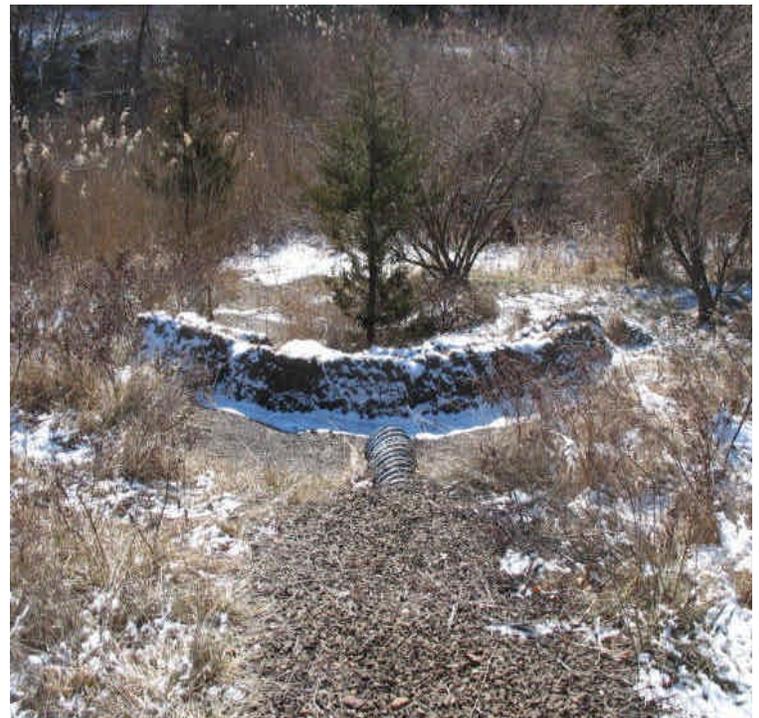
Remove degraded haybales when feasible. Site is stable.
