Docket No. 272 – Development and Management Plan Inspection

Segment 1a Inspection

Date: February 5, 2007

Location: Segment 1a – Scovill Rock Switching Station to Chestnut Junction, Oxbow Junction to Beseck Switching Station (excluding Royal Oak Bypass), Black Pond Junction to Beseck Switching Station

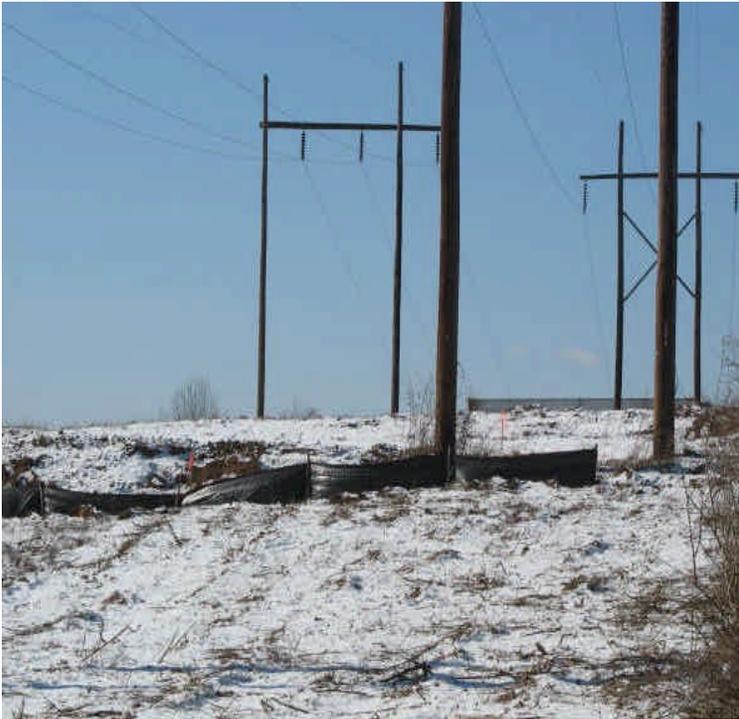
New silt fence installed and staging area in place along the ROW off Little Ln. (to the west)

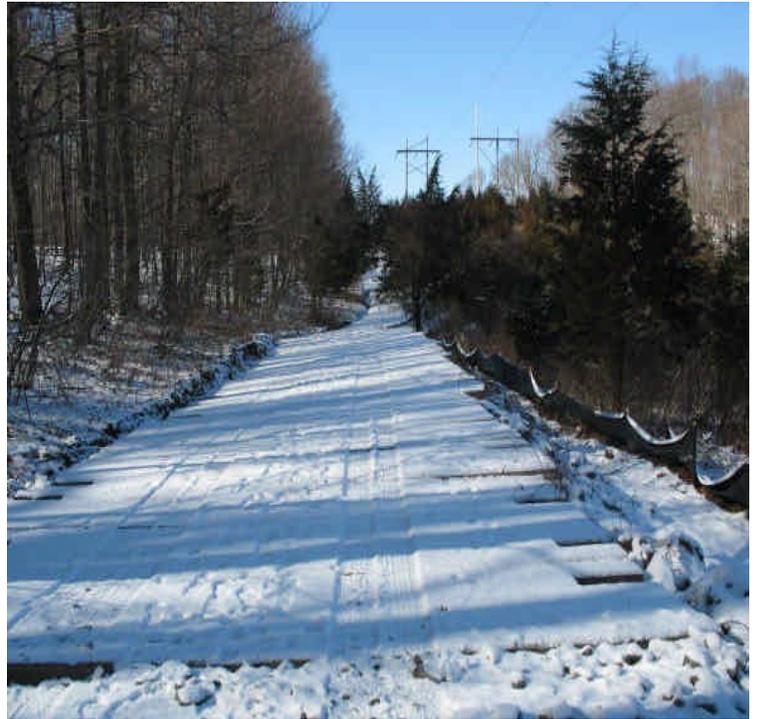
Timber mats in place for access west of Arbutus Street. No run-off was noted during the inspection.

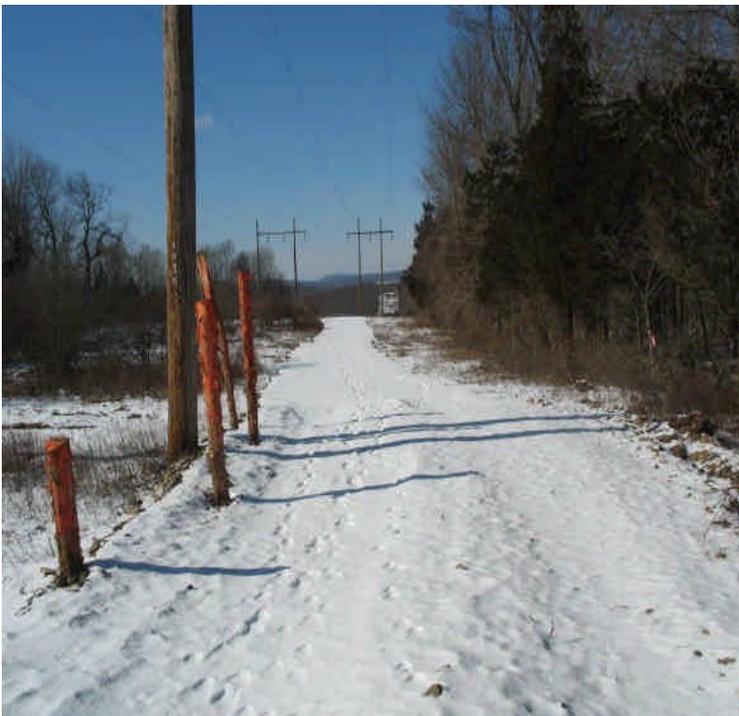
View of access road (timber mats in place) off Haddam Quarter Rd.

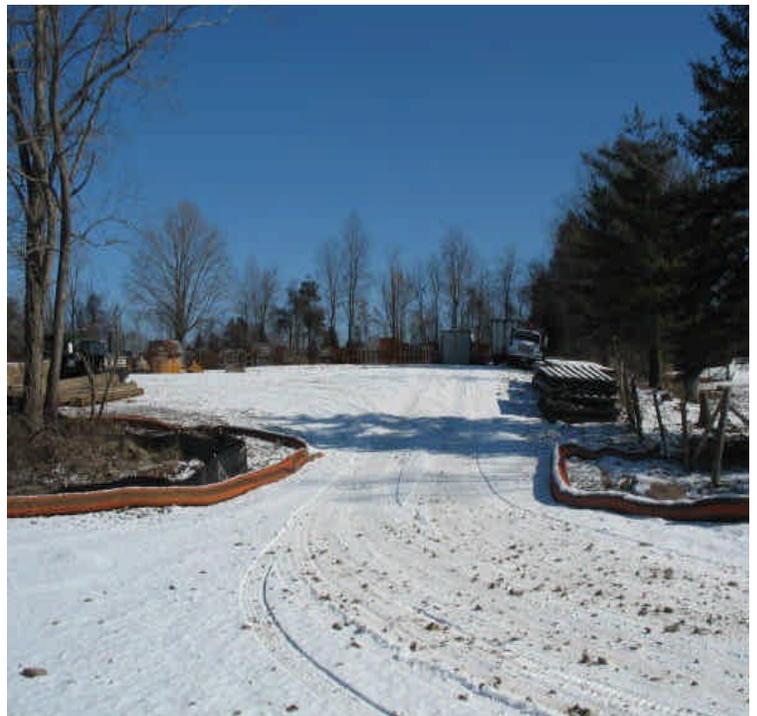
Silt fence, fiber rolls, and hay mulch are in place as a buffer around the perimeter of the contractor receiving yard.

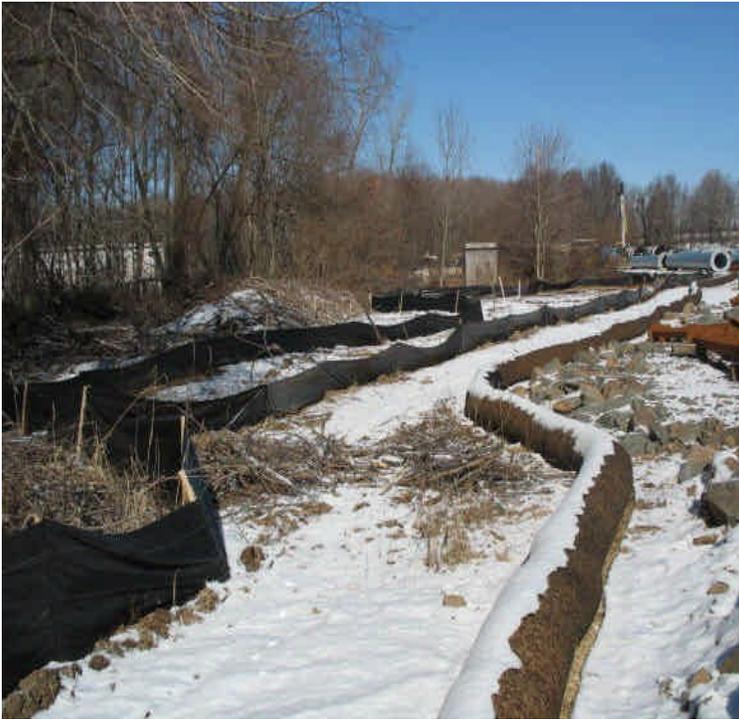
Additional controls remain in place adjacent to wetlands to filter/contain turbid run-off leaving the site.

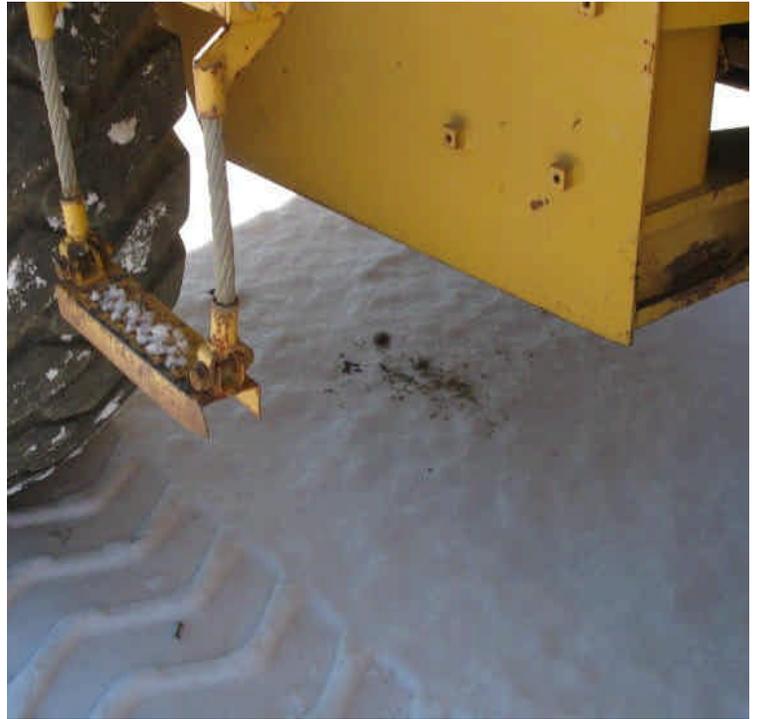
Small stains/drips were noted around the contractor receiving yard under this leaking forklift.

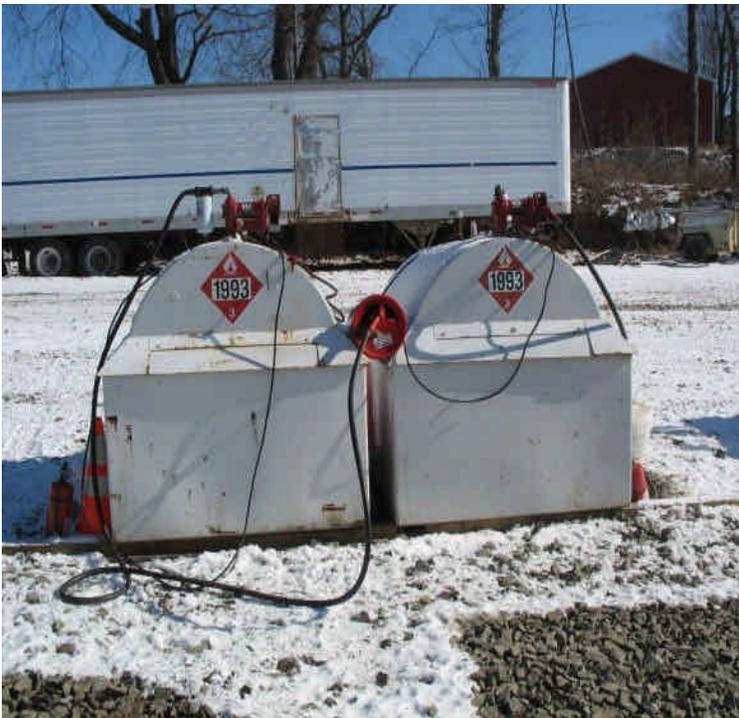
The fuel storage tanks remain in place on the stone spill pad and nozzles are contained. Small drip stains are noted and are contained to the stone.

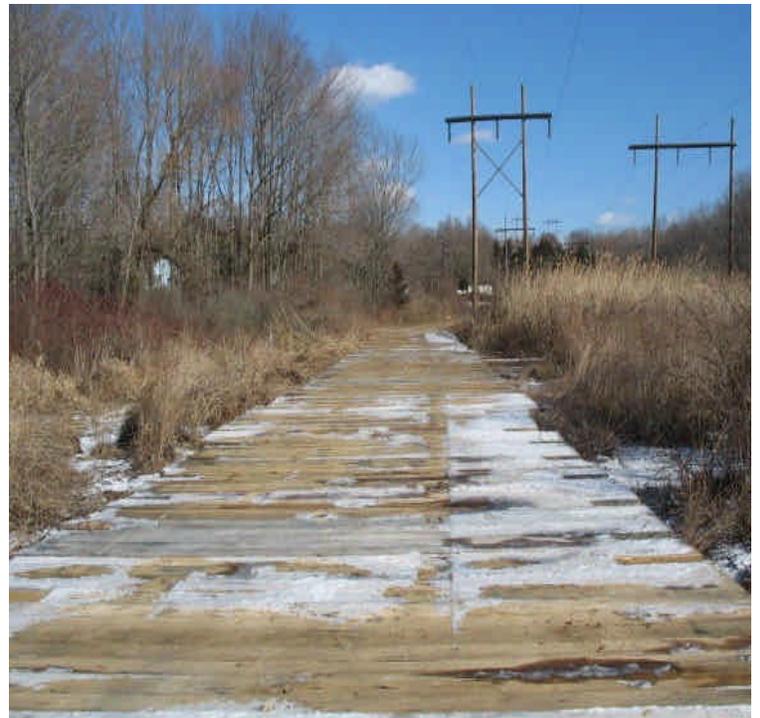
Timber mats are in place off Durham Rd. Add erosion controls if necessary; continue to monitor.

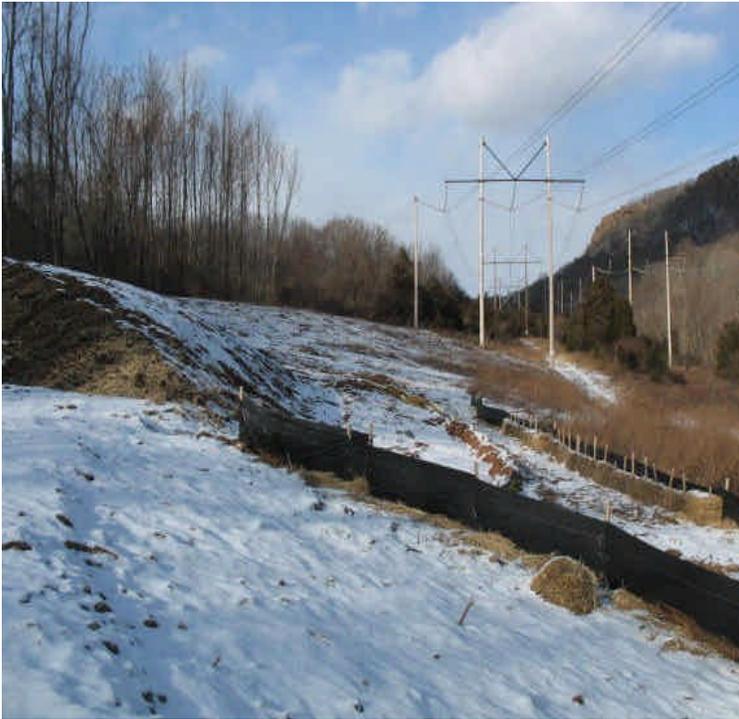
Overview of the haybales, silt fence, and filter socks at Black Pond. Mulch is in place around the site for increased stabilization.

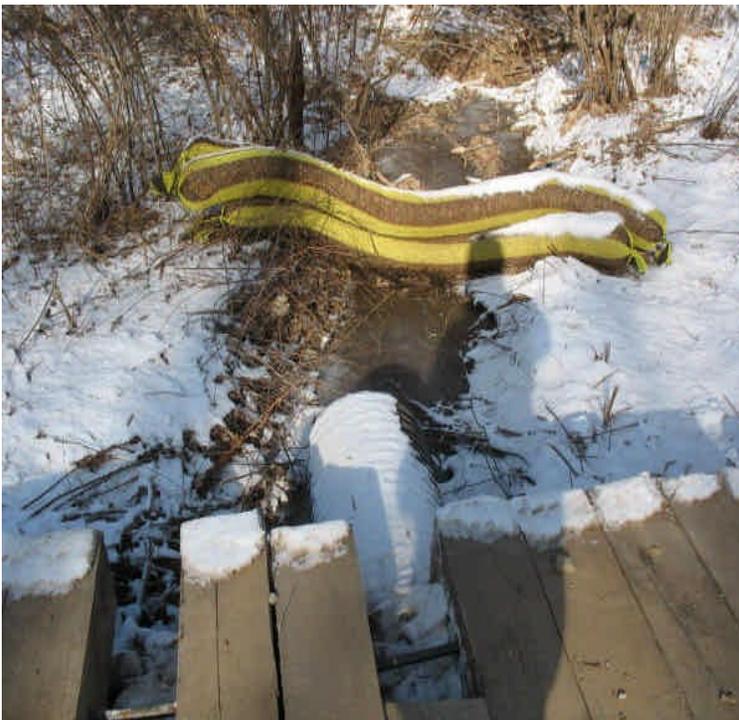
View of a timber mat crossing on a small stream in the wetlands located west of Powder Hill Rd. Filter socks were added as proactive control. No sediment issues were noted in this area.

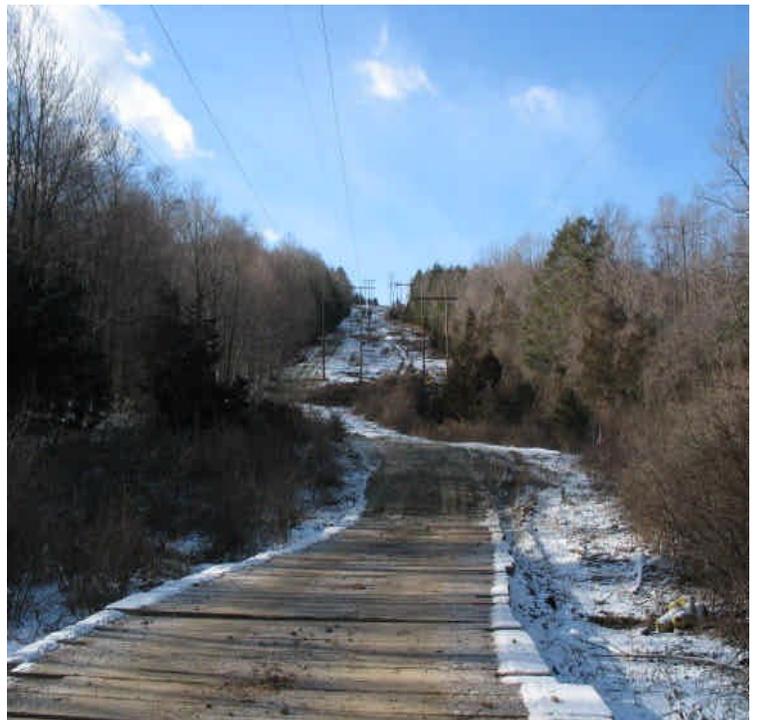
Timber mats in place for access west of Powder Hill Rd. Mats traverse wetlands, uplands, and small streams.
