**Docket No. 272 – Development and Management Plan Inspection**

**Segment 2a Inspection**

**Date:** February 27, 2007

**Location:** Segment 2a – Beseck Switching Station to Cheshire/Hamden Town Line

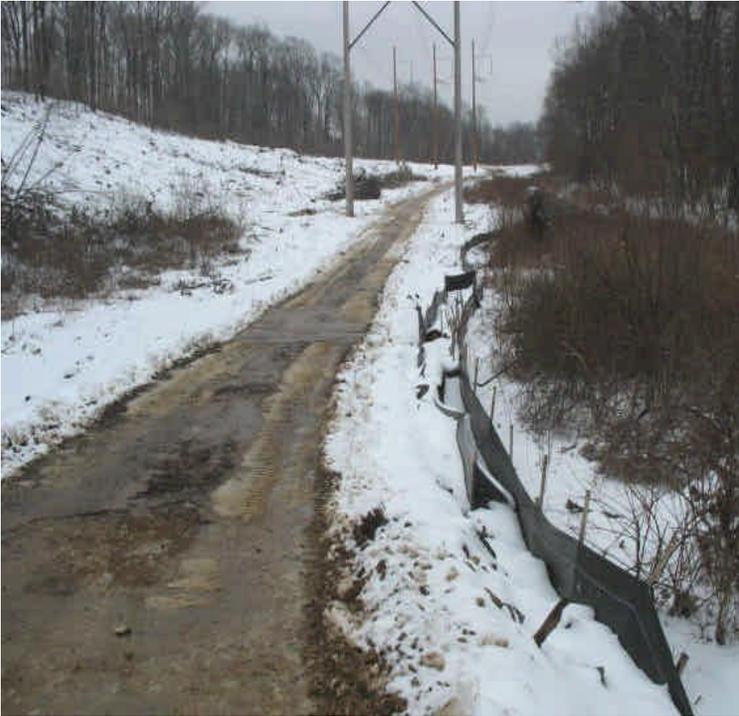
**With the recent snow cover, turbid run-off from the access road was reduced along the High Hill Rd. section of ROW. Continue to monitor controls and make necessary upgrades.**

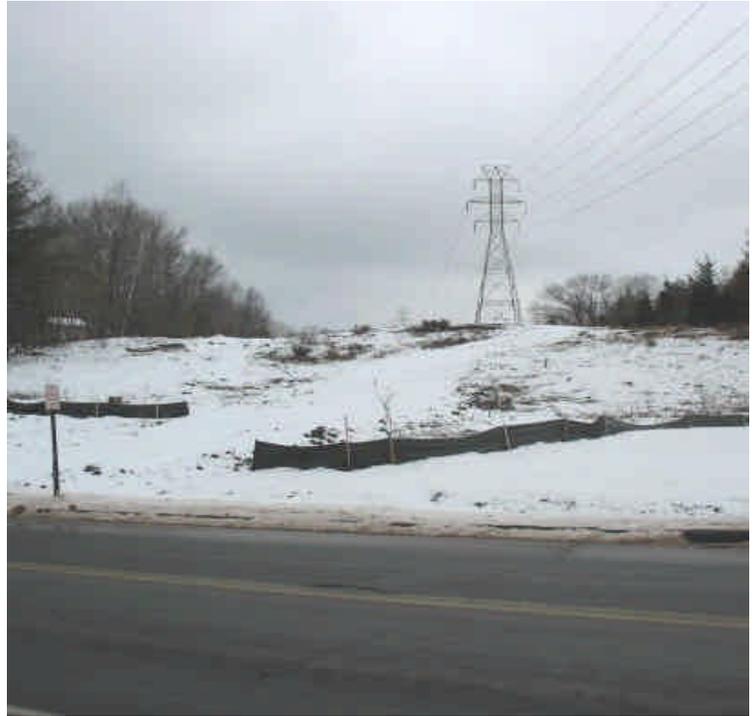
**Silt fence remains intact along South Turnpike. Continue to monitor the slope for erosion. Issues with run-off were not observed at this time.**

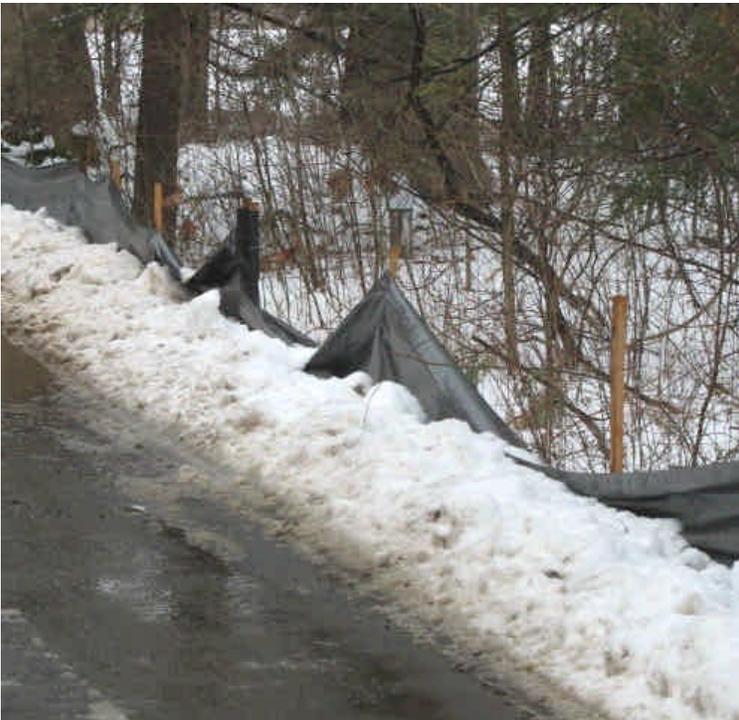
**The silt fence along the access road into the equipment storage area for the 115kV underground work could use minor repair (restapling) when feasible.**

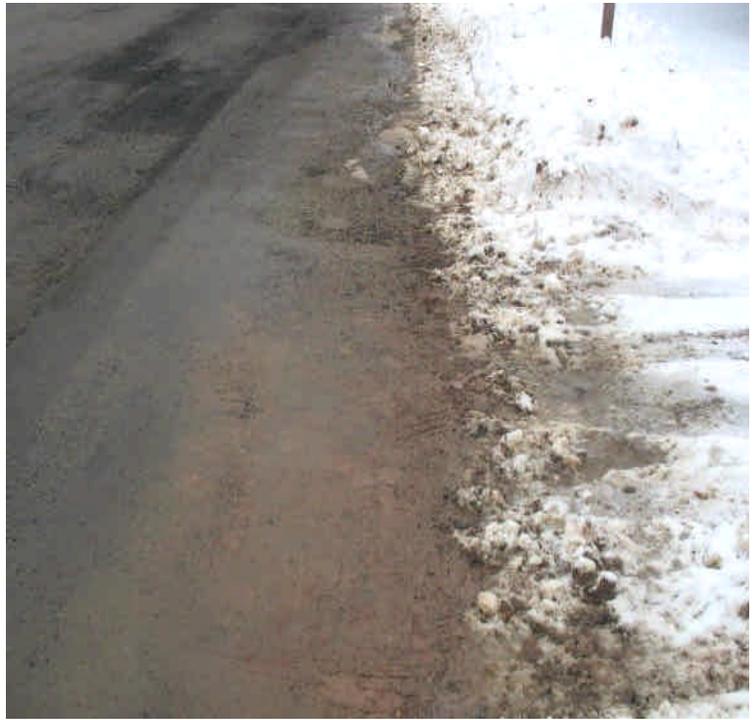
**View of sediment accumulation along the gutter of Old Farms Rd. The gutter buddy was removed from the receiving catch basin so the the town could plow the roadway. Continue to provide regular street sweeping and sweep gutter by hand if necessary.**

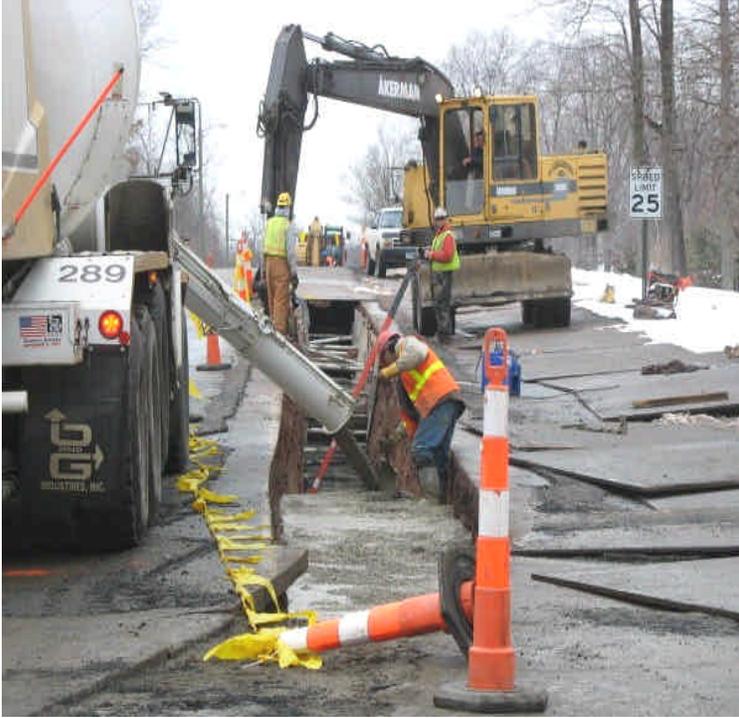
**Concrete pouring and backfilling in the trench along Old Farms Rd.**

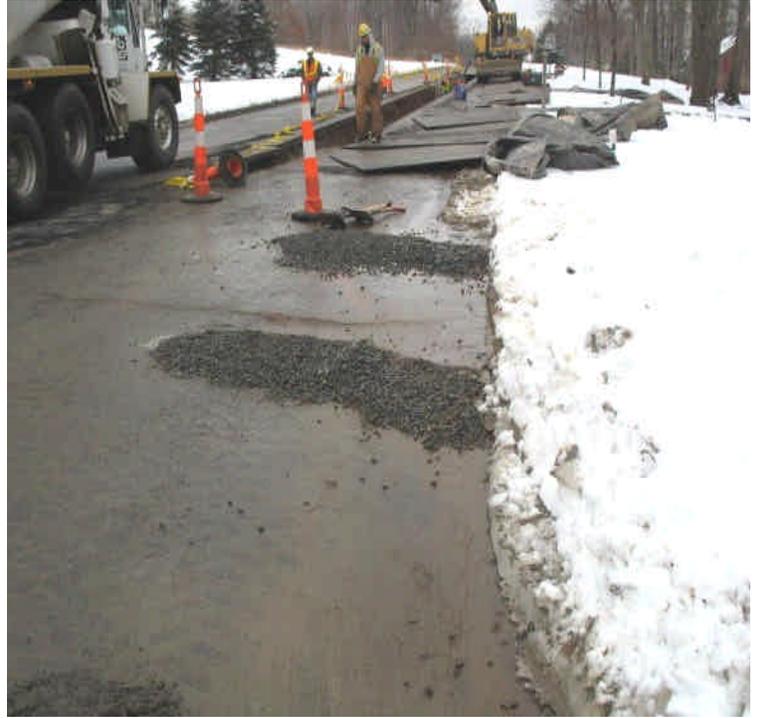
**Dewatering discharge set up to flow through several stone check dams to a CB on Old Farms Rd. Most sediment has been filtered out before the water enters the CB. Remove any sediment remaining on the road when work is complete.**

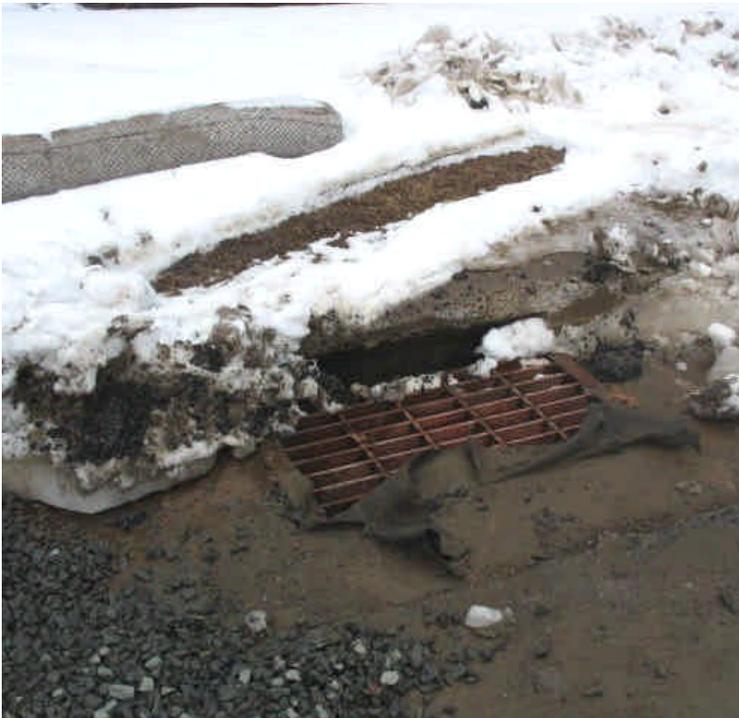
<p><b>Old Farms Rd. (115kV Underground trench-work)</b></p>	<p>All CBs are controlled with liners, however gutter buddies (filter socks) have been removed for town plowing and curb drop inlets are open to run-off. 2/27/07</p>	<p>Replace gutter buddies or provide alternative controls for drop inlets around town plowing needs. 2/21-2/27/07.</p>	<p>Needs attention</p>

**View of a catch basin along Old Farms Rd. Liners are in place but gutter buddies were removed so the town could plow the roadway. Replace as soon as feasible so the curb drop inlet is protected.**

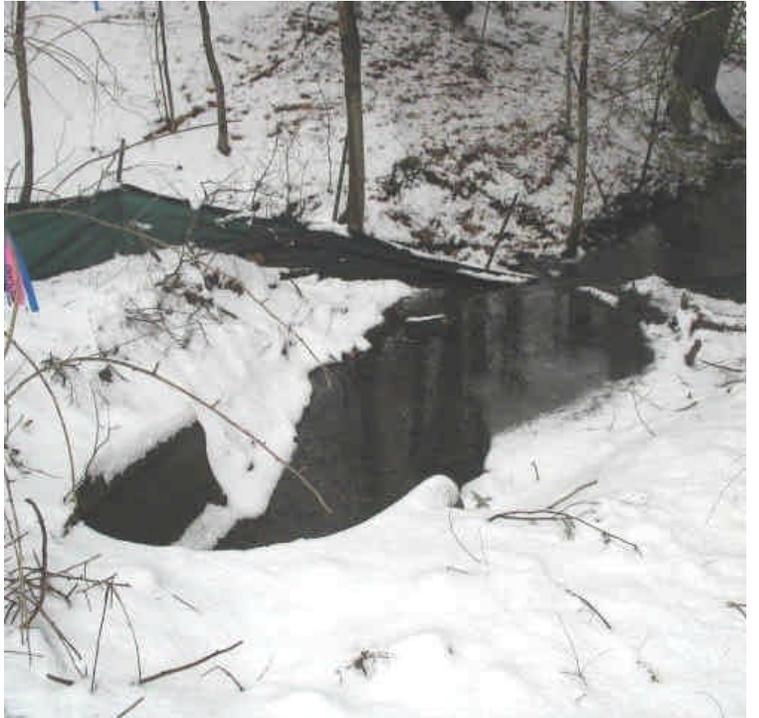
**View of one of the receiving wetlands along Old Farms Rd. There was no evidence of turbidity related to the project in the wetland at this time. However, issues were noted last week during thaw periods. Continue to monitor.**
