**Docket No. 272 – Development and Management Plan Inspection**

**Segment 4a Underground Line**

**Date:** February 1, 2007

**Location:** Singer Substation to Fairfield/Westport Town Line

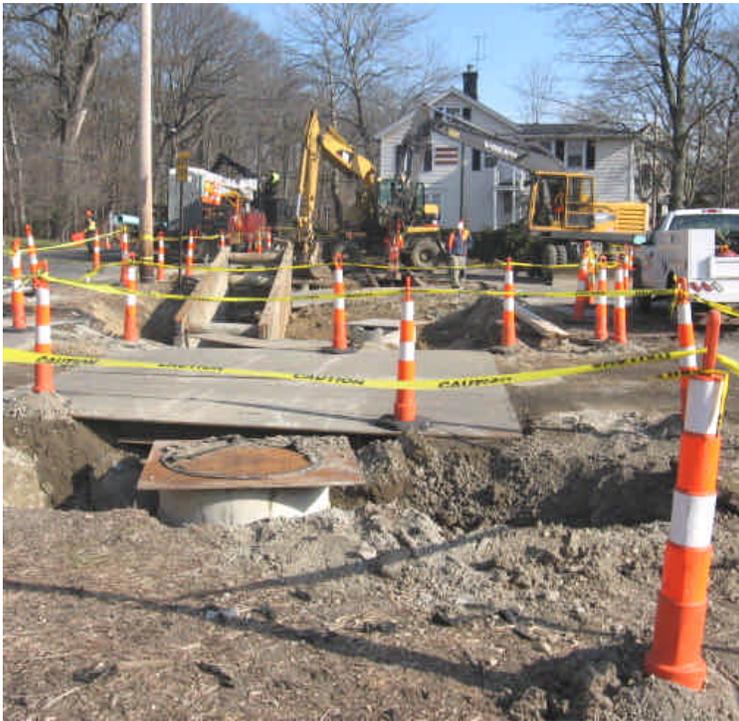
**Trenching activities east of Vault #28.**

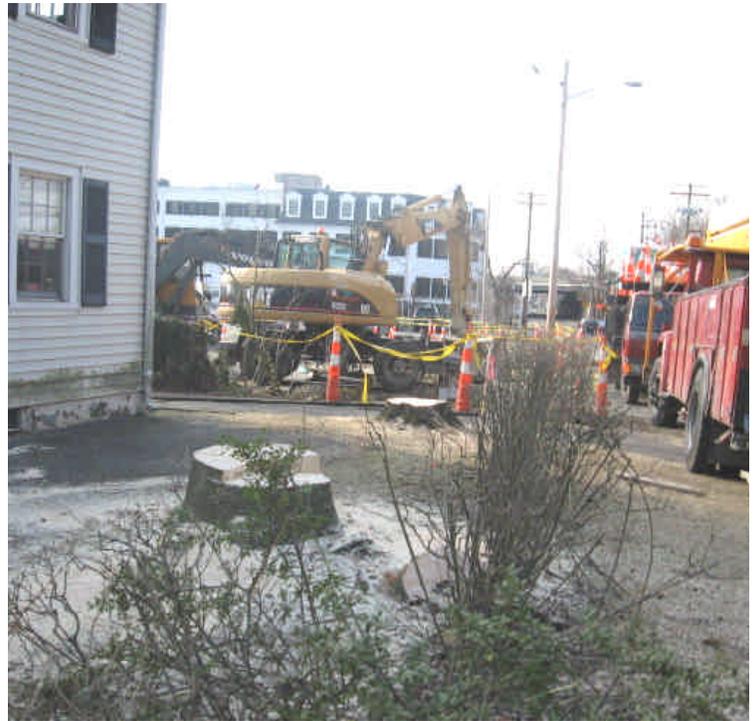
**Photo of an area where a 24" maple and 36" beech tree have been removed in preparation of trenching activities to the east of Vault #28.**

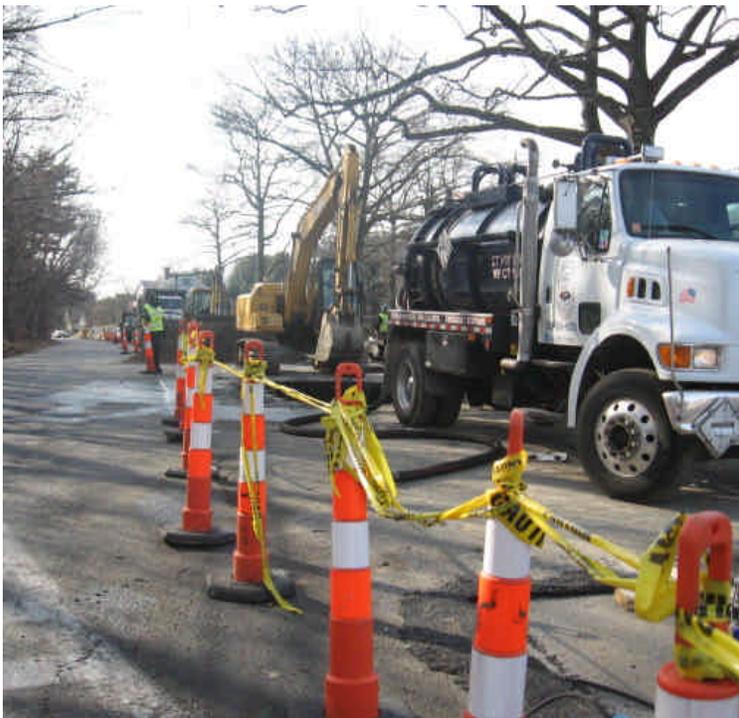
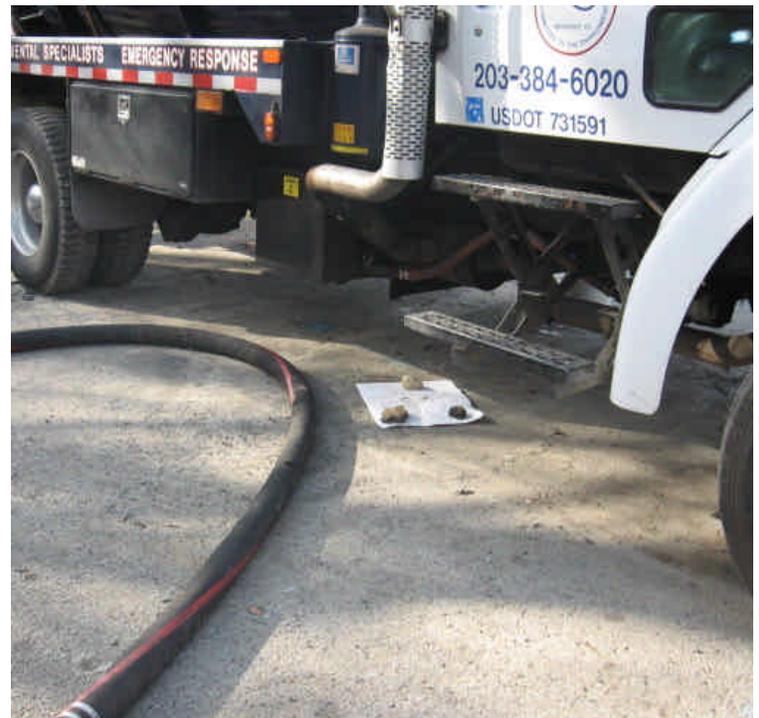
**Photos of gas main repairs taking place along Pequot Ave. An absorbent pad has been proactively placed under the vac truck to catch drips that were observed.**

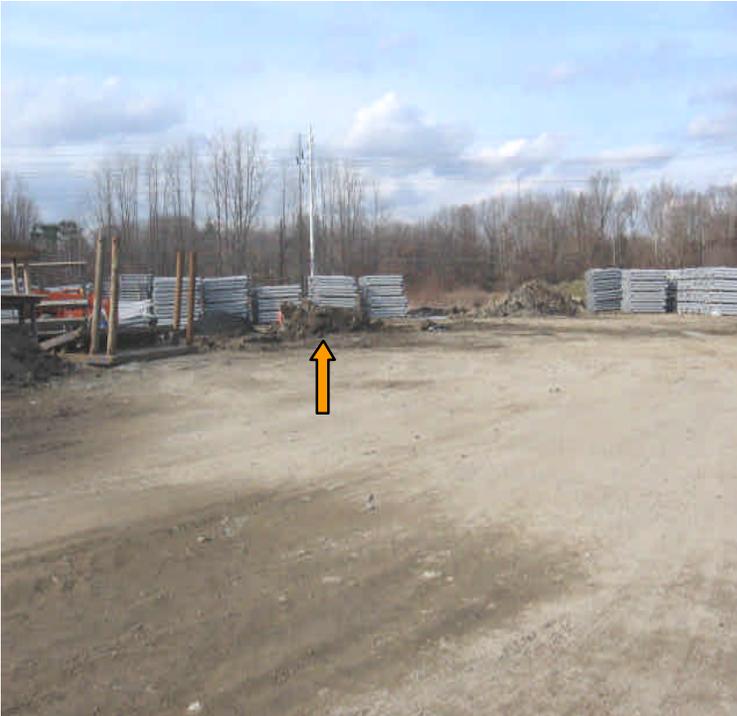
**Kings Highway lay-down yard. The small soil pile indicated is what remains of the concrete washout basin.**

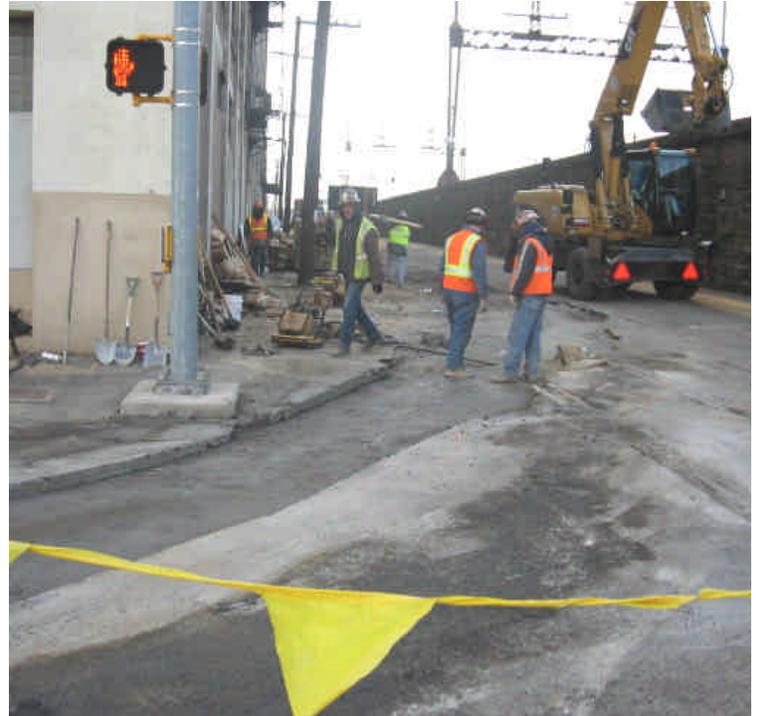
**Trenching activities at the intersection of Howard Ave along Railroad Ave.**

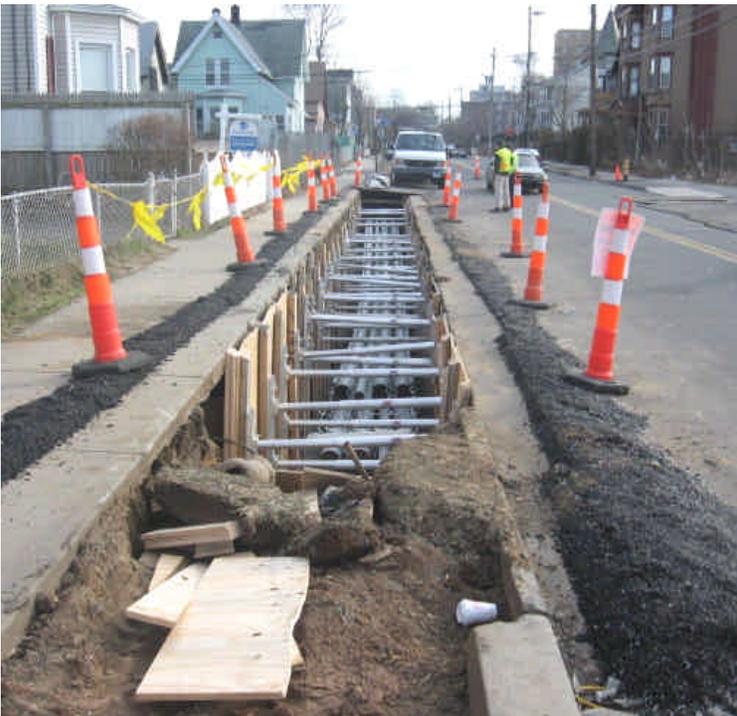
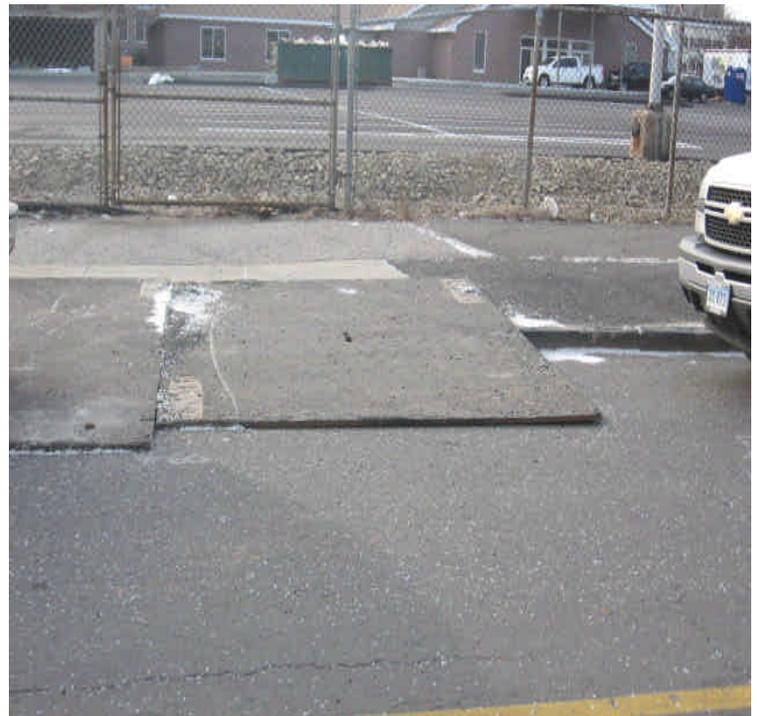
**Photo on the left shows trenching activities along Broad St. Photo on the right shows small piles of PVC shavings on the roadway. This fine plastic material has the potential to migrate to adjacent catch basins, or to the yards of abutters. It should be vacuumed or swept off the roadway and proactively contained in the future.**
