**Docket No. 272 – Development and Management Plan Inspection**

**Segment 4a Underground Line**

**Date:** February 16, 2007

**Location:** Singer Substation to Fairfield/Westport Town Line

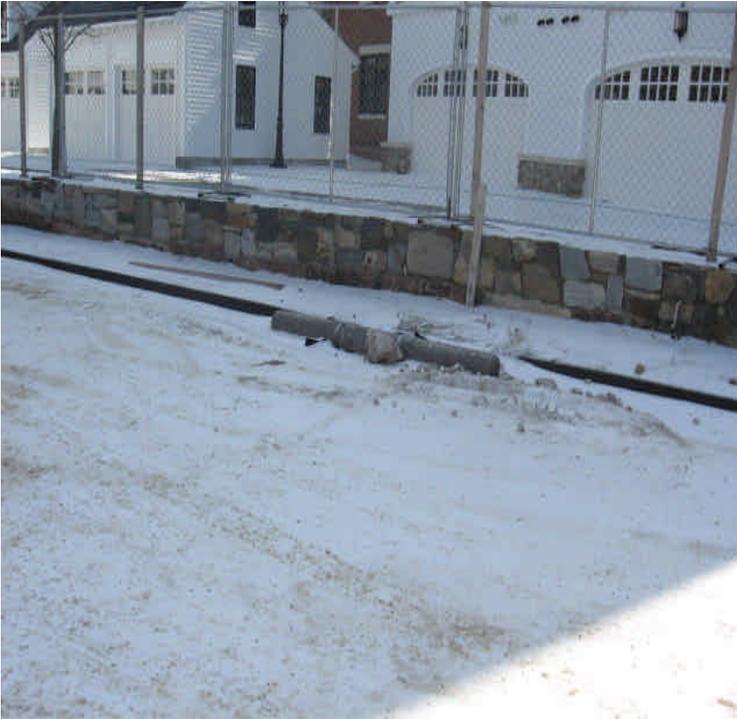
**Catch basins downgradient of Vault #28 trenching activities have been adequately protected.**

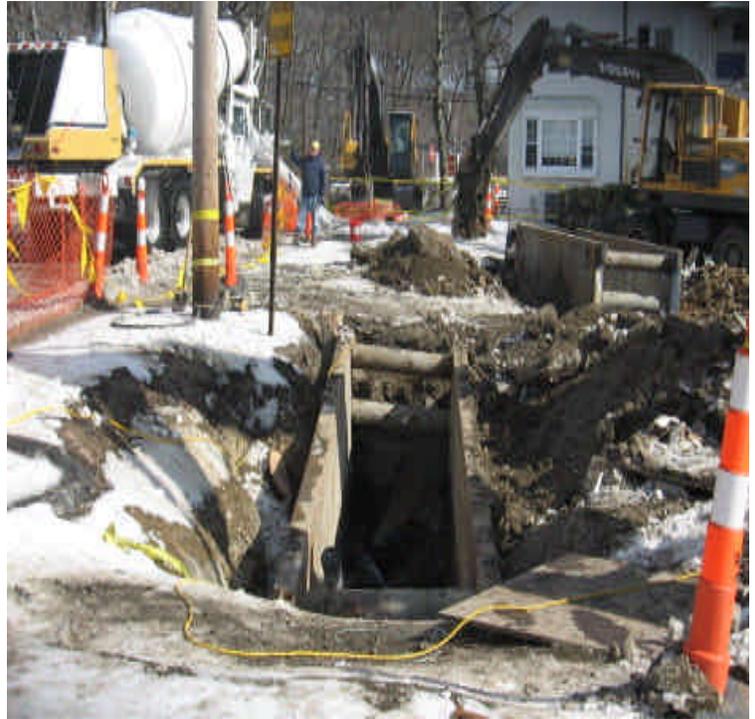
**The trench east of Vault #28 was being backfilled at the time of inspection.**

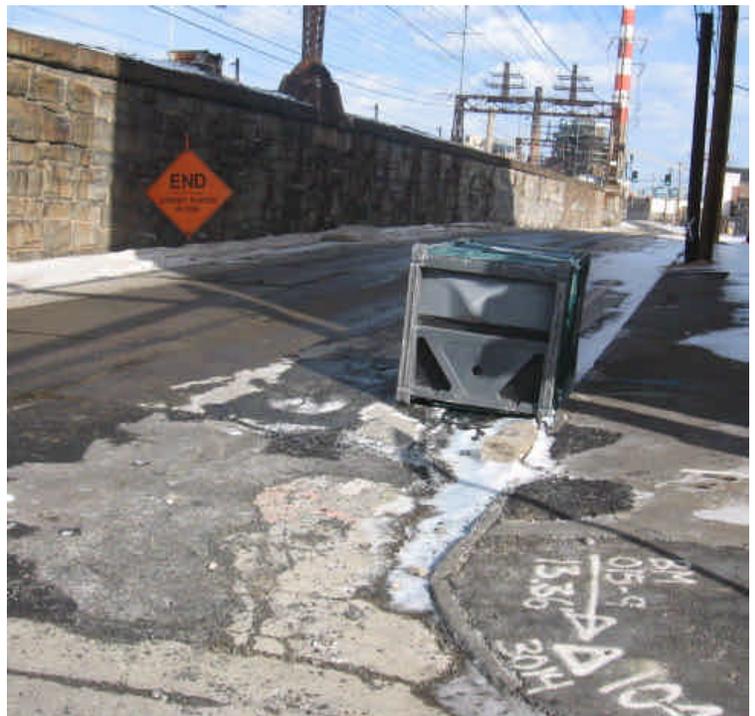
<p>Dewatering</p>	<p>Dewatering activities were not observed during this week's inspection. 2/16/07</p>	<p>Continue to appropriately contain or filter water prior to release. 2/16/07</p>	<p>NA</p>
<p>Blasting</p>	<p>No blasting has been proposed. 2/7/07</p>	<p>None 2/7/07</p>	<p>NA</p>
<p>Spills and Material Storage</p>	<p>Spill cleanup materials/kits were observed in the storage yards. 2/16/07</p> <p>A sani-can had been blown on its side by wind gusts. Contents were leaking into an adjacent catch basin identified as part of the combined sewer and stormwater system. 2/16/07</p>	<p>Ensure that spill kits are also present with each vehicle during active construction 2/16/07</p> <p>Sani-can was to be placed upright and remaining contents were to be cleaned up. Ensure that all similar facilities are placed in appropriate locations, sheltered from wind gusts. 2/16/07</p>	<p>NA</p> <p>Contractor called party responsible for clean-up during inspection. Continue to address the situation.</p>

**A sani-can located on Railroad Ave. near its intersection with Myrtle Ave was blown over by the wind. Contents are leaking into catch basins designed to receive combined stormwater overflow. The contractor contacted the responsible party for clean-up during the inspection.**
