Docket No. 272 – Development and Management Plan Inspection

Segment 4b Underground Line

Date: February 23, 2007

Location: Fairfield/Westport Town Line to Westport Avenue in Norwalk

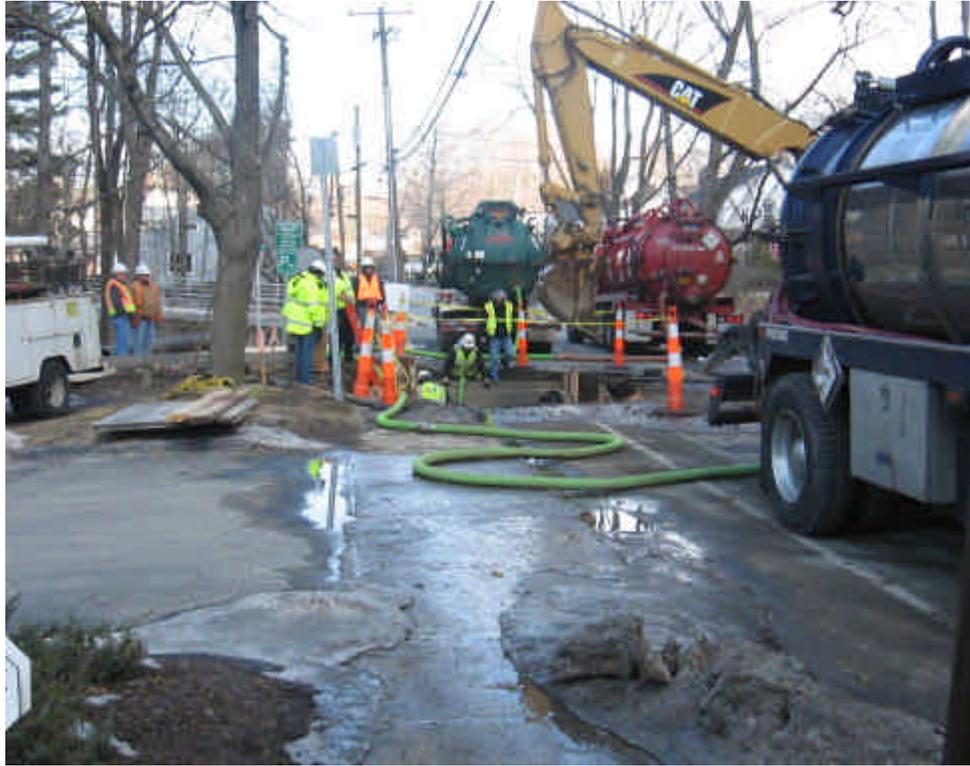
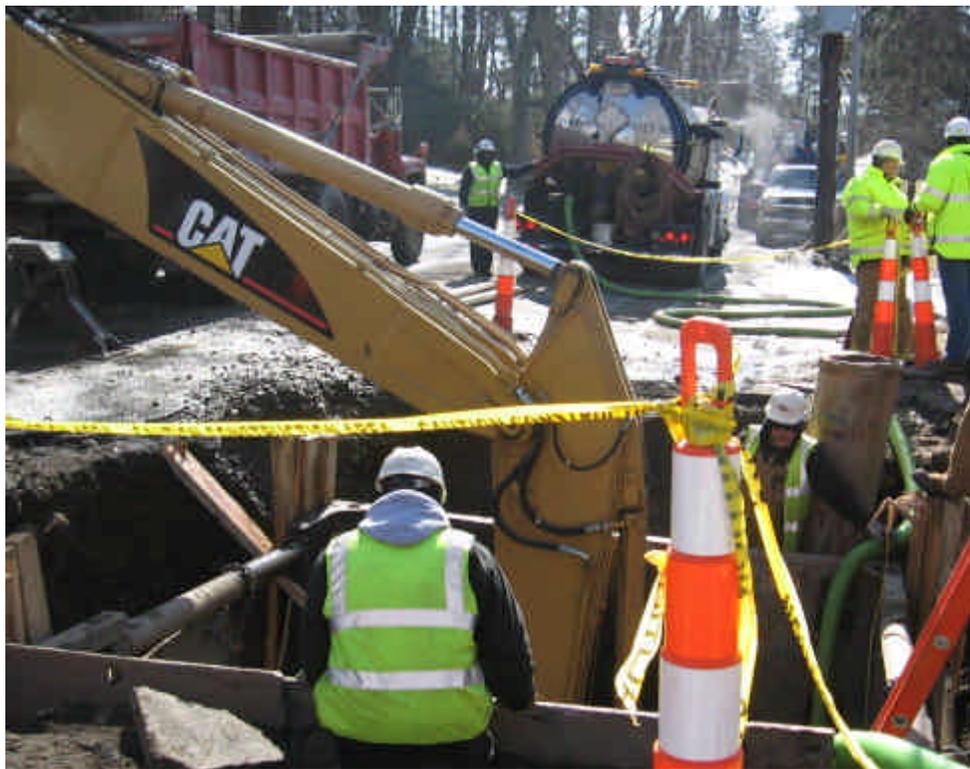
Photos above and below show utility work being conducted on Imperial Ave. immediately adjacent to Dead Man's Creek. Crews have encountered groundwater that required continuous trench dewatering. Three vac trucks were receiving water at the time of inspection. All catch basins adjacent to the work were protected.
