Docket No. 272 – Development and Management Plan Inspection

Beseck Switching Station Inspection

Date: January 9, 2007

Location: Beseck Switching Station

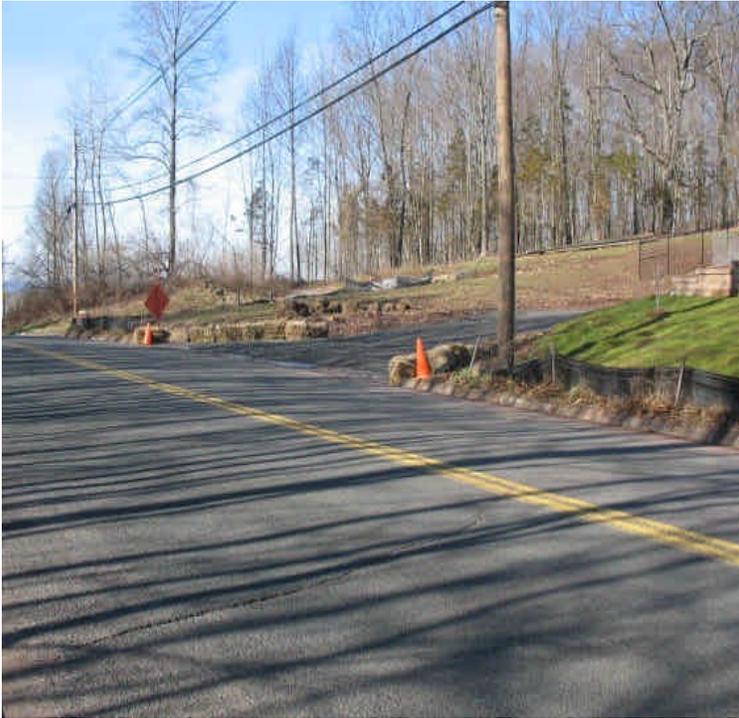
New entrance off Carpenter Lane is at final grade; erosion controls have been removed. Monitor carefully for run-off.

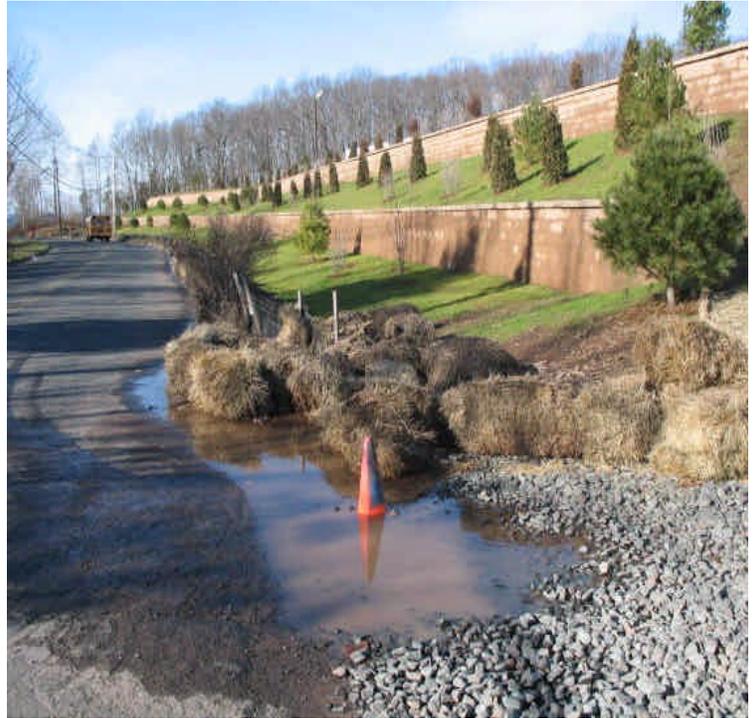
View of Carpenter Lane and retaining walls. Sediment accumulation was noted in the gutters. Run-off was fairly clear as it was observed flowing past the final controls at the site entrance.

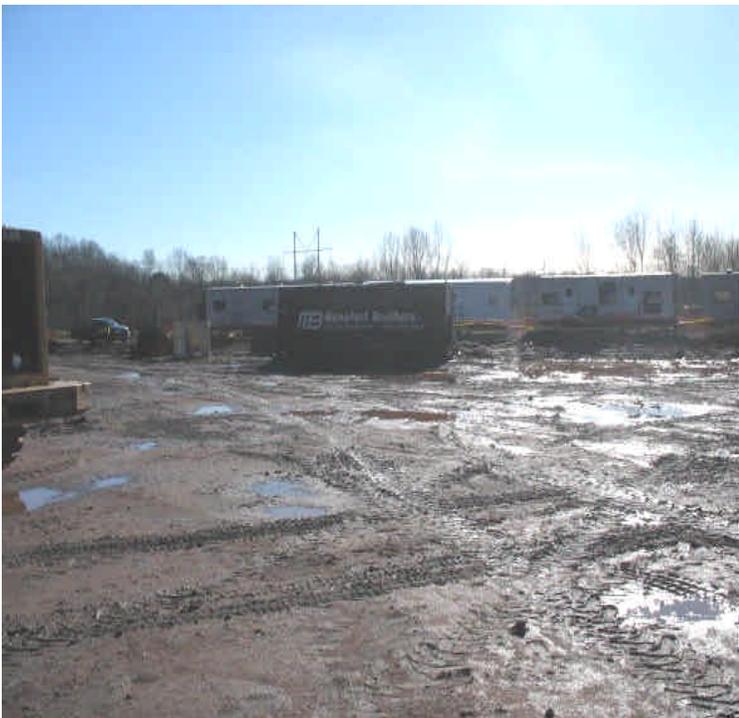
Dewatering from foundation pits is being pumped into a frac tank to settle, and then released to the site. However, this allows run-off to pick up sediment again. Clean water could be pumped directly to the controlled CB at a low flow rate so as not to overtake controls.

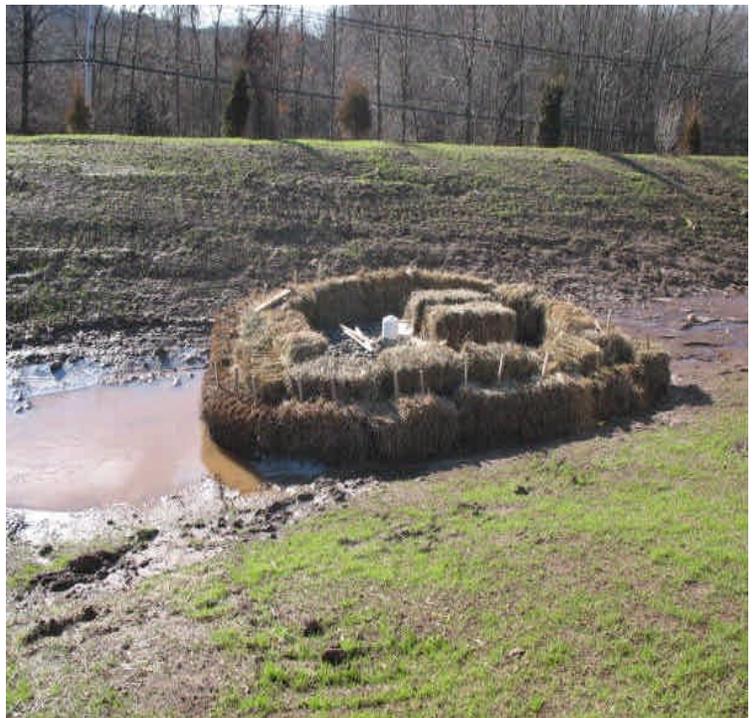
Additional haybales have been installed at the detention basin inlet. Continue to monitor controls and change as needed. Contractors state (as of 1/12/07) that they will monitor water levels in basins and reallocate as necessary until the site is stable.

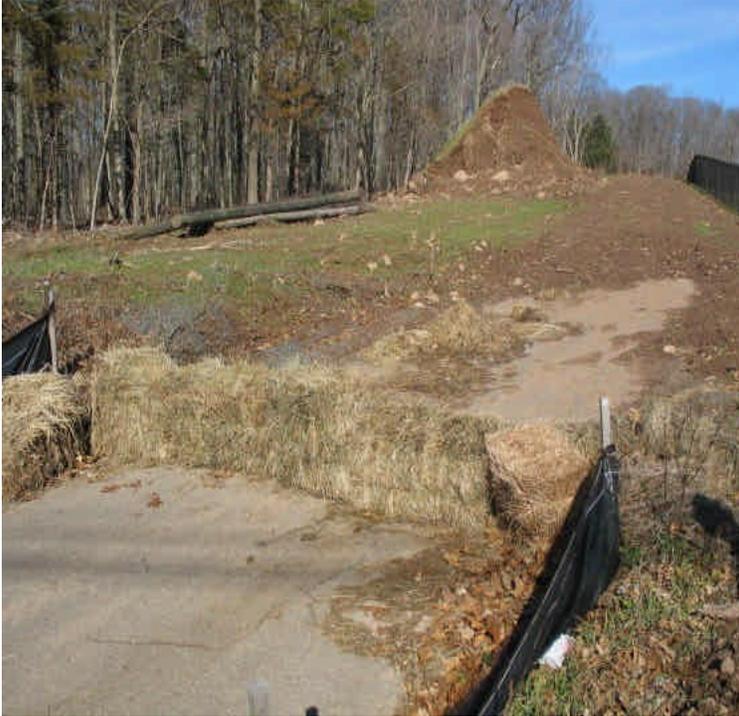
Haybales were replaced across the old Zolnik driveway.

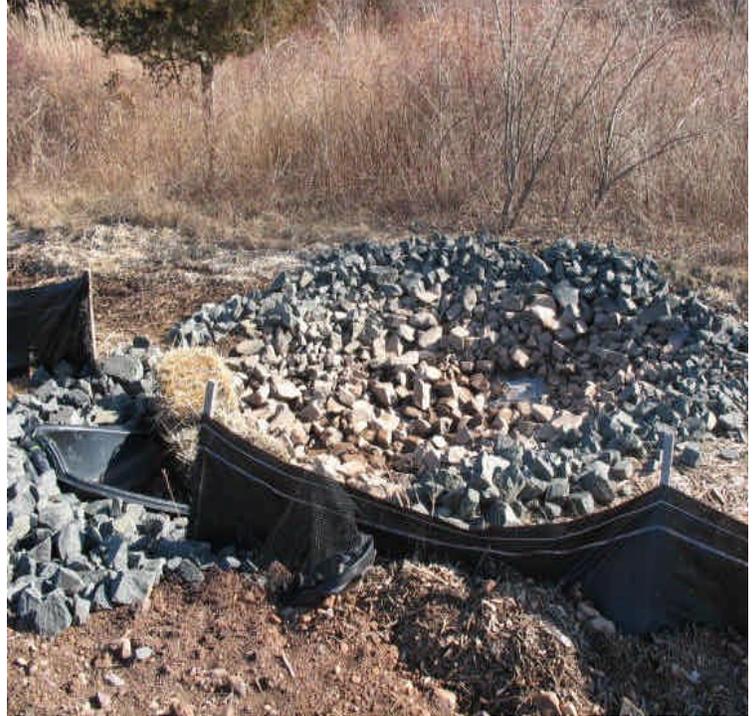
View of the culvert under the new access road. Minor amounts of sediment appear contained within the trap. Beseck and Seg 1A contractors are jointly sharing the access road.

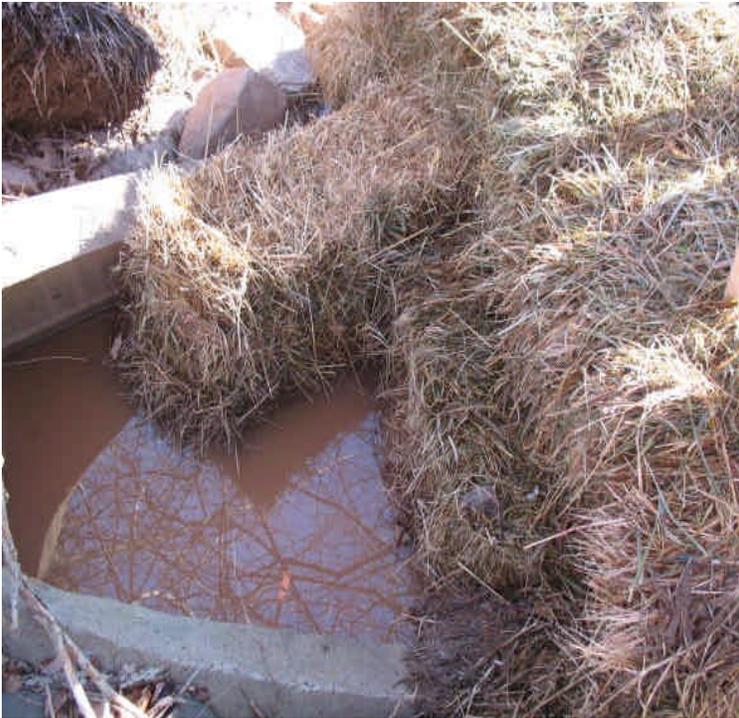
Another 1" rainstorm the previous day has resulted in turbid water flowing through the outlet pipe across Carpenter Lane. Haybales have been replaced and water flowing through the controls had very little sediment by the time it reached the wetland.

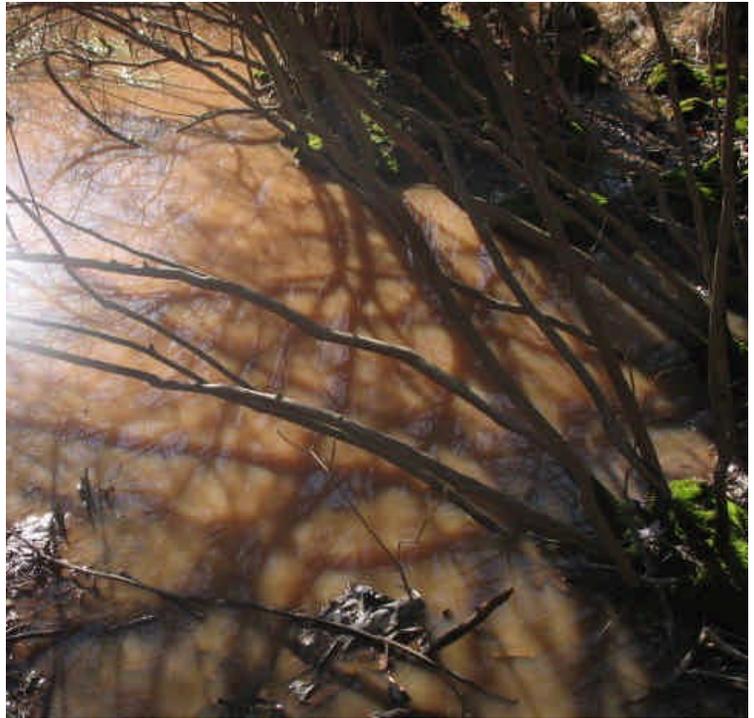
The wetlands across Carpenter Lane remain turbid after another 1" rain event. The sediment is extremely fine and difficult to filter and will take time to settle out of the water column. The addition of new haybales and efforts on site are beginning to improve the run-off quality. Sediment removal may be necessary in the future.
