Docket No. 272 – Development and Management Plan Inspection

Beseck Switching Station Inspection

Date: January 23, 2007

Location: Beseck Switching Station

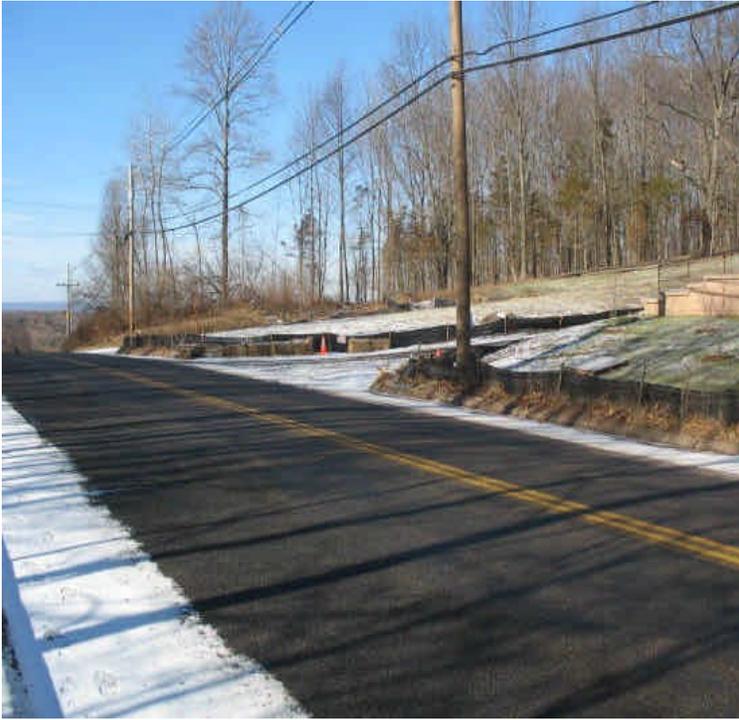
Site entrance off Carpenter Lane is at final grade; Monitor carefully for run-off and add controls as necessary.

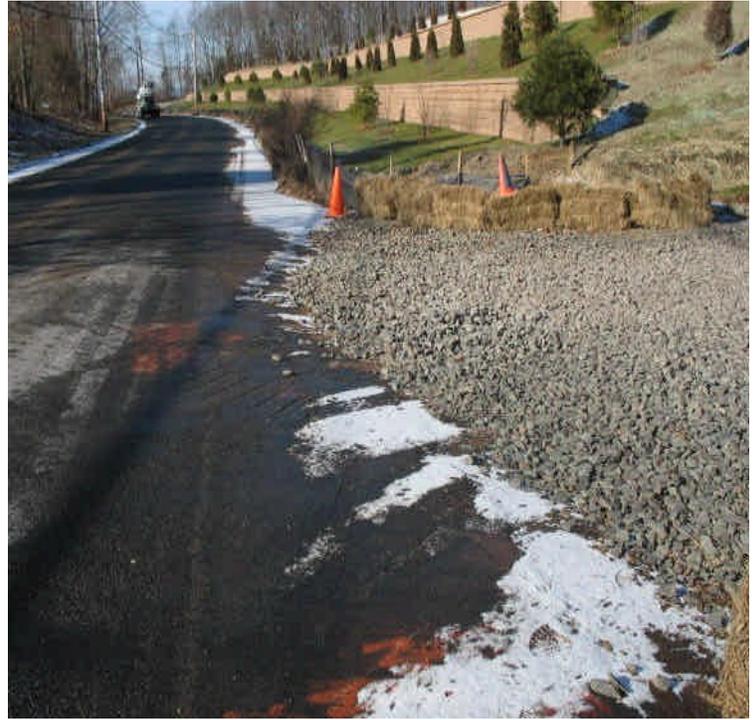
View of Carpenter Lane and retaining walls. Since the improvements were made at the stone pad and along the roadway, sediment tracking and turbid run-off were not issues at this time.

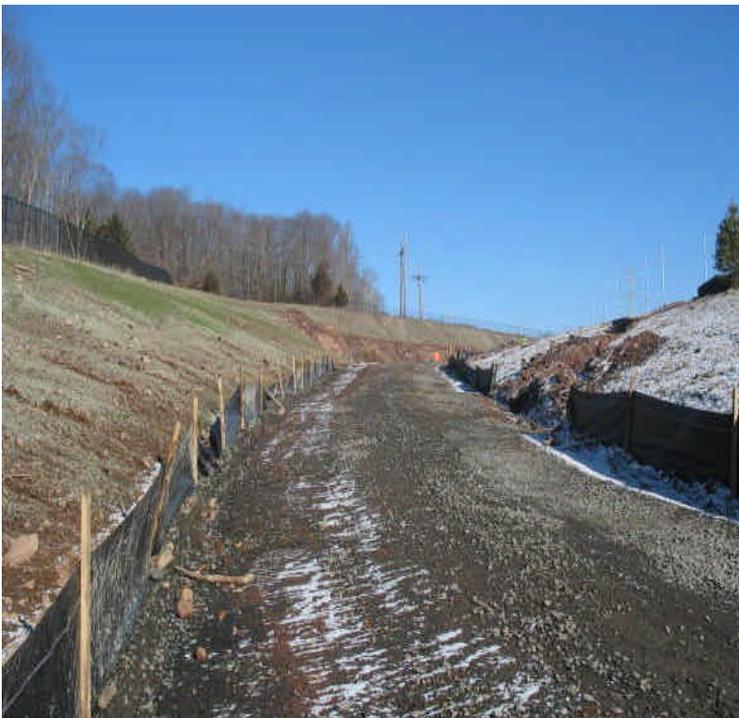
Conduit has been installed within the site entrance and adjacent areas. Repair fallen sections of silt fence once installation process is complete.

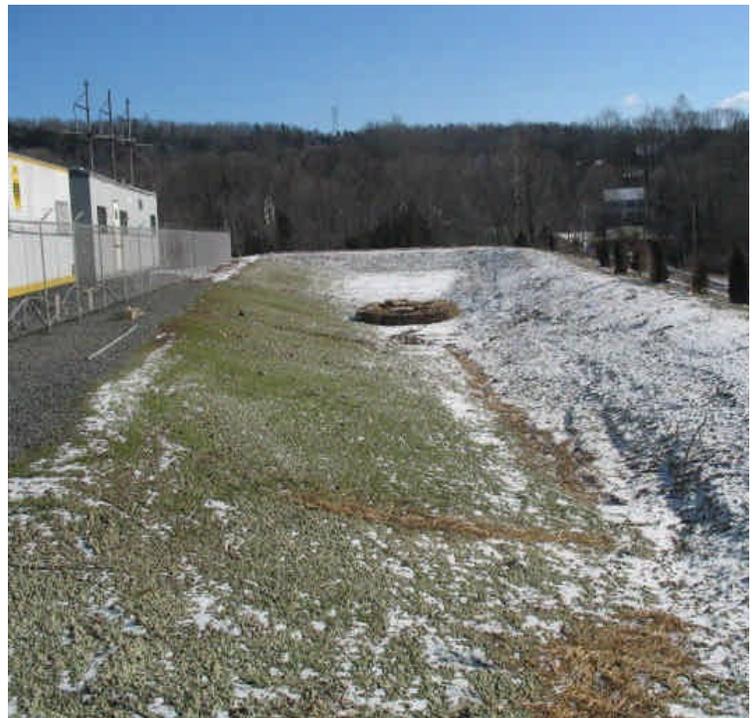
Surface areas on site are fully hydroseeded (including a tackifier) in an effort to stabilize soils. Additional haybales were installed at the inlet. Hay mulch was also added to the eroded gullies on the basin slope. No run-off was observed this week.

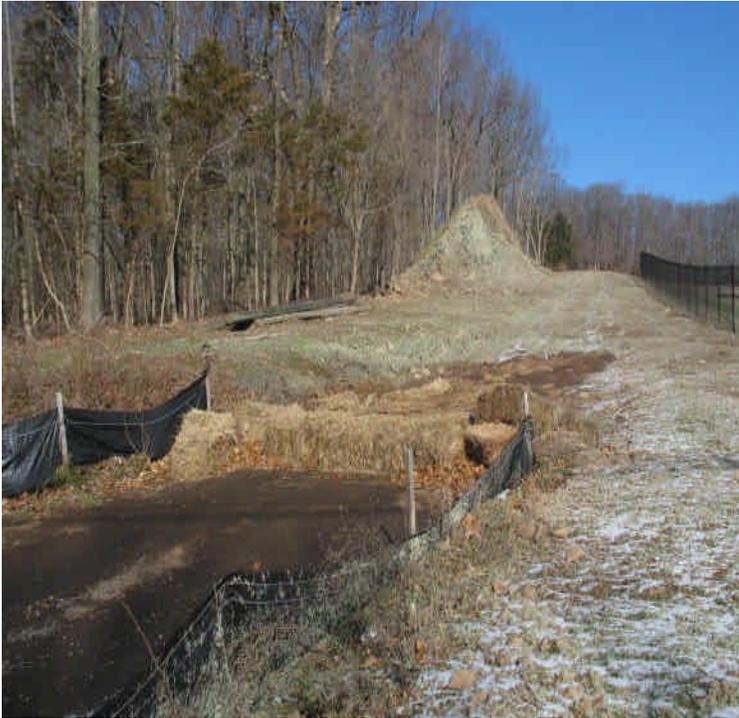
Haybales were replaced across the old Zolnik driveway. The remaining stockpile and exposed surfaces are hydroseeded (including a tackifier).

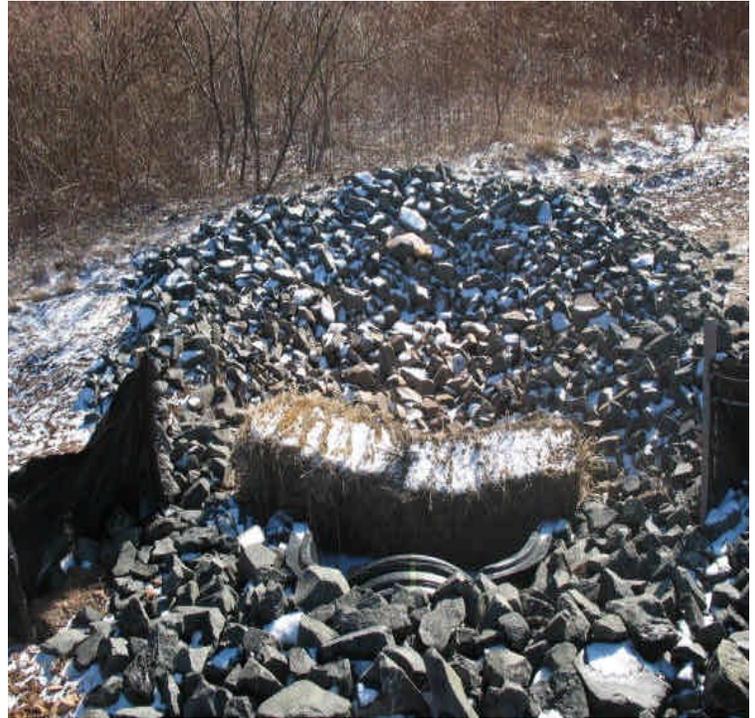
View of the culvert under the new access road. A minor amount of sediment was noted but appears well contained within the trap. Beseck and Seg. 1A contractors are jointly sharing the access road.

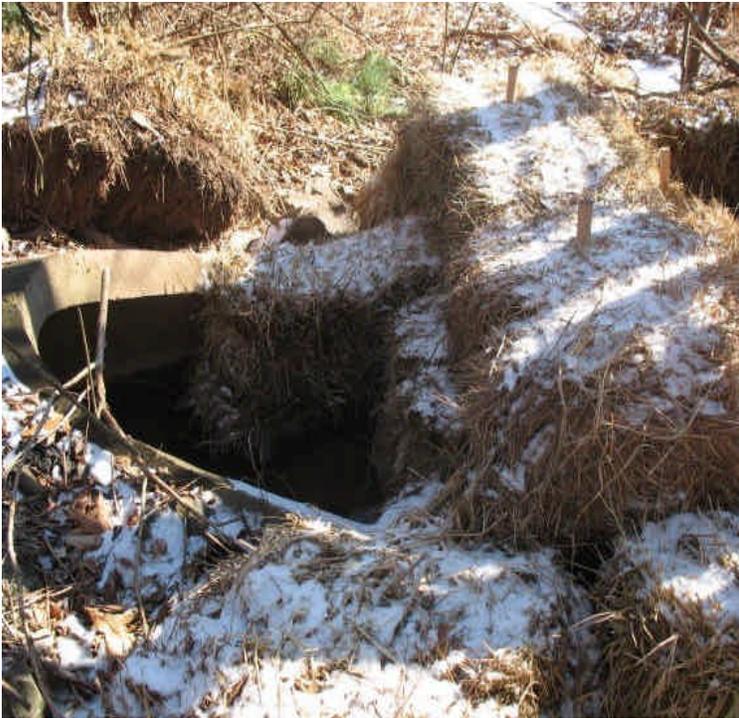
Sediment has settled out at the storm drain outlet across Carpenter Lane. Clear water was noted flowing through the recently replaced haybales. The additional efforts on site appear to be effective at reducing sediment. Continue to monitor.

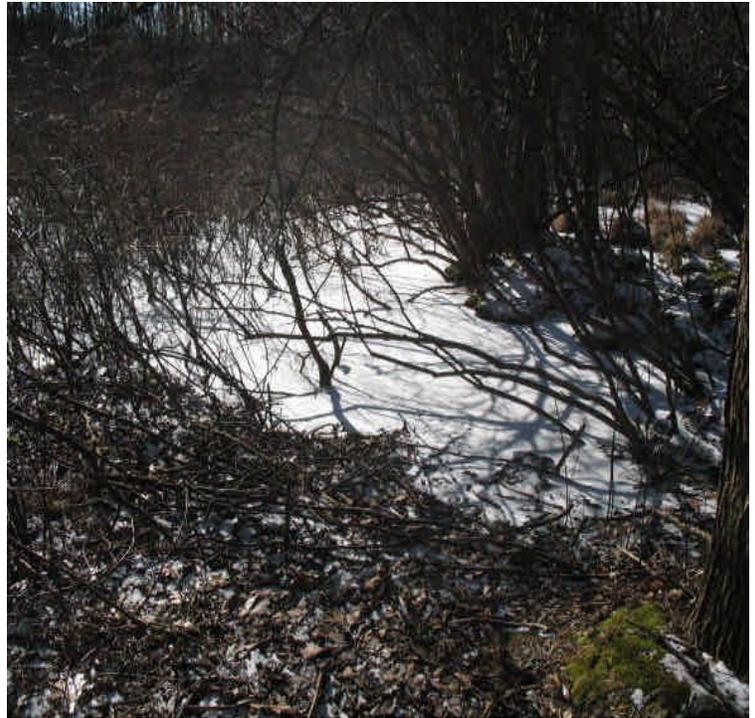
Snow and ice cover made conditions difficult to observe in the wetlands across Carpenter Lane. Sediment removal may still be necessary once the water level subsides. It will be evaluated whether the amount of accumulation justifies the minor disturbance to remove it.
