Docket No. 272 – Development and Management Plan Inspection

Scovill Rock Switching Station Inspection

Date: January 29, 2007

Location: Scovill Rock Switching Station

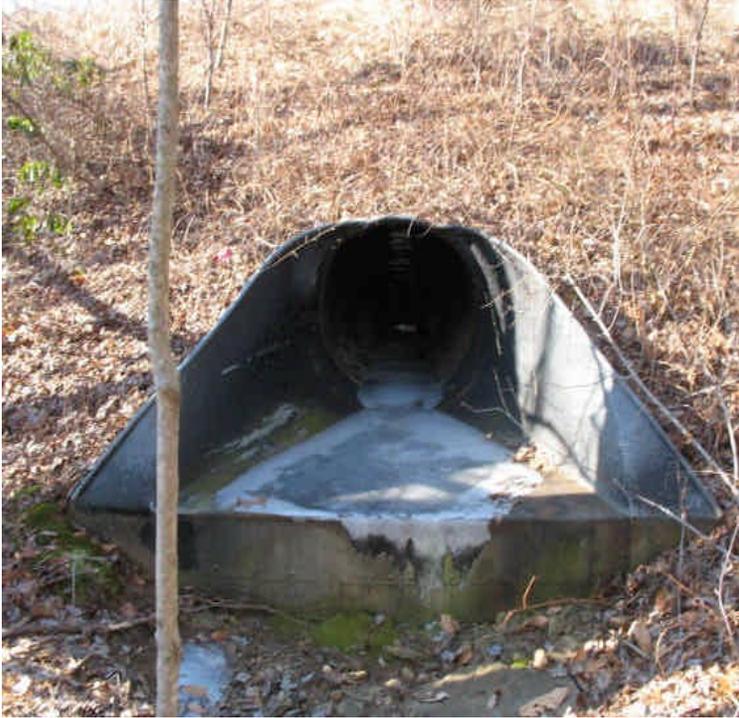
View of the culvert under the access drive. No sediment issues have been observed.

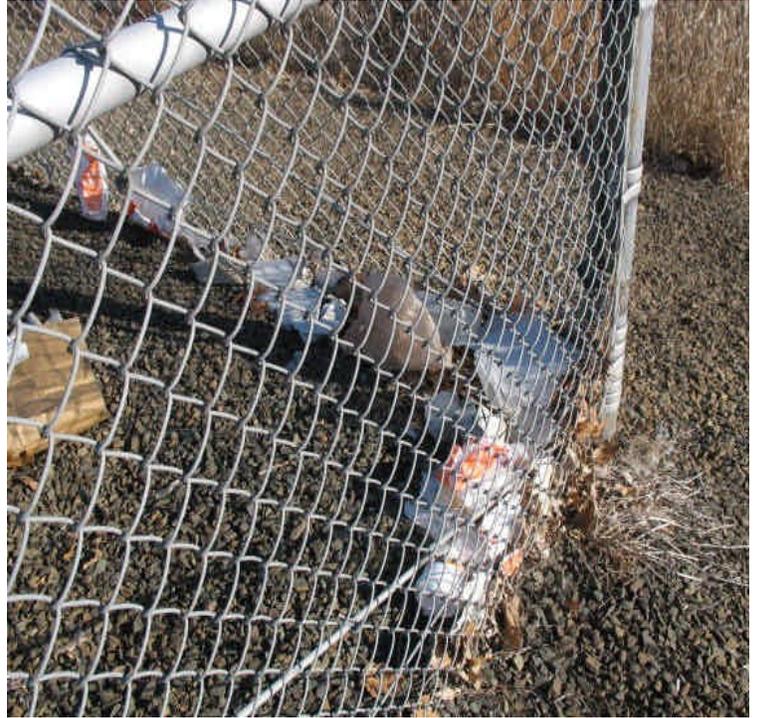
Minor wind blown debris/trash within the yard. The site is stable and soil disturbing work is now complete.

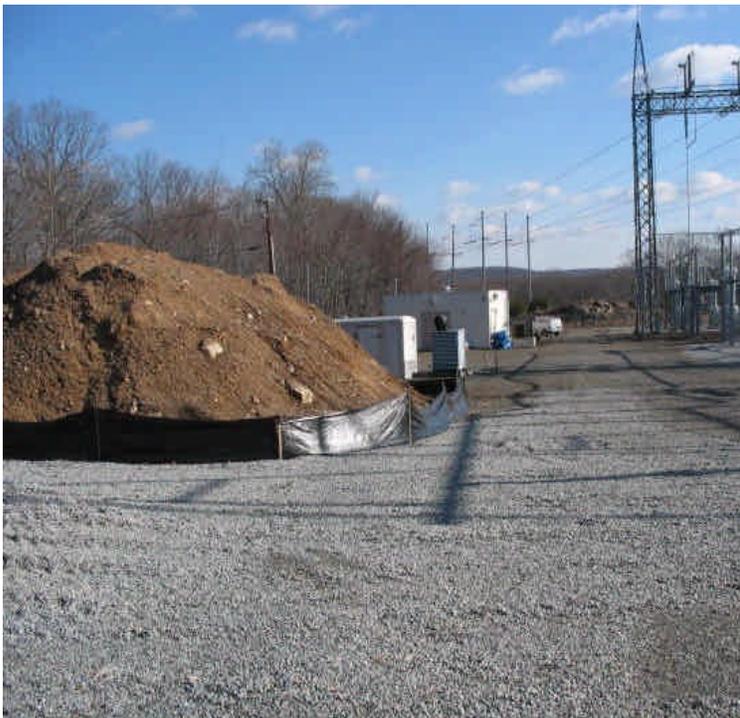
Silt fence surrounding the remaining soil stockpile remains intact. All soils are well contained to the site.

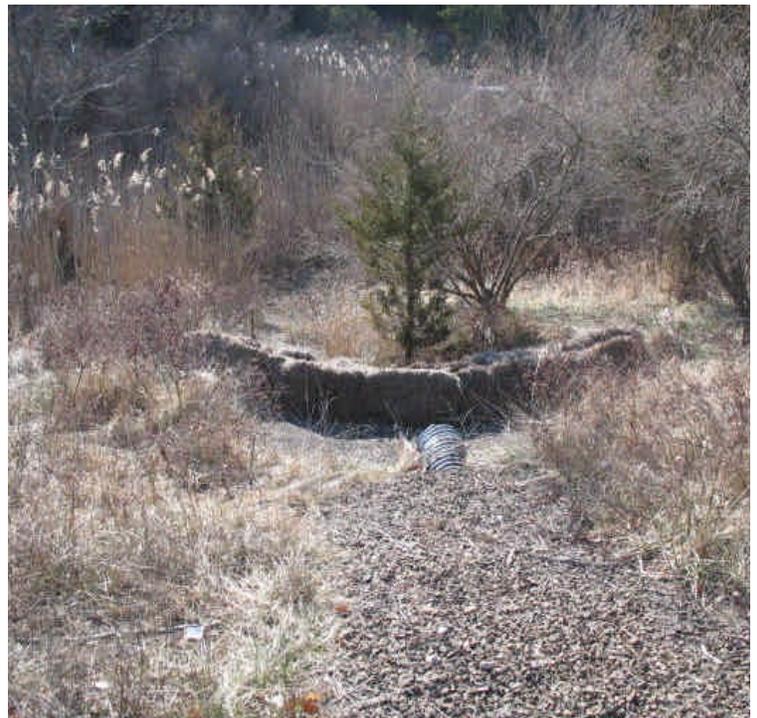
Remove degraded haybales when feasible. Site is stable.
