Docket No. 272 – Development and Management Plan Inspection

Segment 2a Inspection

Date: January 16, 2007

Location: Segment 2a – Beseck Switching Station to Cheshire/Hamden Town Line

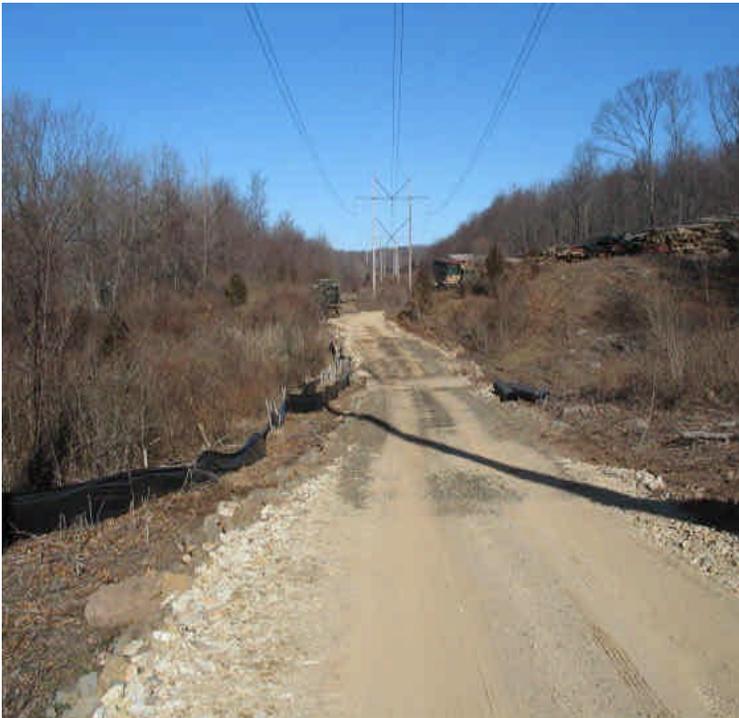
Access road, timber mats, and erosion controls off High Hill Road at a non-federally jurisdictional wetland crossing

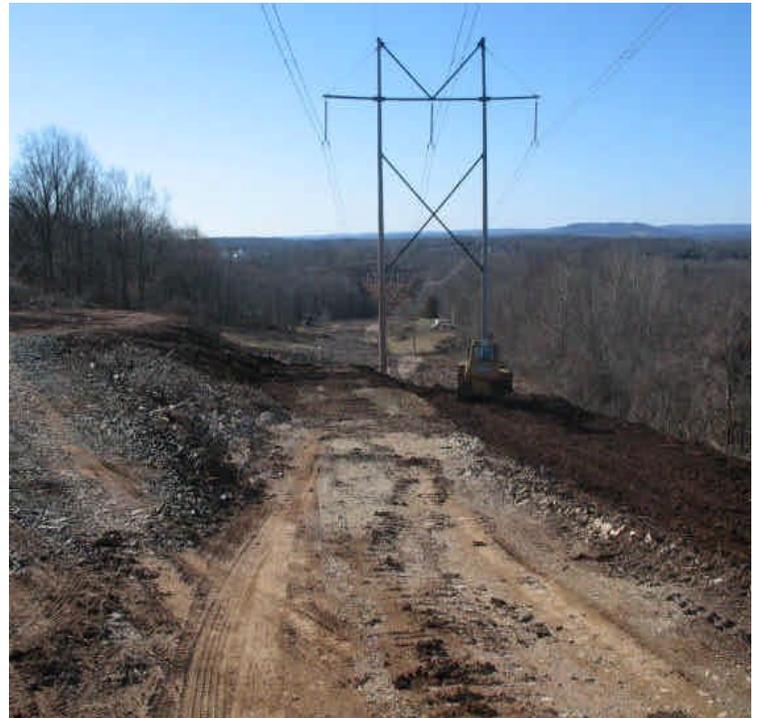
New staging areas prepared for pole construction. Temporary stabilization measures (mulch) are added as needed.

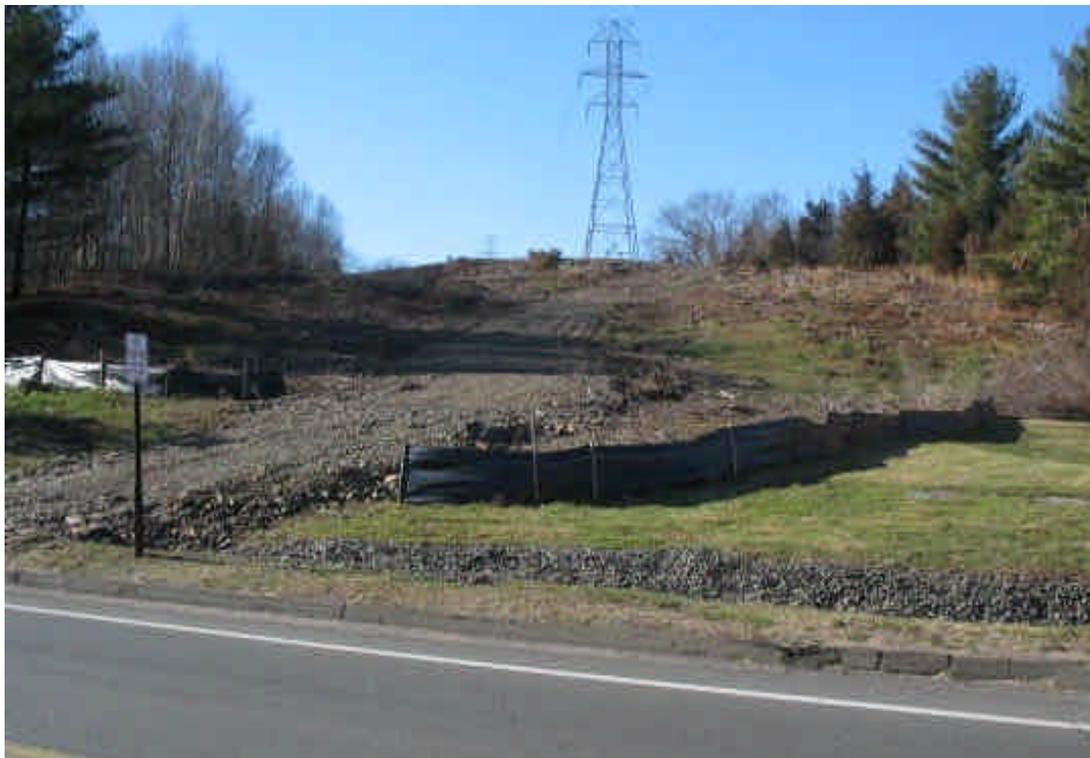
The small section of fallen silt fence was repaired along South Turnpike. Continue to monitor the slope for erosion.

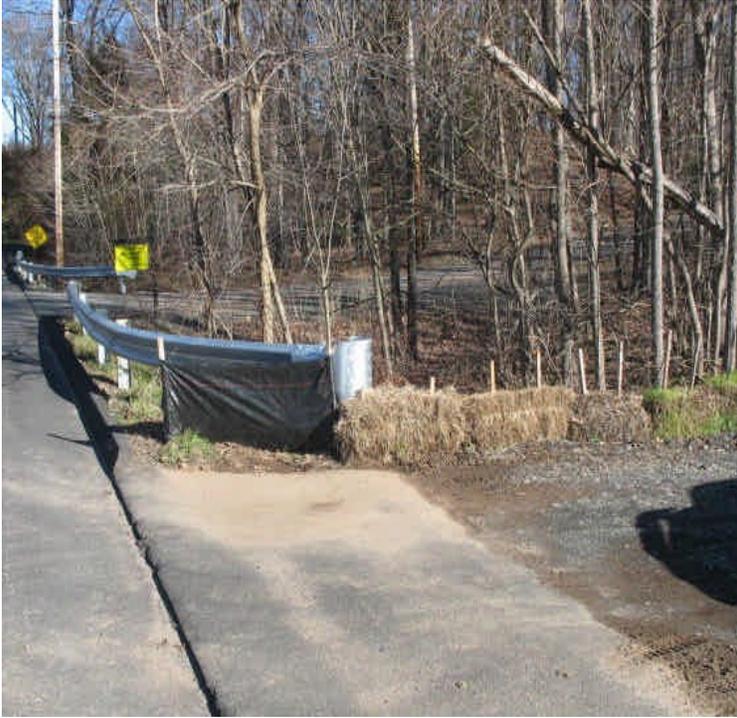
Sediment accumulation was removed and silt fence was added at the ROW entrance off Mansion Rd.

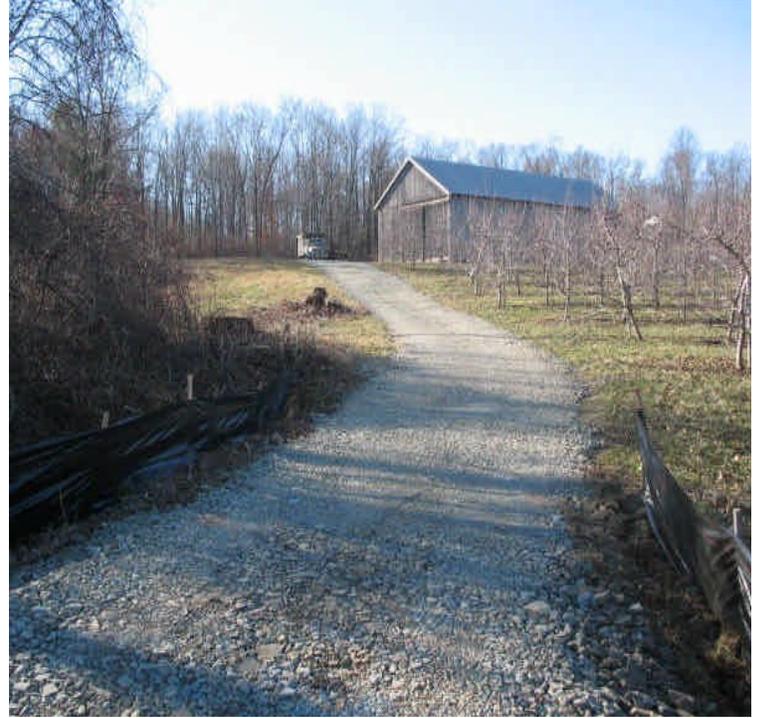
Silt fence was added along the new access road adjacent to wetlands within the apple orchard off Mansion Rd.

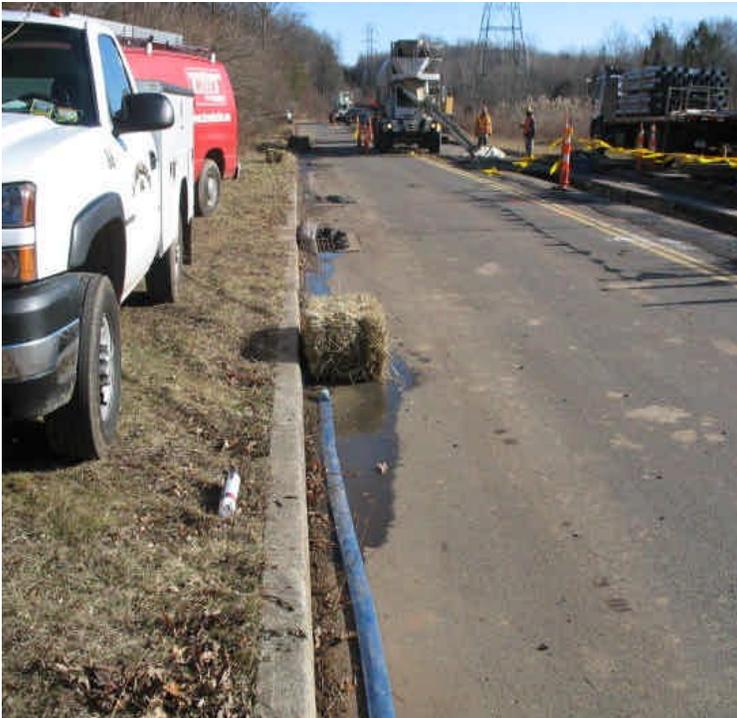
View of trenching on Old Farms Road for underground work. Clean water was being dewatered from the trench and released to the CBs. Adjacent wetlands showed no signs of sedimentation. Continue to sweep road as necessary especially as soon as sawcut slurry is created.

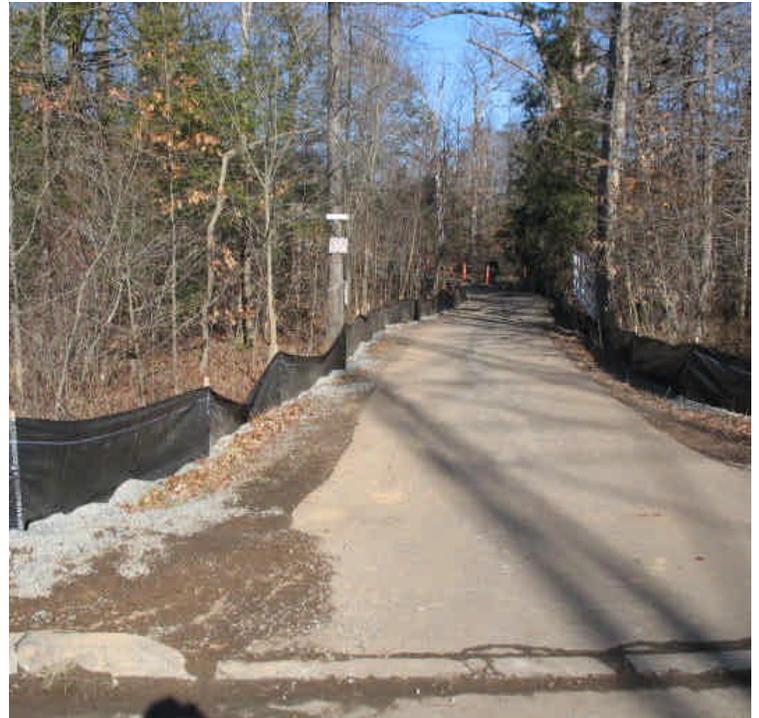
Silt fence was extended along the driveway to the equipment storage area. No sediment issues were observed in the adjacent wetlands.
