**Docket No. 272 – Development and Management Plan Inspection**

**Segment 2a Inspection**

**Date:** January 23, 2007

**Location:** Segment 2a – Beseck Switching Station to Cheshire/Hamden Town Line

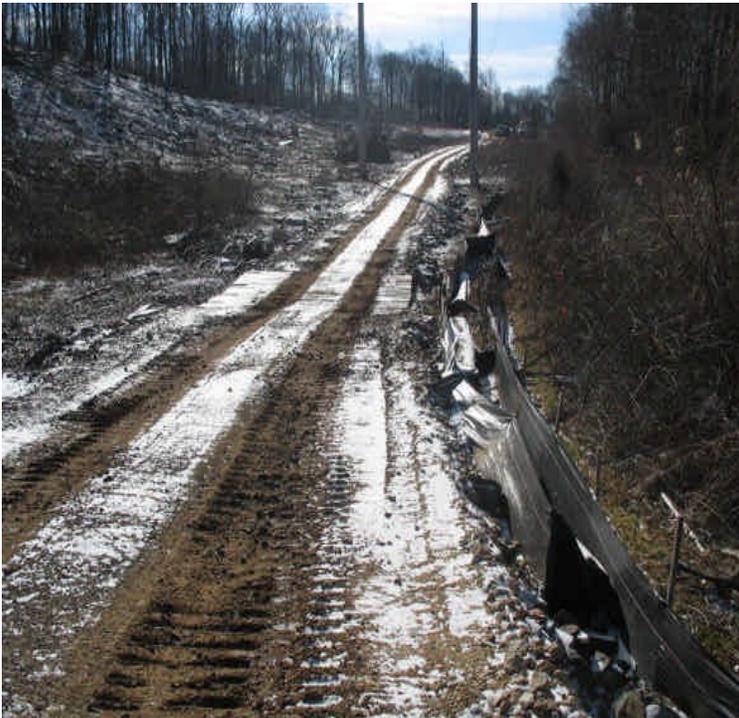
**Access road, timber mats, and erosion controls off High Hill Road at a non-federally jurisdictional wetland crossing**

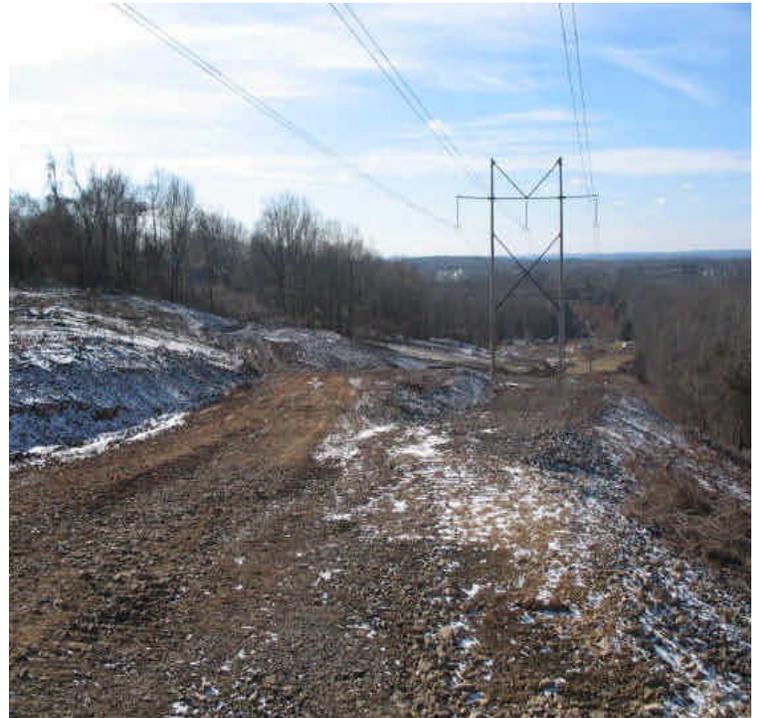
**View of the staging areas prepared for pole construction. Temporary stabilization measures (mulch) are added as needed.**

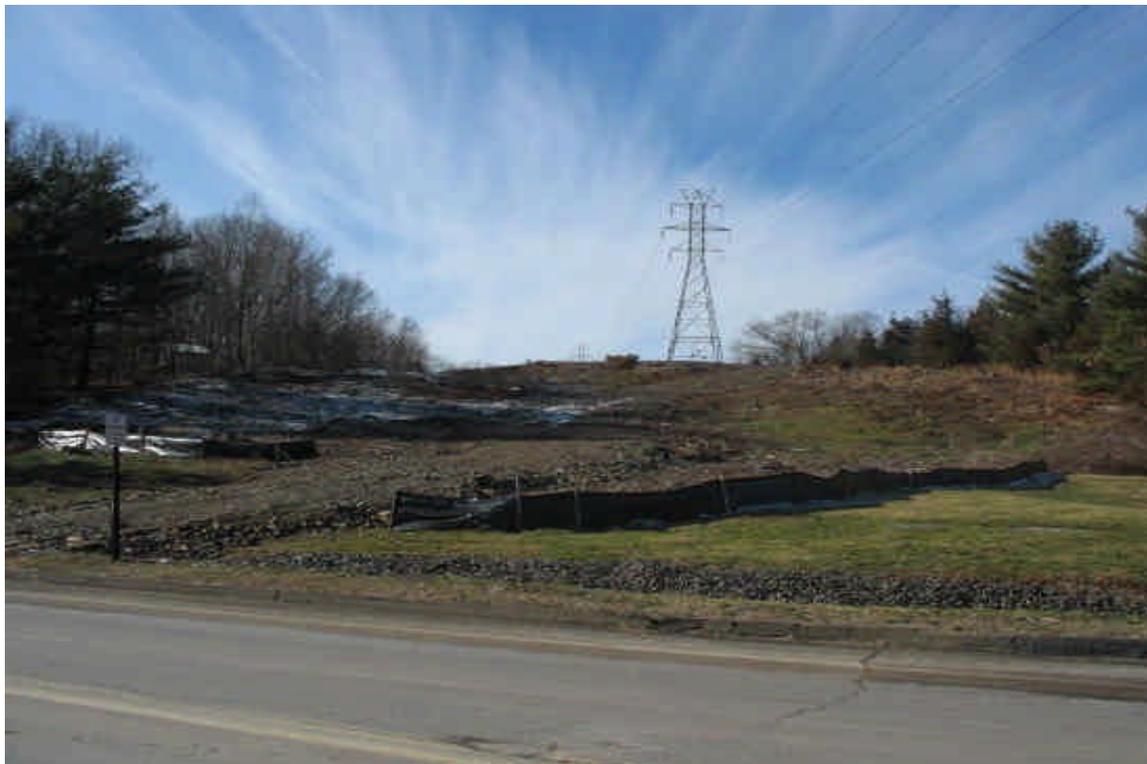
**Silt fence remains intact along South Turnpike. Continue to monitor the slope for erosion but issues with run-off were not observed at this time.**

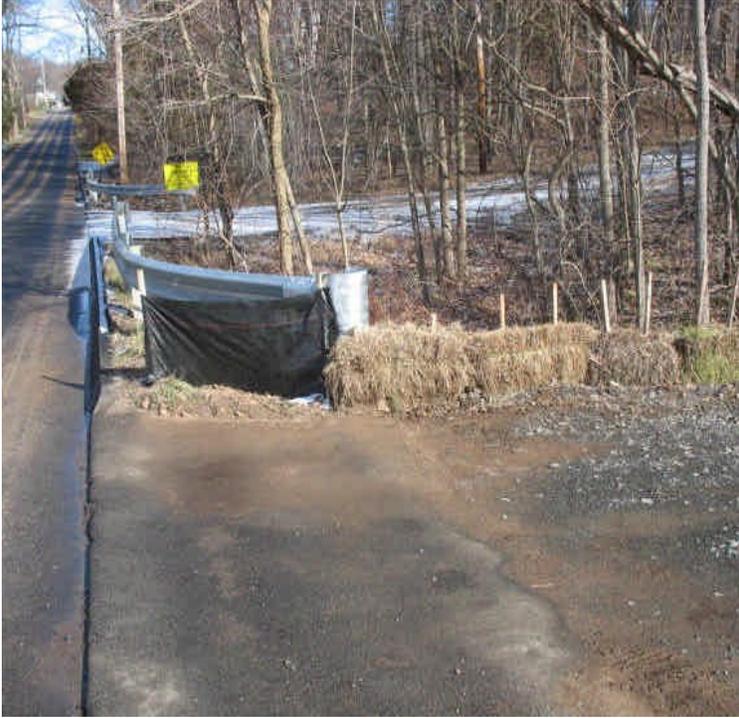
**The silt fence at the entrance to Mansion Rd. remains intact.**

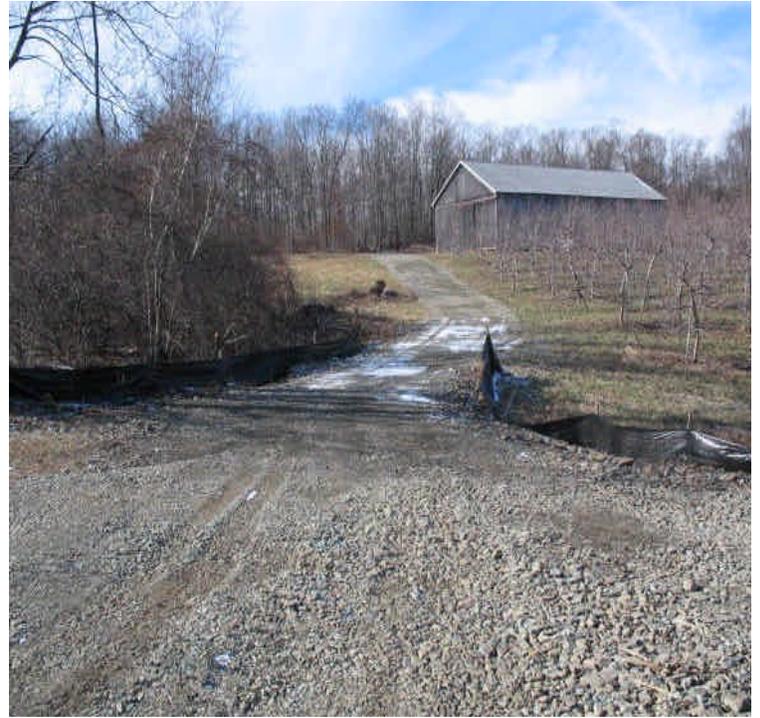
**Silt fence is intact along the access road adjacent to wetlands within the apple orchard off Mansion Rd.**

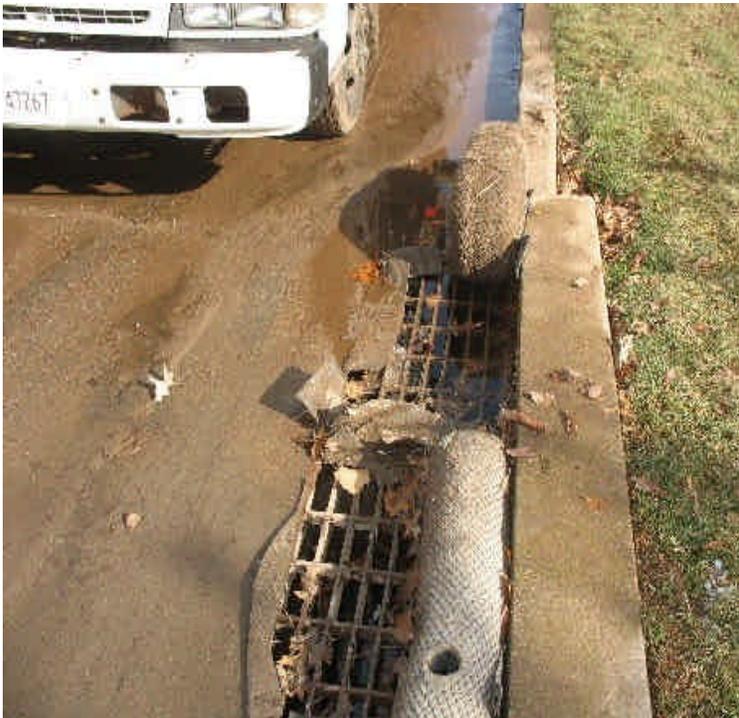
<p><b>Old Farms Rd. (115kV Underground trench-work)</b></p>	<p><b>Most CBs are well controlled with liners and gutter buddies (filter socks). A few south of work have socks but not liners as saw cutting in the area has resulted in slurry on the roadway. 1/23/07</b></p> <p><b>One of the socks was removed to prevent water from ponding and subsequent icing on the roadway. Sediment/slurry buildup was noted in this area at this CB but adjacent wetlands still appear free of sedimentation. 1/23/07</b></p>	<p><b>Maintain controls for CBs as the underground work approaches. Install gutter buddies at CB drop inlets as needed. Monitor carefully during production of sawcut slurry. Don't remove controls until work is complete in the area. 1/23/07</b></p> <p><b>Remove existing sediment from the controls. Rather than remove controls when ponding is an issue, consider alternatives to dewatering to CB or slow the release rate. 1/23/07</b></p>	<p><b>Some of the silt liners were being replaced at this inspection.</b></p> <p><b>Needs regular attention</b></p> <p><b>Street sweeper was scheduled to clean the roadway during the inspection.</b></p> <p><b>Needs regular attention</b></p>

**Gutter buddy was folded to prevent flooding on Old Farms Road. Sediment should be removed from roadway and cleared from the controls.**

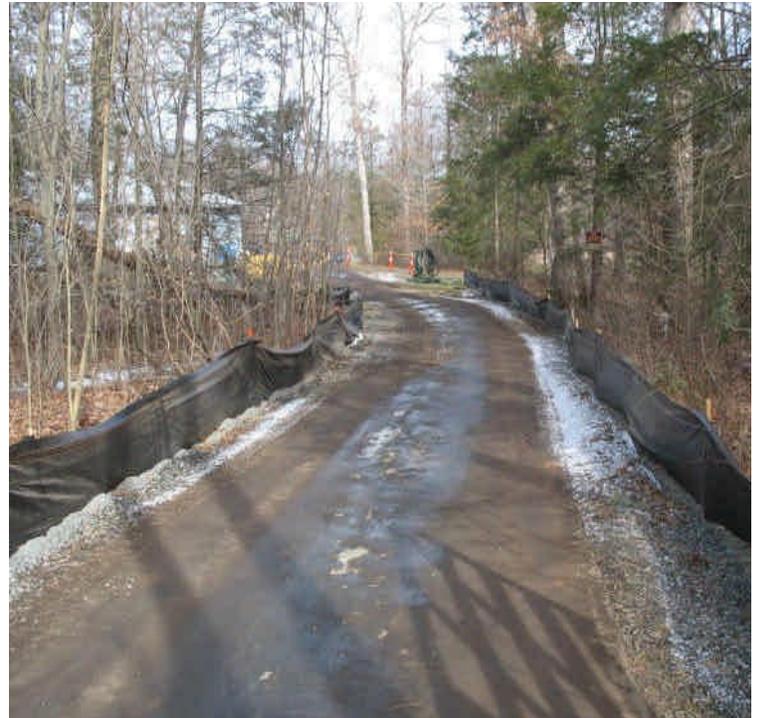
**Extended silt fence is intact along the driveway to the equipment storage area. No sediment issues were observed in the adjacent wetlands.**
