**Docket No. 272 – Development and Management Plan Inspection**

**Segment 4a Underground Line**

**Date:** January 23, 2007

**Location:** Singer Substation to Fairfield/Westport Town Line

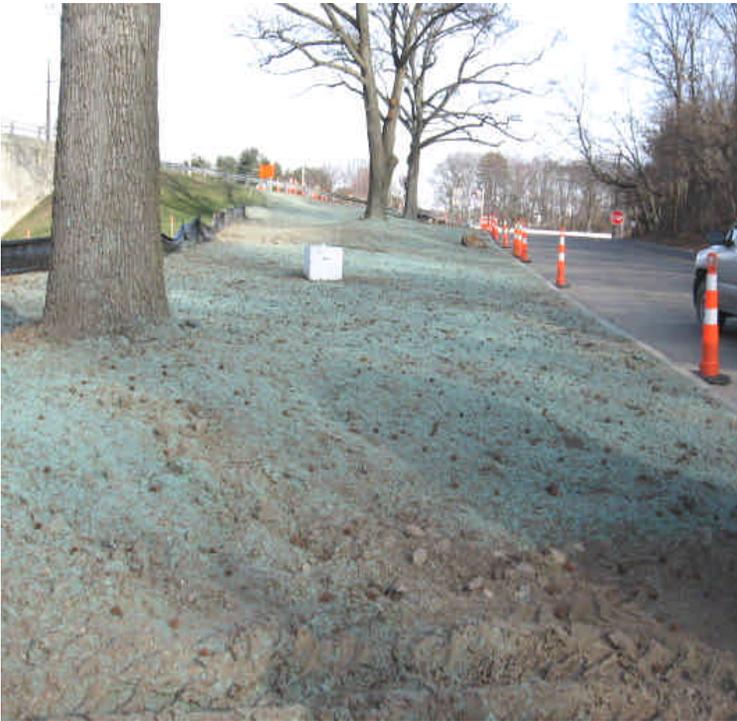
**Exposed soils from trenching activities along Pequot Ave. have been hydro-mulched. A portion of the trench remains active in this area.**

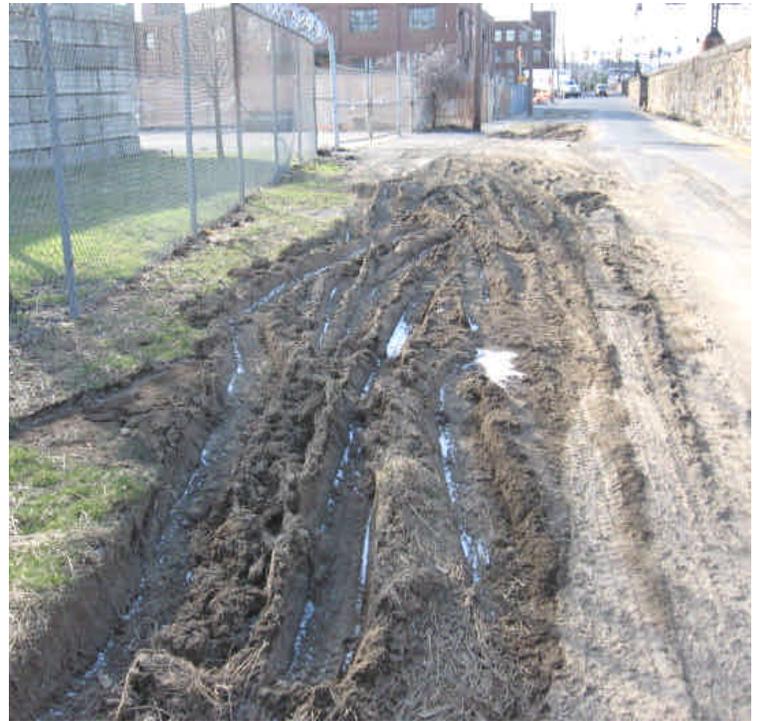
**Rutting/tracking continues along the shoulder of Railroad Ave. as a result of non-project related vehicles. It appears that flow-fill was mixed in with the soil. Solutions are being investigated here.**

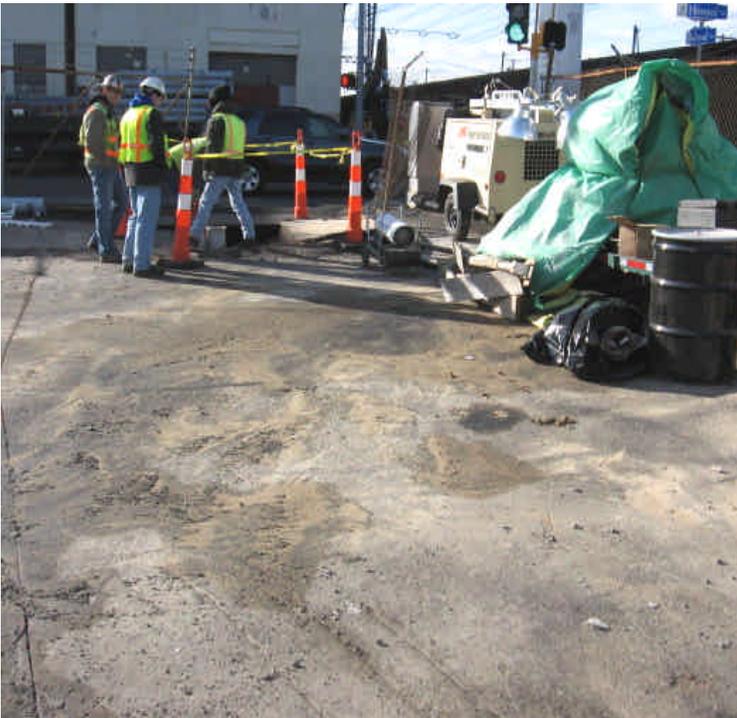
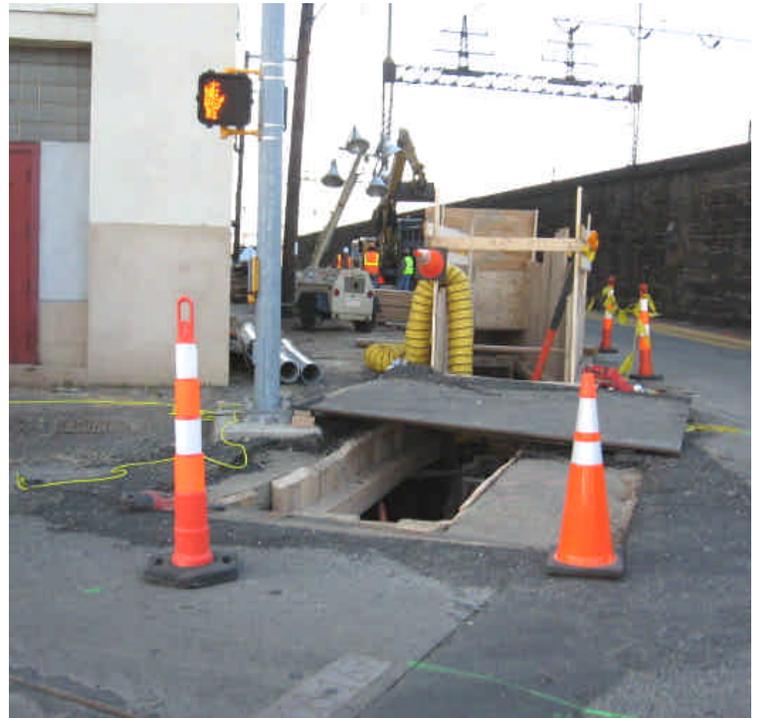
**Both photos of trenching activities at the intersection of Railroad Ave and Howard Ave. On the left: Photo shows accumulated sediment from the filtering equipment. It appears that attempts were made to sweep the sediment, but additional attention is needed.**

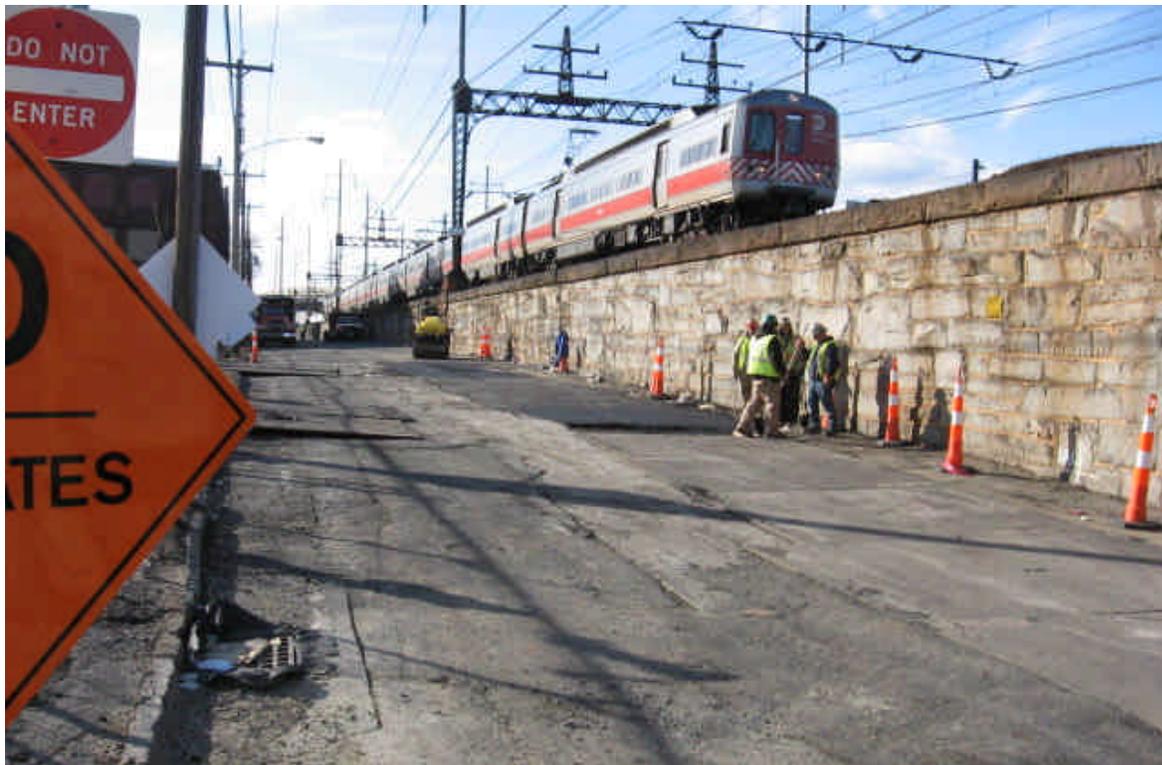
**Photo of crew patching trench with asphalt along Railroad Ave. near the intersection with Myrtle Ave.**

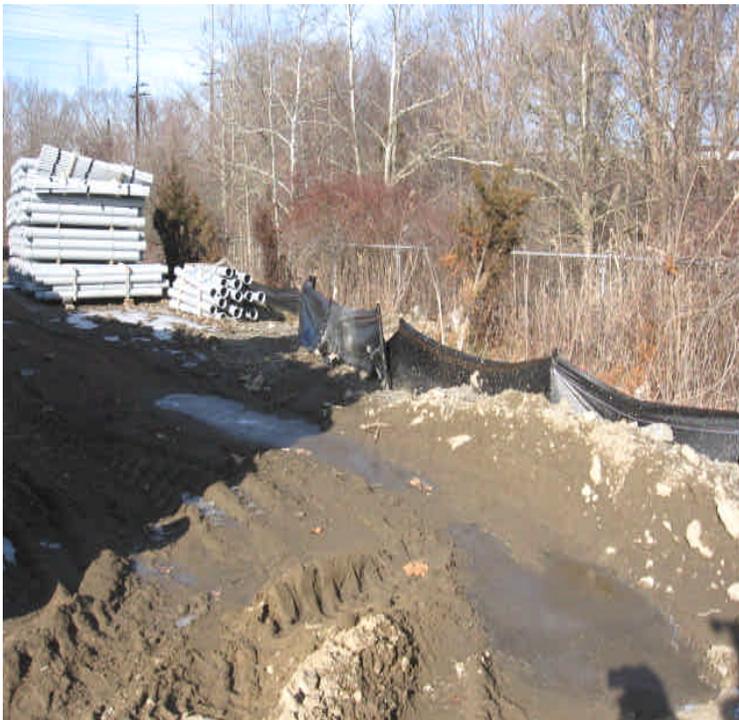
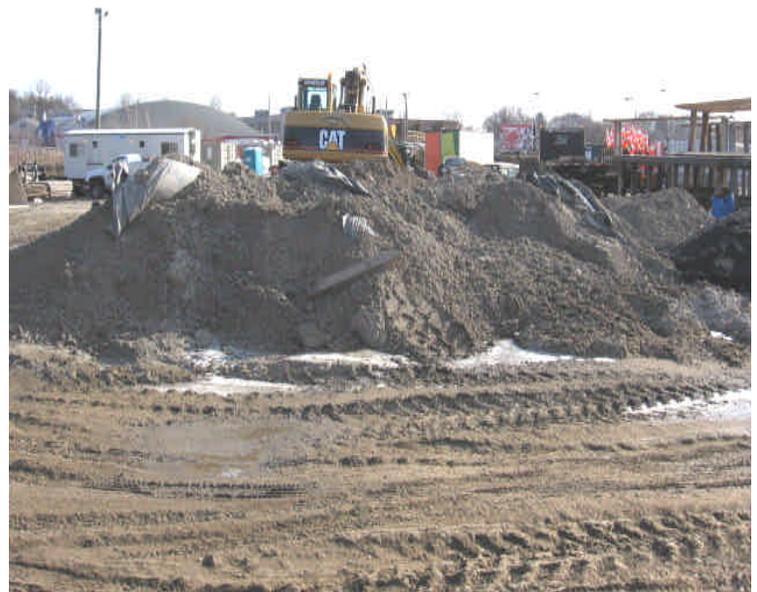
**Both photos show the King's Highway lay-down yard. Left: Attempts have been made to repair silt fence; ensure that run-off will not escape at the gaps between sections. Right: Photo of material being removed from yard at the concrete washout basin.**
