**Docket No. 272 – Development and Management Plan Inspection**

**The Connecticut Light and Power Company Certificate of Environmental Compatibility and Public Need for the construction of a new 345-kV electric transmission line and associated facilities between Scovill Rock Switching Station in Middletown and Norwalk Substation in Norwalk, Connecticut, including reconstruction of portions of existing 115-kV and 345-kV electric transmission line, the construction of Beseck Switching Station in Wallingford, East Devon Substation in Milford, (and Singer Substation in Bridgeport), modifications at Scovill Rock Switching Station and Norwalk Substation, and the reconfiguration of certain interconnections.**

**Segment 4b Underground Line**

**Date:** January 3, 2006

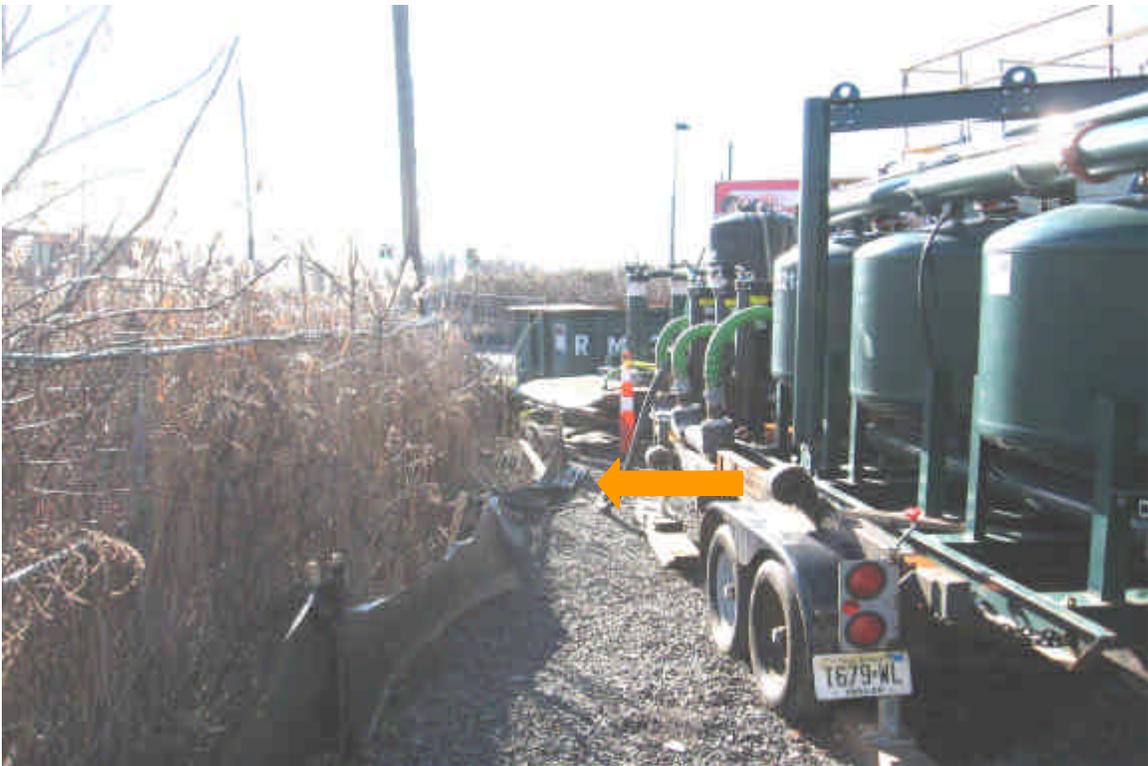
**Photo of a small section of the perimeter silt fence that is in disrepair along the side of the yard that is adjacent to the resource area.**
