**Docket No. 272 – Development and Management Plan Inspection**

**Segment 4b Underground Line**

**Date:** January 9, 2006

**Location:** Fairfield/Westport Town Line to Westport Avenue in Norwalk

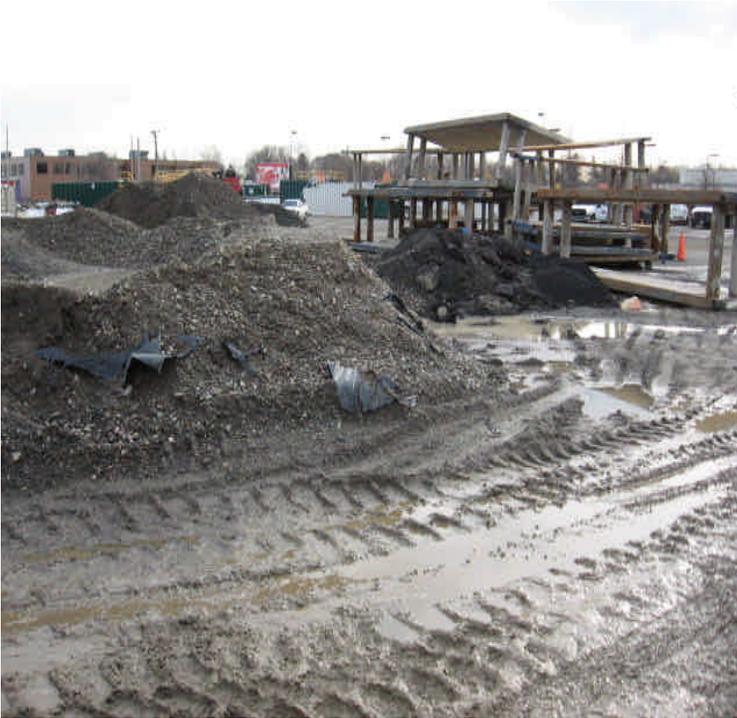
**KINGS HIGHWAY LAY-DOWN YARD**

**Concrete washout is not fully contained to the basin. It is recommended that improvements be made to contain all washout.**

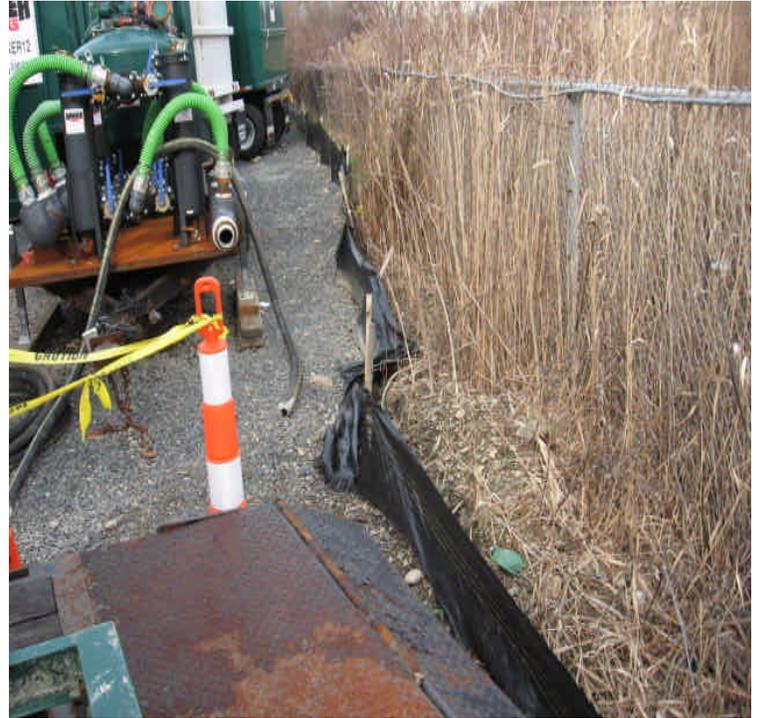
**A small section of silt fence remains down near the entrance to the yard. The other side was repaired but controls here need maintenance.**

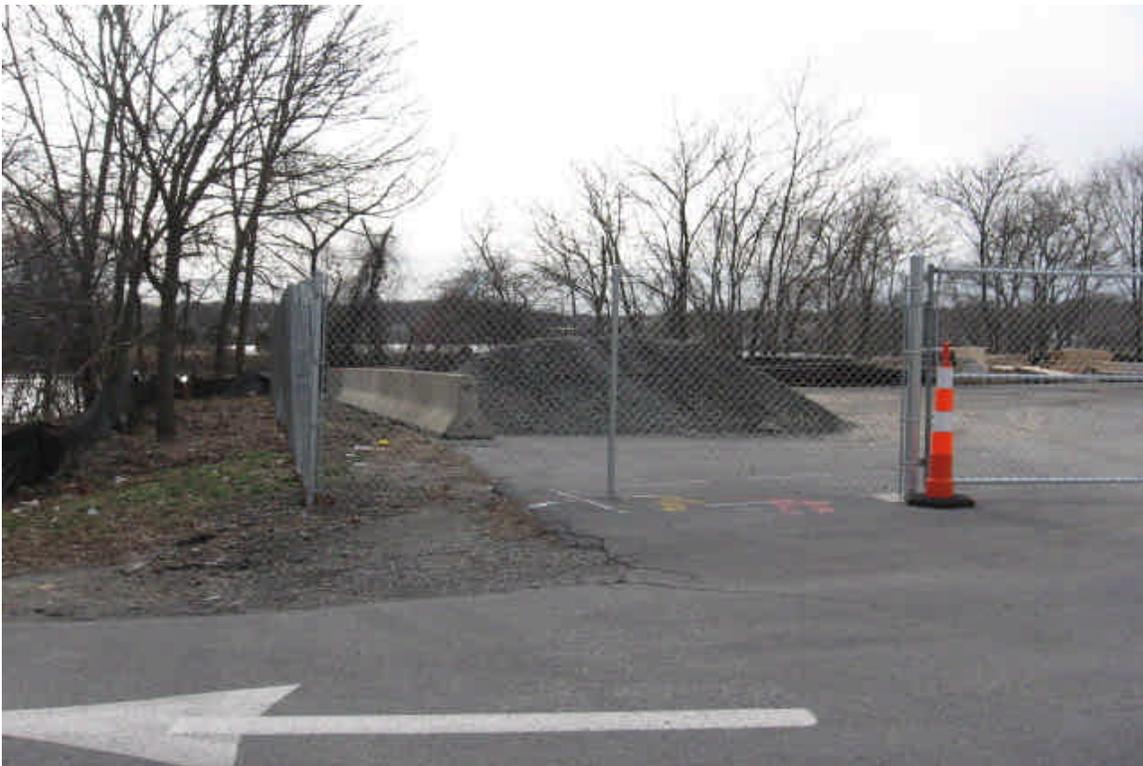
**IMPERIAL AVE. LAY-DOWN YARD**

**The materials stockpiled in the yard have been contained within jersey barriers. Continue to monitor to ensure run-off will not reach the river.**
