Docket No. 272 – Development and Management Plan Inspection

Segment 4b Underground Line

Date: January 16, 2007

Location: Fairfield/Westport Town Line to Westport Avenue in Norwalk

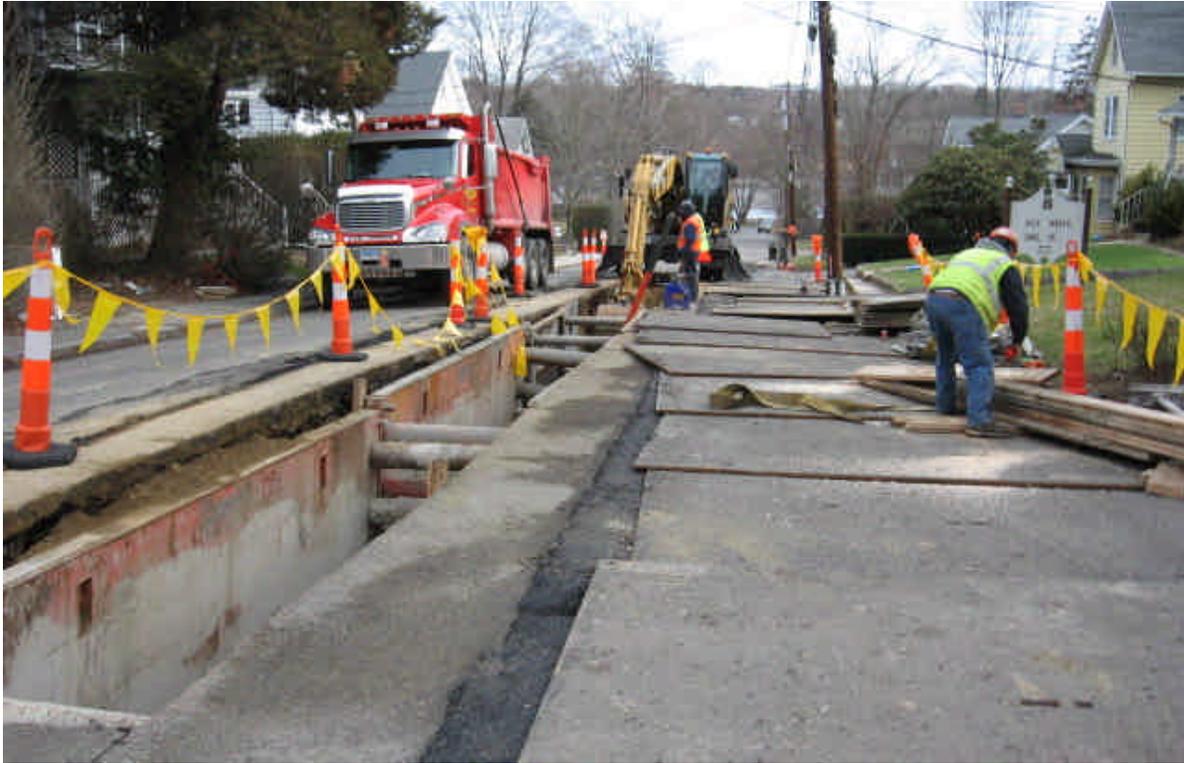
| Areas of Inspection | Observation | Recommended Action | Corrected Action |
|---|---|--|---|
| Vault Openings and Trench Construction Westport | Trenching activities have commenced on Lincoln St. 1/16/07 | Continue to monitor and be proactive in containing sawcut slurry and sediment. 1/16/07 | Catch basins have been protected proactively. |

Photo of trenching activities on Lincoln St. All catch basins that are downgradient of trenching and saw-cutting have been adequately protected.

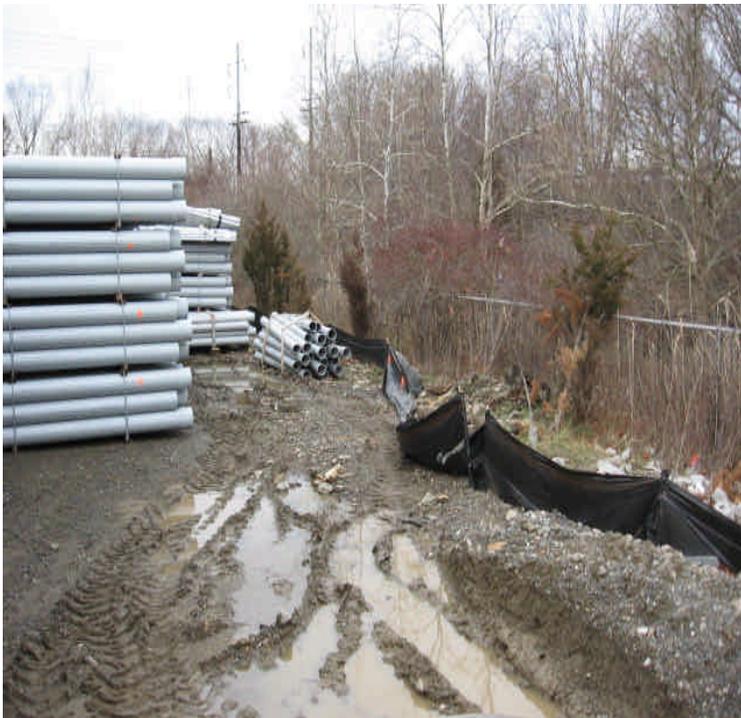
| Areas of Inspection | Observation | Recommended Action | Corrected Action |
|--|--|---|---|
| for Segment 4a and 4b operations.) | <p>The sections of perimeter silt fence near the entrance to the yard have both been repaired. 1/16/07</p> <p>Another section of the perimeter fence adjacent to the resource area is in disrepair. 1/16/07</p> | <p>Maintain controls as needed. 1/16/07</p> <p>Repair section of fence and continue to maintain controls as needed. 1/16/07</p> | <p>Silt fence has been re-established near the yard entrance.</p> <p>Needs attention.</p> |

Photo of the perimeter erosion controls in the King's Highway lay-down yard. Sections of the fence have been compromised and are in need of repair.

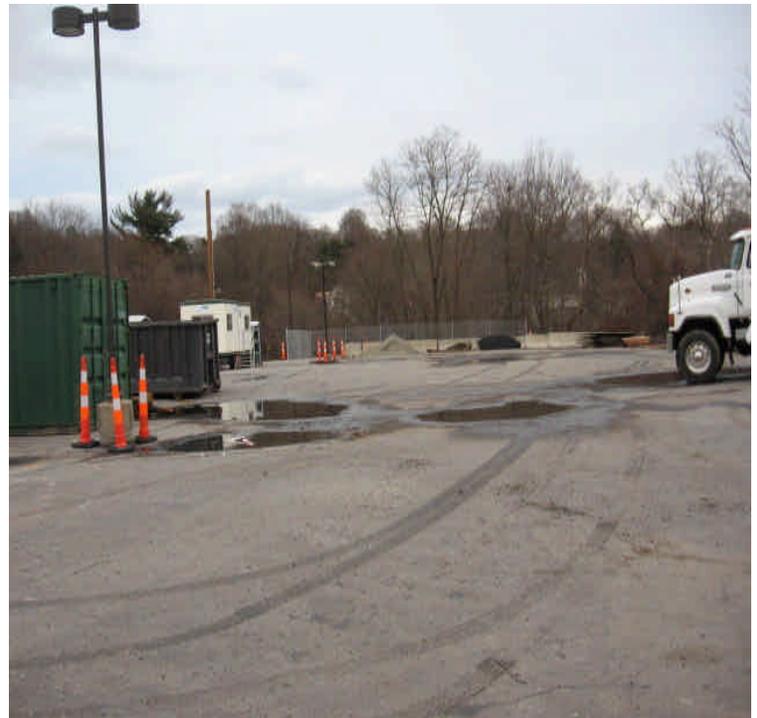
| Areas of Inspection | Observation | Recommended Action | Corrected Action |
|---|---|--|---|
| Imperial Ave Lay-down Area | The lay-down area is surrounded by the Saugatuck River on the southwestern, western, and northern sides of the yard. Perimeter silt fence and haybales are appropriately maintained in these areas. 1/16/07 | Continue to carefully monitor controls and maintain silt fence due to the adjacent resource area. 1/16/07 | NA |

Photo of the Imperial Ave. lay-down yard. No outstanding issues were noted at the time of inspection.
