Docket No. 272 – Development and Management Plan Inspection

Beseck Switching Station Inspection

Date: July 10, 2007

Location: Beseck Switching Station

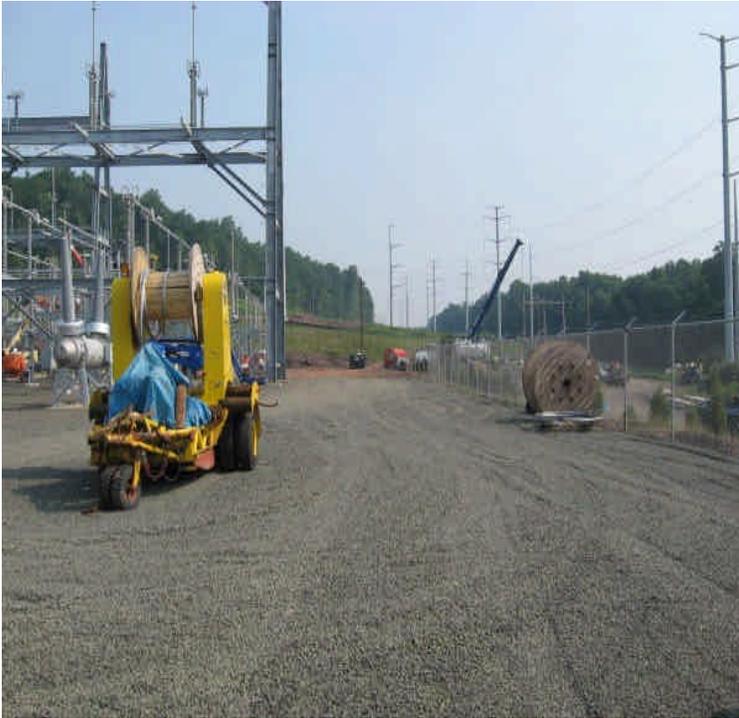
View of the site along the eastern fence. All debris was removed.

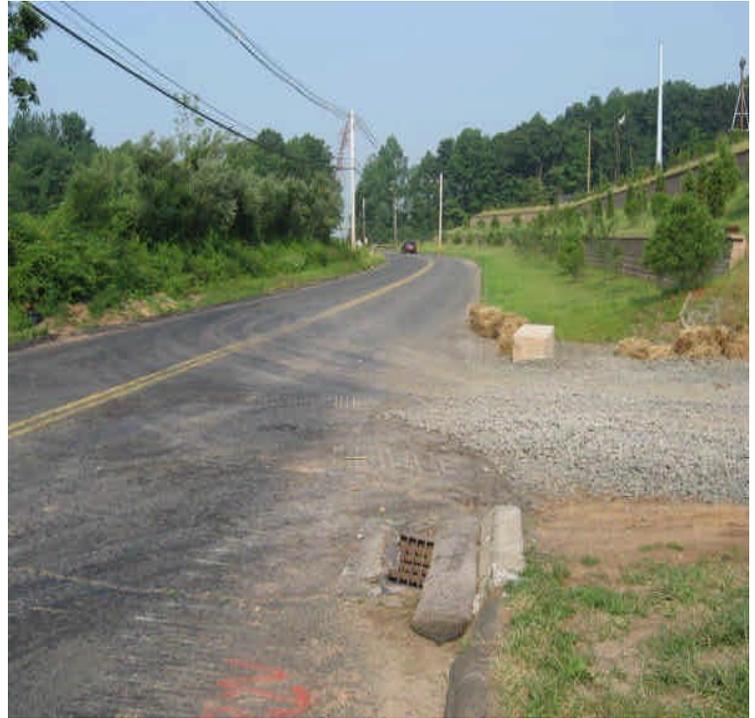
View of the eastern site exit at Carpenter Lane. Haybales and a concrete block were in place at the corner of the drive in an effort to contain run-off. Refresh stone as needed.

Areas of Inspection	Observation	Recommended Action	Corrected Action
Access roads and adjacent roadways	Turbid run-off was not observed leaving the site egress to the east during this week's inspection. Haybales and a concrete block are in place to prevent trucks from driving over the haybales. 7/10/07	Continue to monitor and evaluate during larger storm events. Continue to monitor controls in an attempt to contain and filter the run-off until the site is fully stabilized. Stone should be cleaned 7/10/07	Not Applicable (NA)
	Clean stone and check dams remain along the western site entrance. A line of haybales remains across the entrance. 7/10/07	See erosion control section for more details and recommendations. 7/10/07	NA
	The stone access east of Beseck remains in place to reduce tracking to the main pad. 7/10/07	Continue to maintain and work out schedule with 1A contractors to share responsibility. 7/10/07	NA

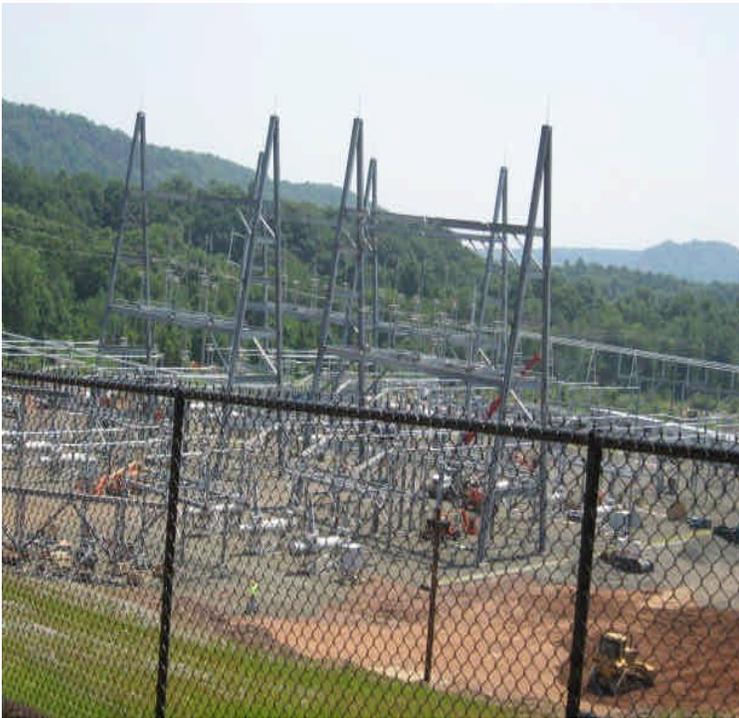
View of the site from the northeast looking southwest. Many structures are in place and stone is being spread at completed areas for further stabilization.

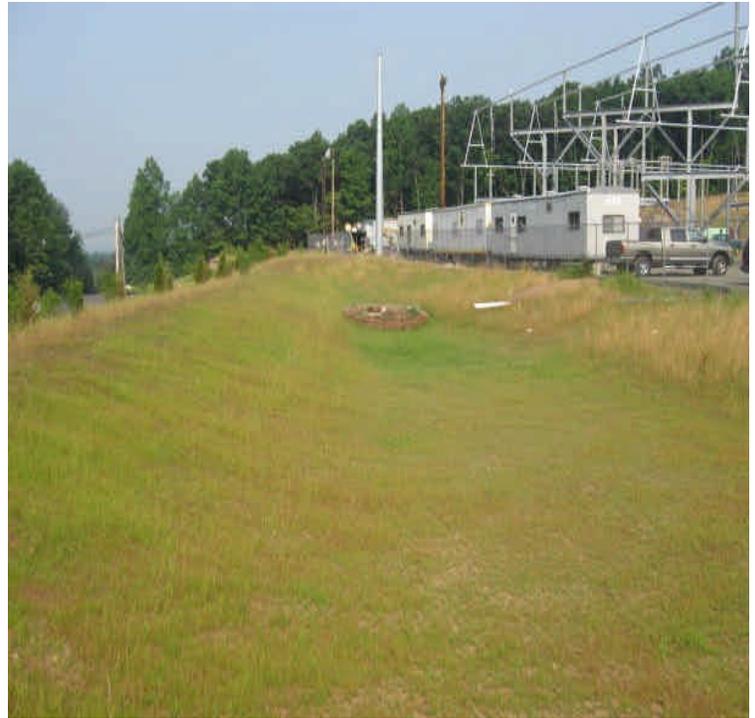
Haybales and controls remain in place at the inlet of the detention basin. Grass cover continues to establish well in hydroseeded areas and is almost fully stable.

<p>Erosion and sediment controls</p>	<p>Perimeter silt fence along the east side of the site is secure and well maintained. 7/10/07</p> <p>Filter fabric and numerous haybales remain in place over and around the drain inlets in the permanent detention basins. Haybales within the detention basins are deteriorating. 7/10/07</p>	<p>Continue to inspect and maintain silt fence throughout site and repair as needed. 7/10/07</p> <p>Continue to monitor and replace haybales as needed within the detention basins. 7/10/07</p>	<p>NA</p> <p>NA.</p>

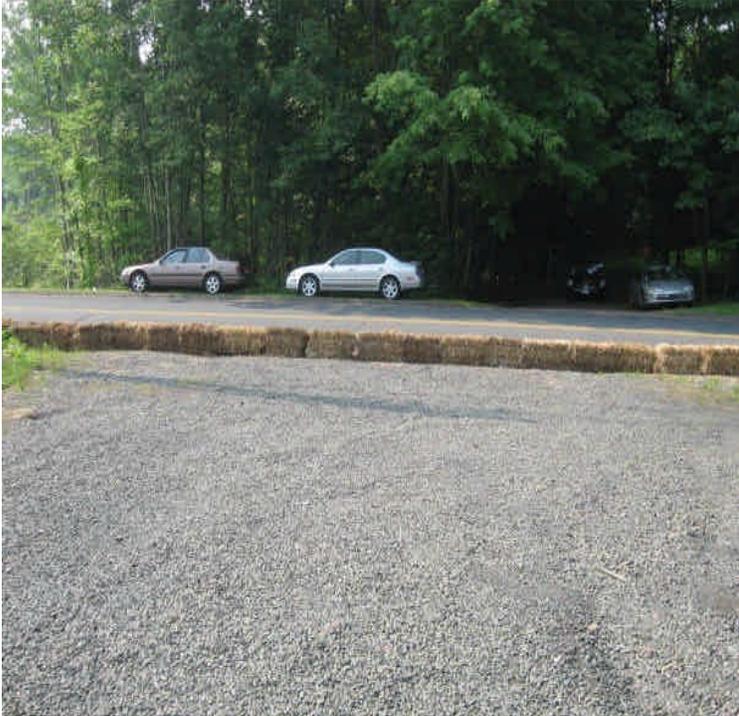
New haybales remain in place across the site entrance at Carpenter Lane.

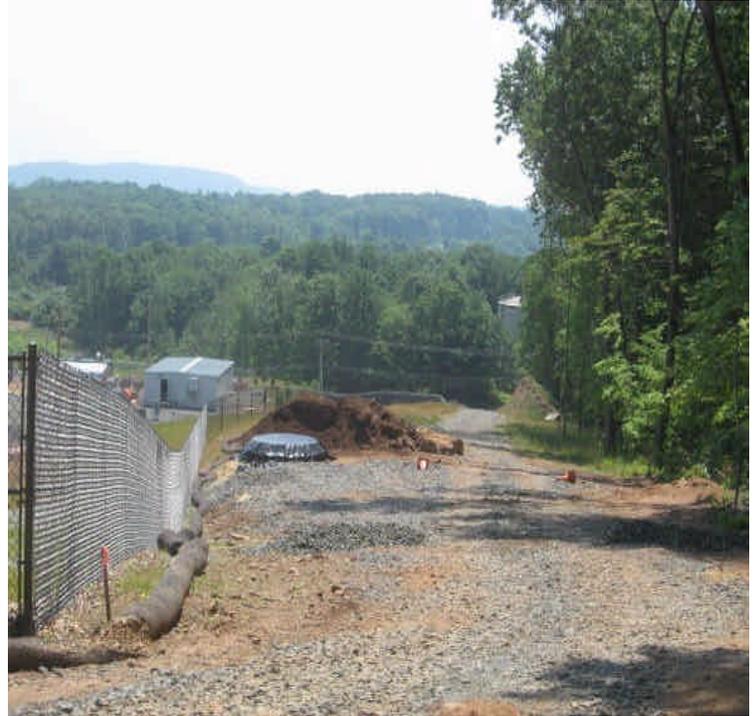
View of foundation installed for a bypass structure at the north-western corner of the site. Ensure that the stockpile is contained.

Areas of Inspection	Observation	Recommended Action	Corrected Action
	<p>Grass cover was increasing along the slopes and floors of the basins and along the slopes at the eastern site egress. 7/10/07</p> <p>A stockpile was generated during the foundation installation of the bypass structure, north along the access drive. 7/10/07</p> <p>Haybales remain at the storm water outlet pipe at the wetland across Carpenter Lane. Standing water within the outlet is clear and water flowing into the wetlands is clear. Sediment accumulation noted within the wetlands from previous storms. In general, sediment from the site is very fine and difficult to filter but efforts continue to be made onsite to reduce turbid run-off. 7/10/07</p>	<p>Continue to monitor the area for vegetative cover, until fully stabilized. 7/10/07</p> <p>Ensure that the stockpile soil remains contained. 7/10/07</p> <p>Continue to monitor and replace haybales as needed at the storm drain outlet. Stormwater should continue to be contained and filtered before leaving the site to the extent possible. Continue addressing stormwater issues at the source. Good efforts were made on site to reduce run-off. Stone check dams along Carpenter Ln. should be considered to help reduce turbid run-off from entering the CBs. 7/10/07</p>	<p>Grass cover is almost fully established.</p> <p>Continue to monitor</p> <p>Water at the storm drain outlet and within the wetlands is clear.</p>

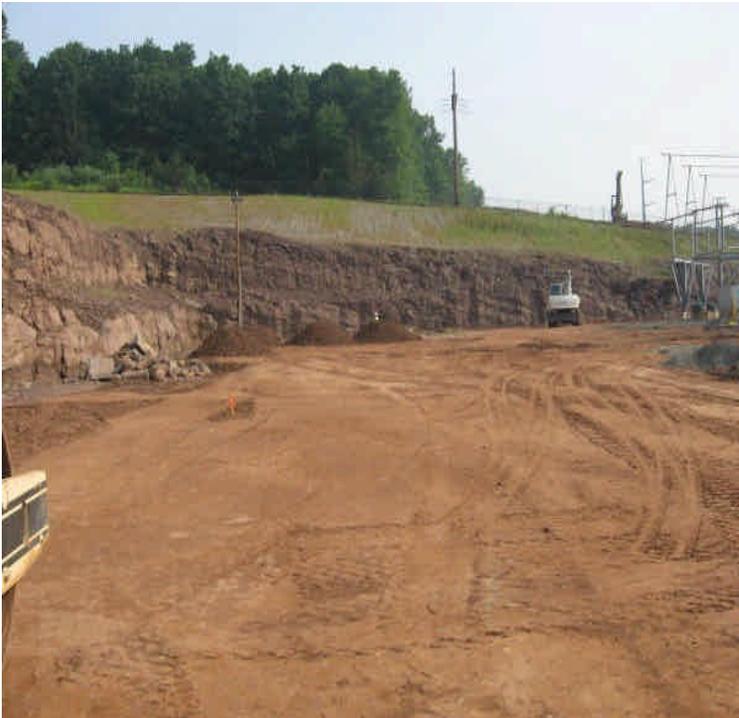
Final grading and stone installation along the western edge of the site.

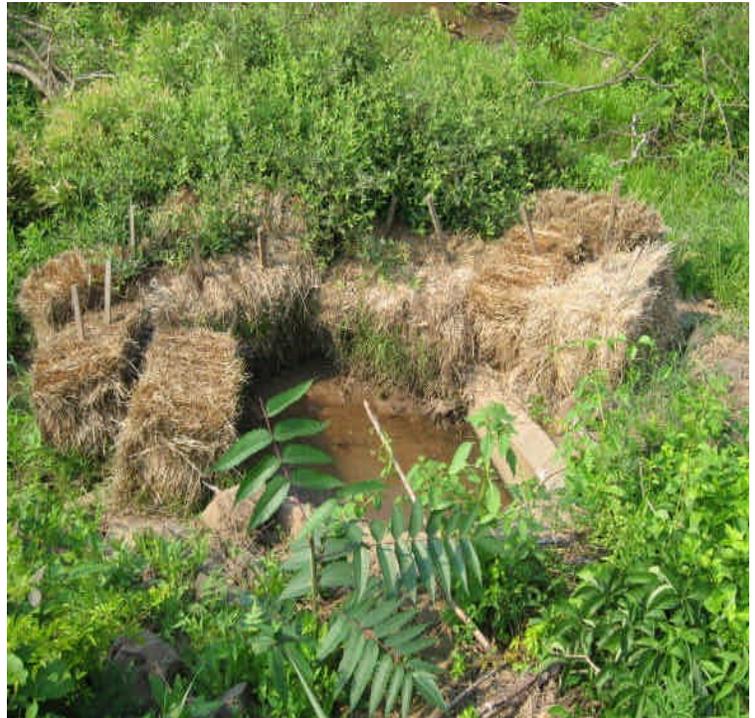
Clear water was observed leaving the haybales and entering the wetlands. The new haybales helped to filter out the sediment. Evaluate whether the amount of sediment accumulation justifies the minor disturbance needed to remove it, once the water subsides.

<p>Inland Wetland and Watercourse encroachment and mitigation</p>	<p>Clear water was noted within the outlet and wetlands across Carpenter Lane. Haybales still don't appear capable of containing all sediment during peak flows. 7/10/07</p> <p>Additional work in the wetlands to the south and east of Beseck are covered in other project reports. 7/10/07</p>	<p>Several areas in the wetland have sediment accumulation. Sediment should be removed from the outlet and adjacent areas when water levels recede 12/26/06- 7/10/07. It will be evaluated whether the accumulation justifies the minor disturbance required to remove it. 1/23-7/10/07</p> <p>See Segment 1a or 2a inspection reports for more details 7/10/07</p>	<p>Continue to evaluate and add controls as needed.</p> <p>Not jurisdictional to this D&M plan.</p>
