**Docket No. 272 – Development and Management Plan Inspection**

**Beseck Switching Station Inspection**

**Date:** July 17, 2007

**Location:** Beseck Switching Station

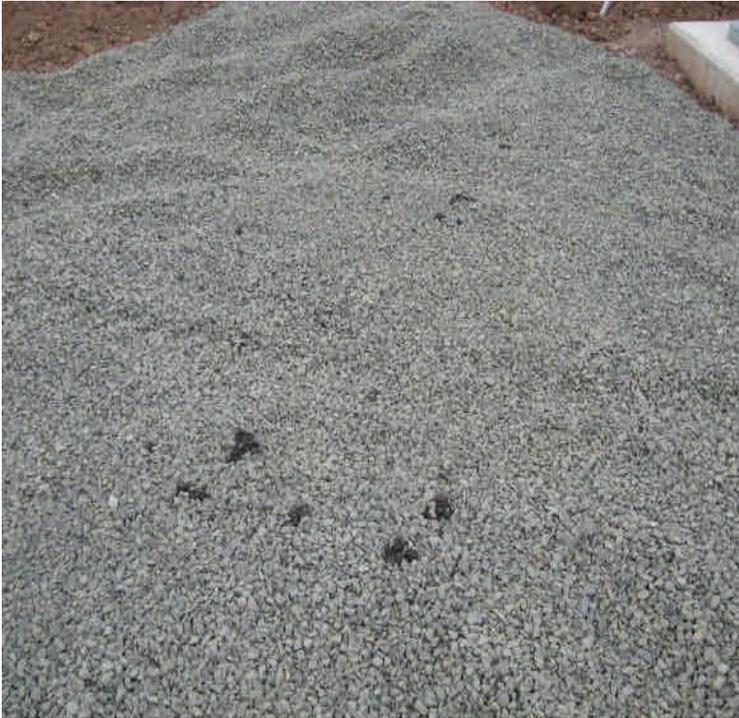
**Small drips noted in the stone along the eastern fence. Check equipment and repair as needed.**

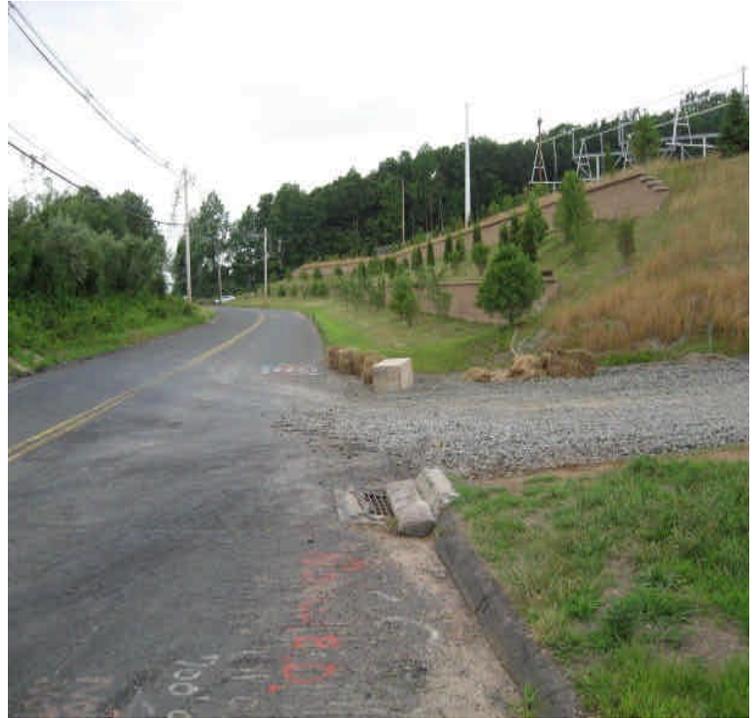
**View of the eastern site exit at Carpenter Lane. Haybales and a concrete block were in place at the corner of the drive in an effort to contain run-off. Refresh stone as needed**

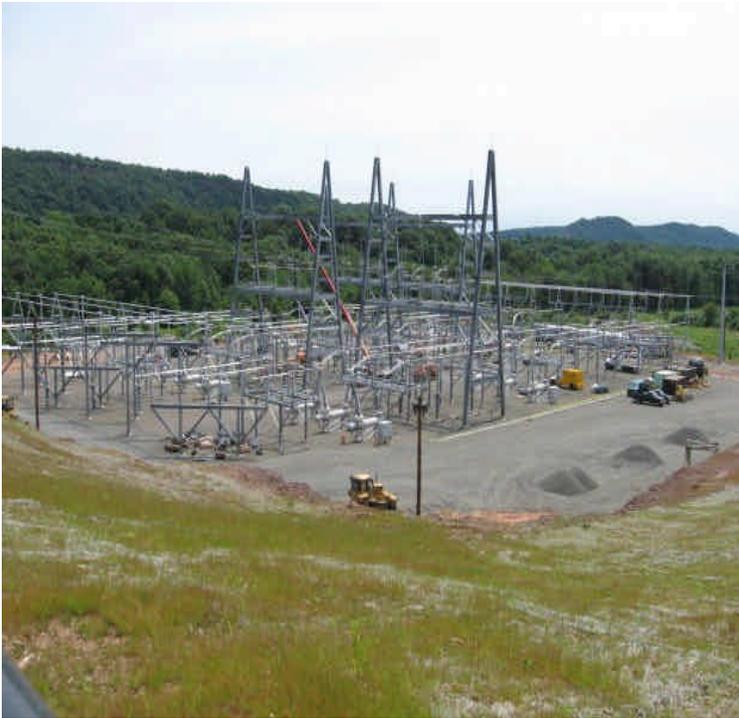
**View of the site from the northeast looking southwest. Most structures are in place and stone is being spread at completed areas for further stabilization.**

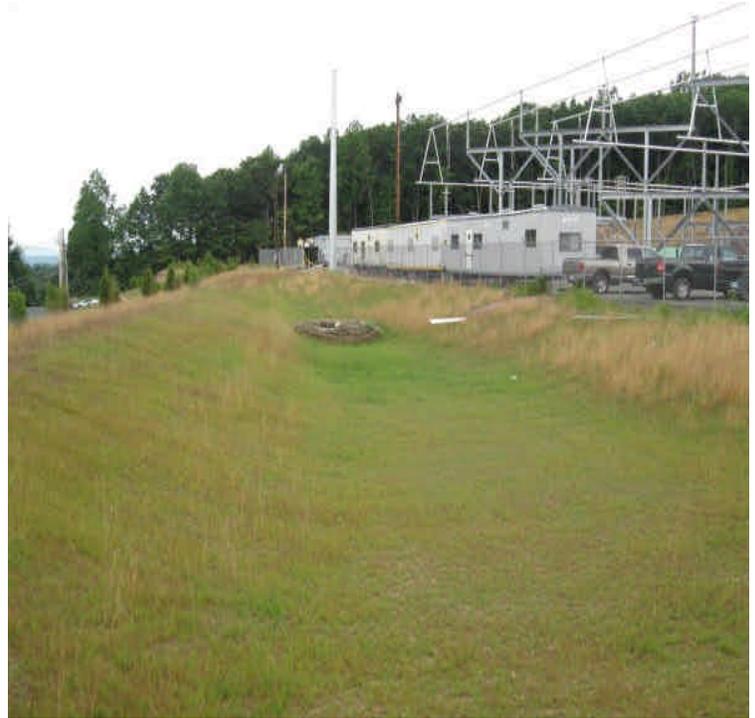
**Haybales and controls remain in place at the inlet of the detention basin. Grass cover continues to establish well in hydroseeded areas.**

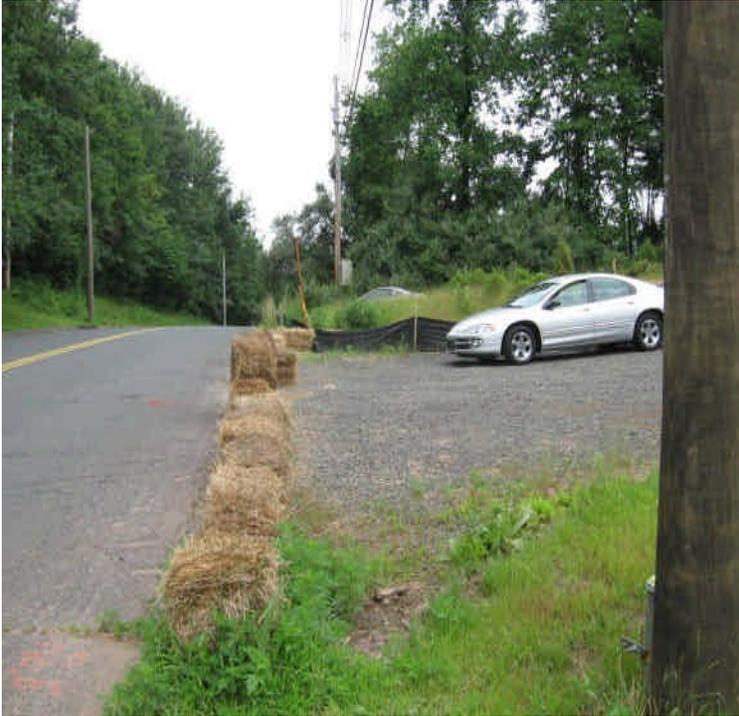
**New haybales remain in place across the site entrance at Carpenter Lane.**

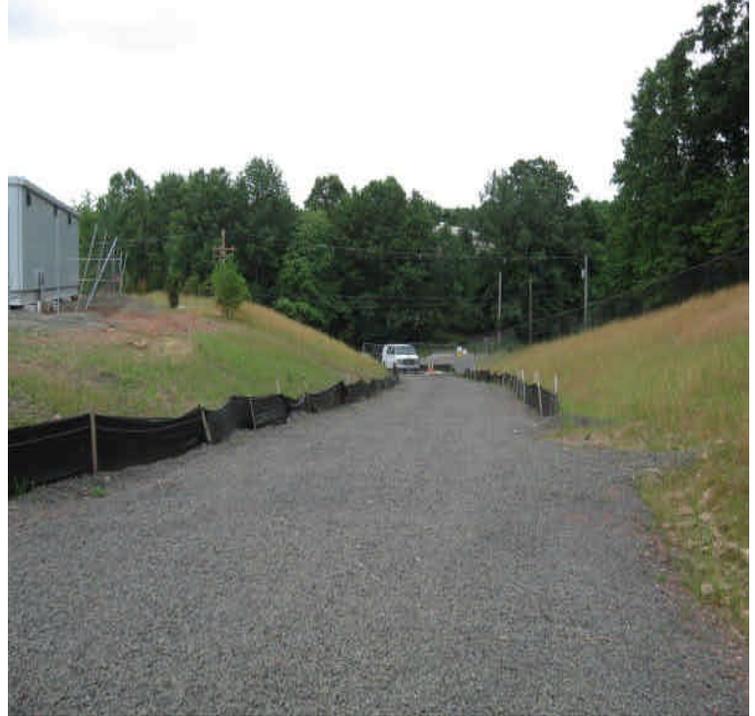
**The western site entrance is closed to truck traffic and is currently used for parking personal vehicles.**

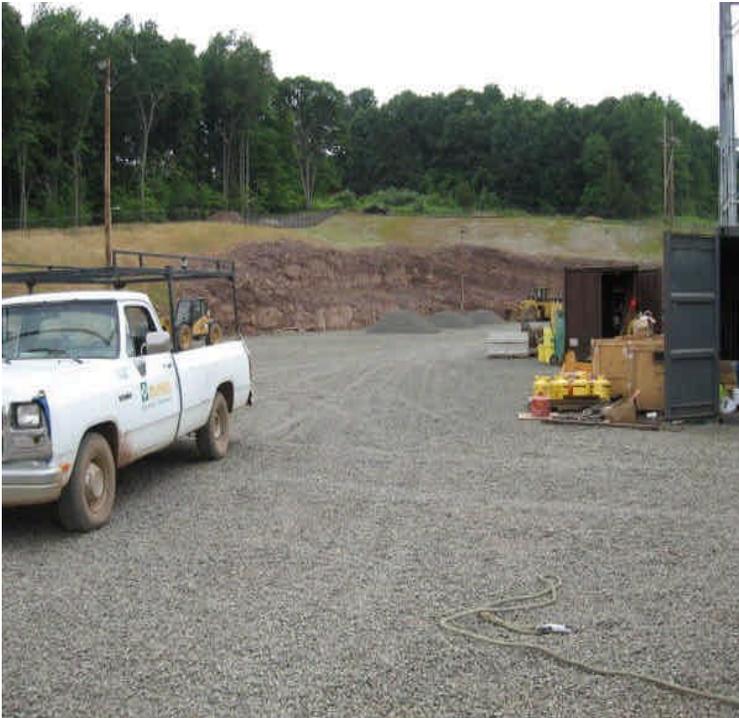
**Final grading and stone installation along the western edge of the site.**

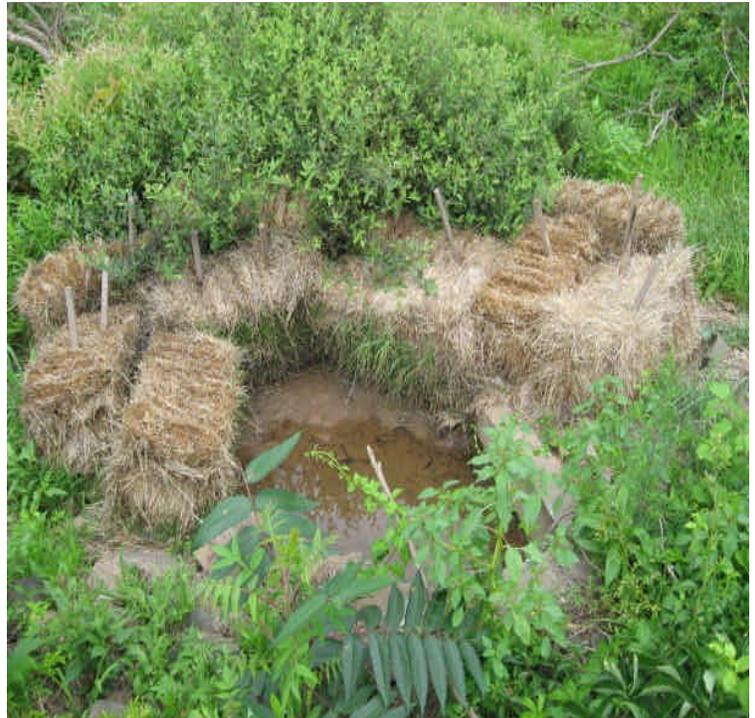
<p><b>Inland Wetland and Watercourse encroachment and mitigation</b></p>	<p>Clear water was noted within the outlet and wetlands across Carpenter Lane. Haybales still don't appear capable of containing all sediment during peak flows. 7/17/07</p> <p>Additional work in the wetlands to the south and east of Beseck are covered in other project reports. 7/17/07</p>	<p>Several areas in the wetland have sediment accumulation. Sediment should be removed from the outlet and adjacent areas when water levels recede 12/26/06- 7/17/07. It will be evaluated whether the accumulation justifies the minor disturbance required to remove it. 1/23-7/17/07</p> <p>See Segment 1a or 2a inspection reports for more details 7/17/07</p>	<p>Continue to evaluate and add controls as needed.</p> <p>Not jurisdictional to this D&amp;M plan.</p>
<p><b>State species of concern, threatened and endangered species.</b></p>	<p>According to the D&amp;M plan, state-listed species are not located in this work area.</p> <p>Several different species of frogs, turtles, and</p>	<p>None. 7/17/07</p> <p>Although these species were not state-listed, it</p>	<p>NA</p> <p>NA</p>

**Clear water was observed leaving the haybales and entering the wetlands. The haybales help to filter out the sediment. Evaluate whether the amount of sediment accumulation justifies the minor disturbance needed to remove it, once the water subsides.**
