Docket No. 272 – Development and Management Plan Inspection

Segment 1a Inspection

Date: July 2, 2007

Location: Segment 1a – Scovill Rock Switching Station to Chestnut Junction, Oxbow Junction to Beseck Switching Station (excluding Royal Oak Bypass), and Black Pond Junction to Beseck Switching Station

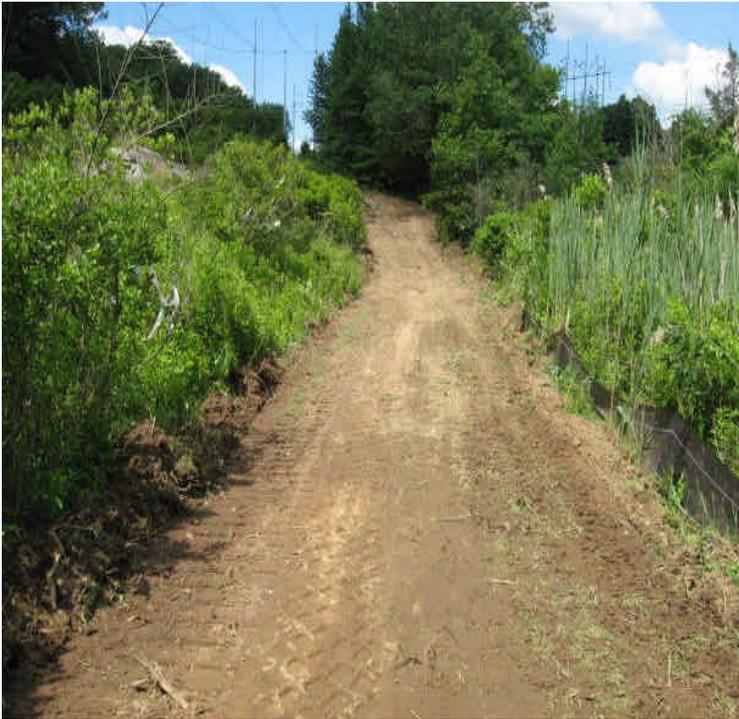
Access road installation south of Scovill SS off Rte 9.

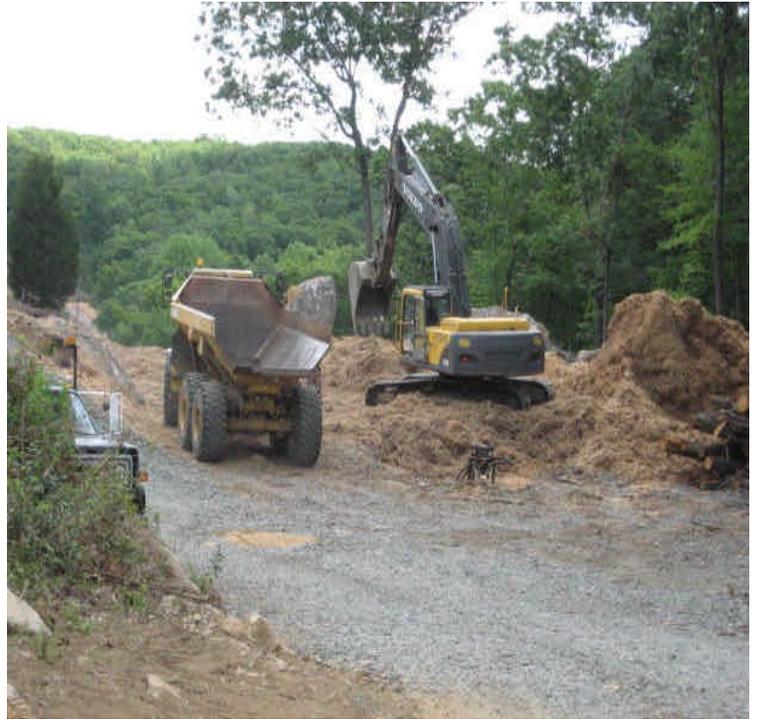
Crews were spreading mulch along exposed soil areas west of Scovill SS, off Rte 9.

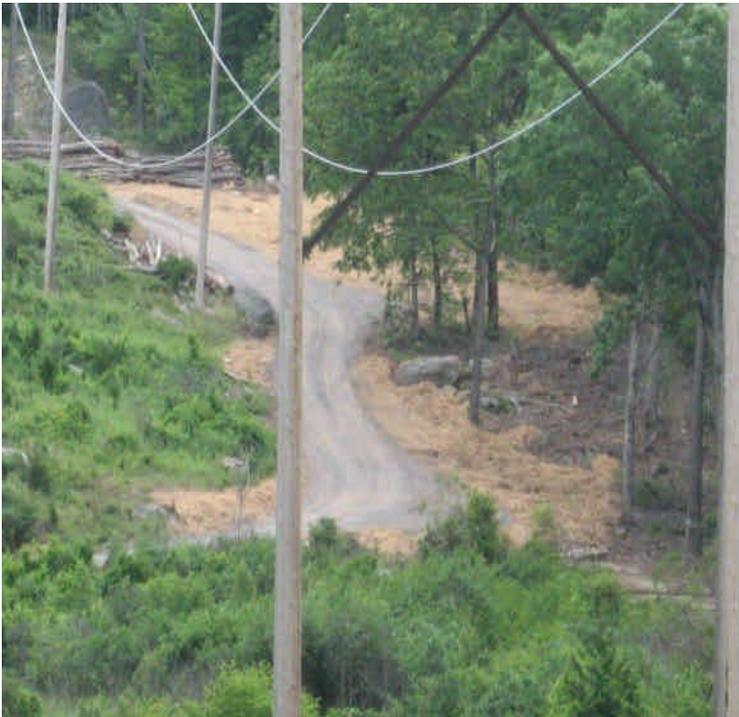
New mulch being placed along the edge of the access road off Rte 9.

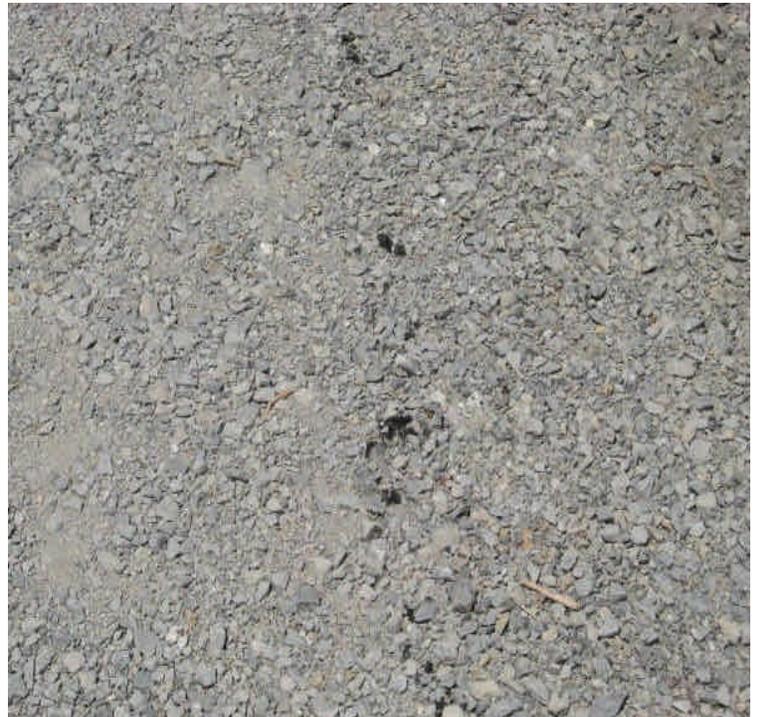
Small drip stains noted from equipment working off Rte 9.

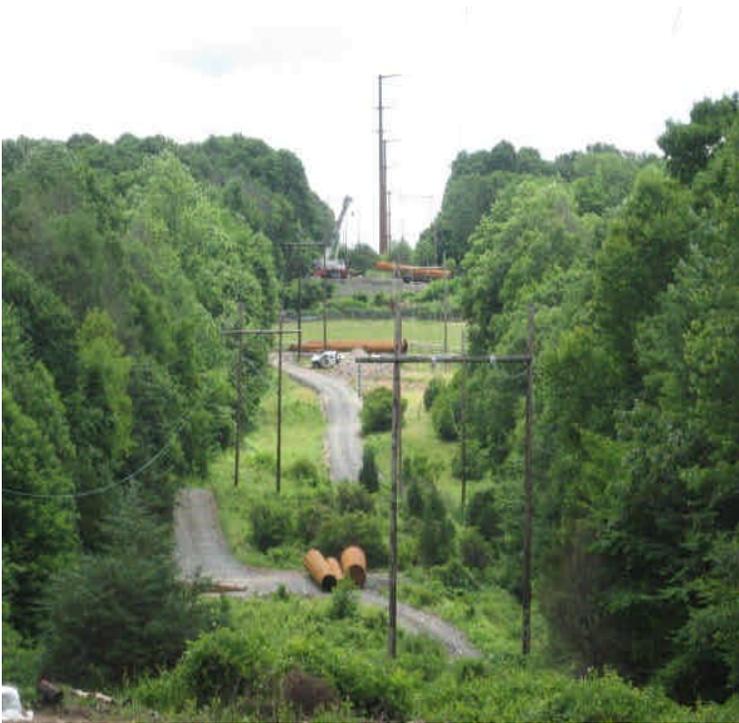
Pole installation off Foot Hills Rd. Adjacent areas appear to be well vegetated along the access road.

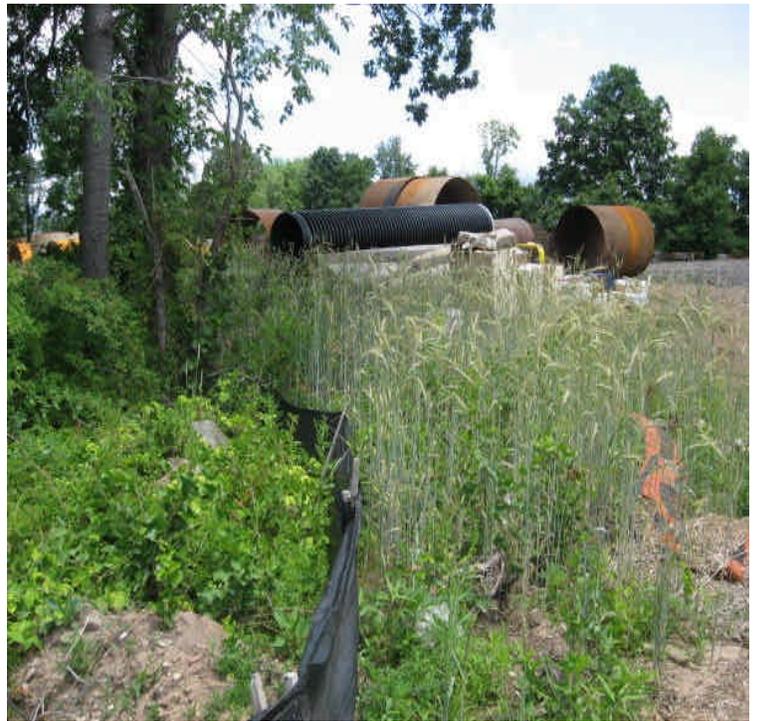
Some vegetative growth was noted within the contractor receiving yard.

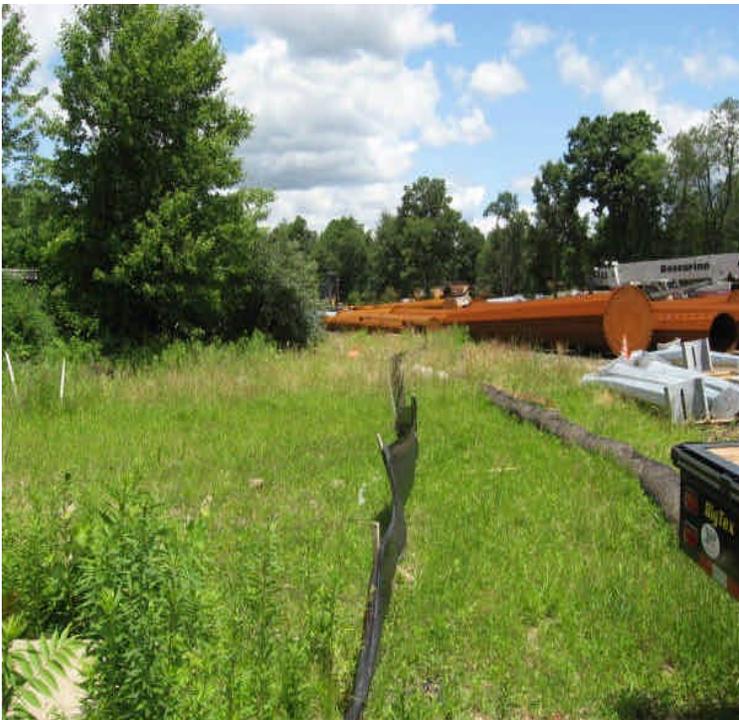
Controls upgradient from the pond within the contractor receiving yard.

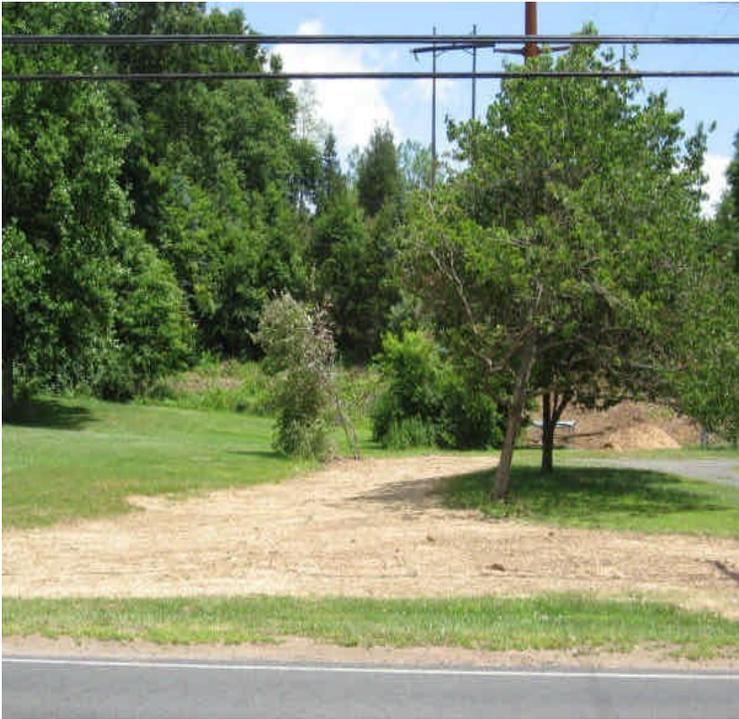
Hay mulch and seed were applied within a lawn off Cherry Hill Rd.

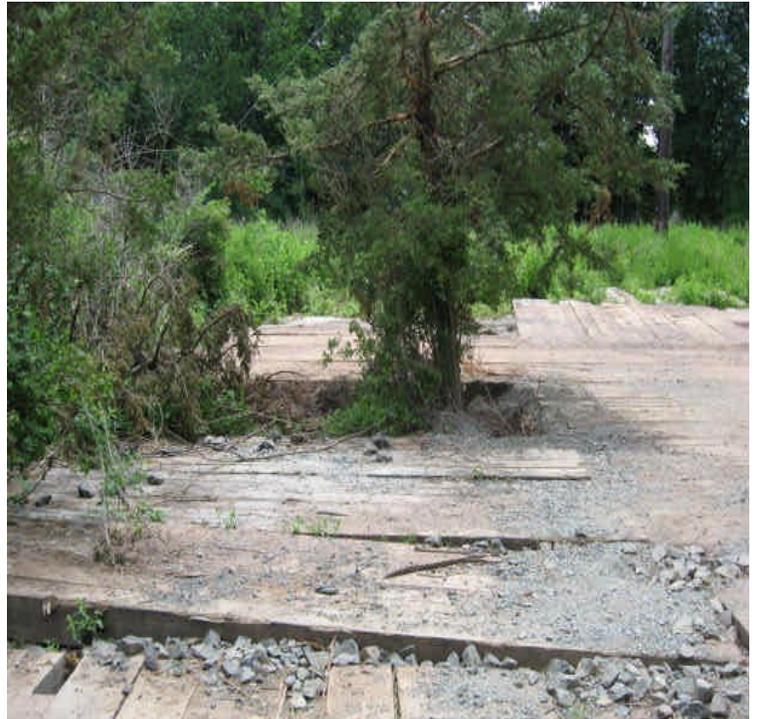
Portable sanitary facility and small soil stockpiles were removed from the wetland edge off Durham Road.

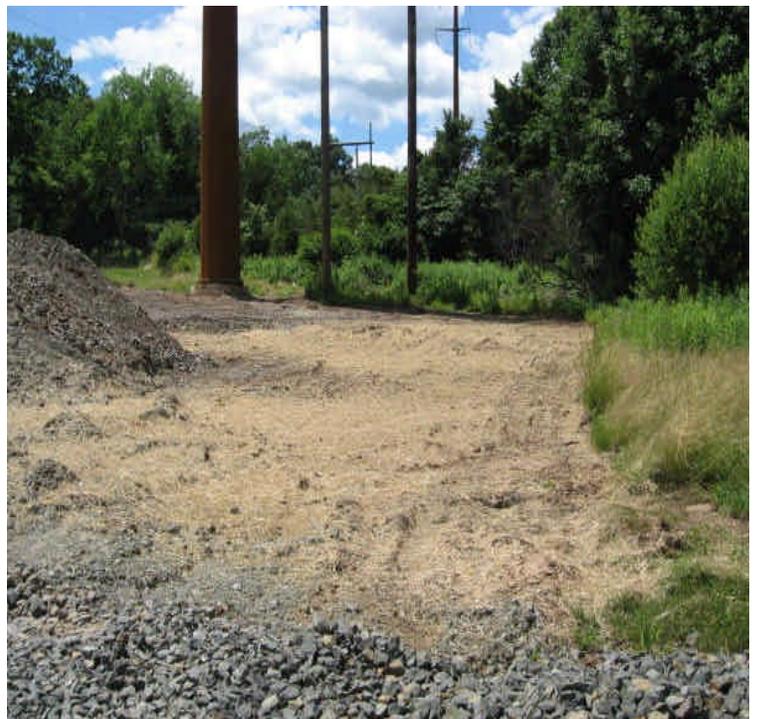
View of an area off Elihu Drive that was regraded, mulched, and seeded

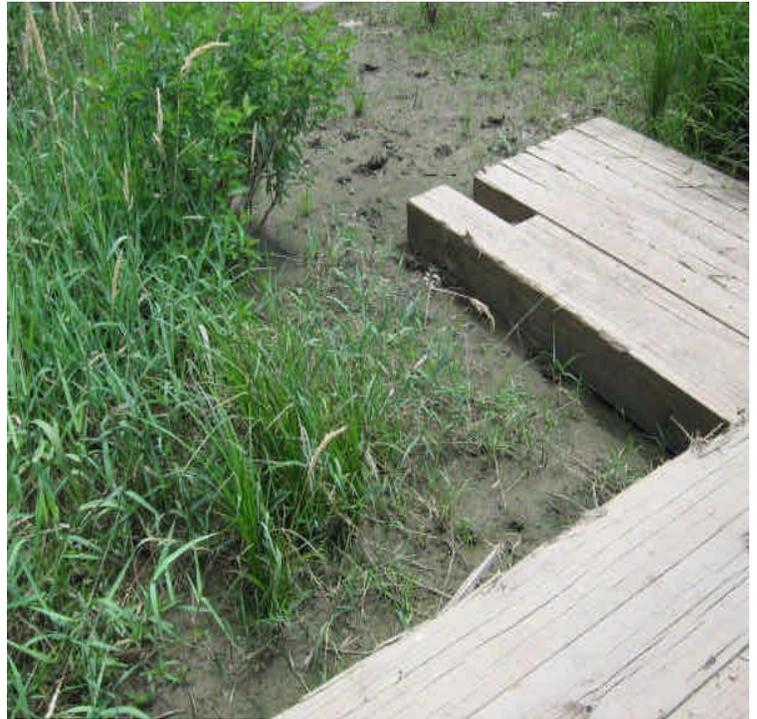
Timber mats within a small pond east of Beseck SS. The pond is now dry.

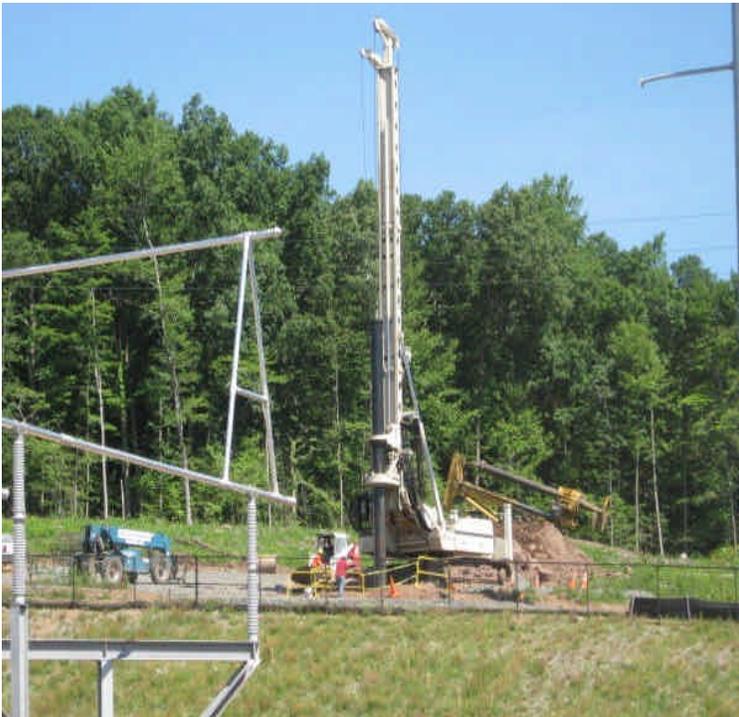
Foundation drilling was occurring in the ROW north of Beseck SS.

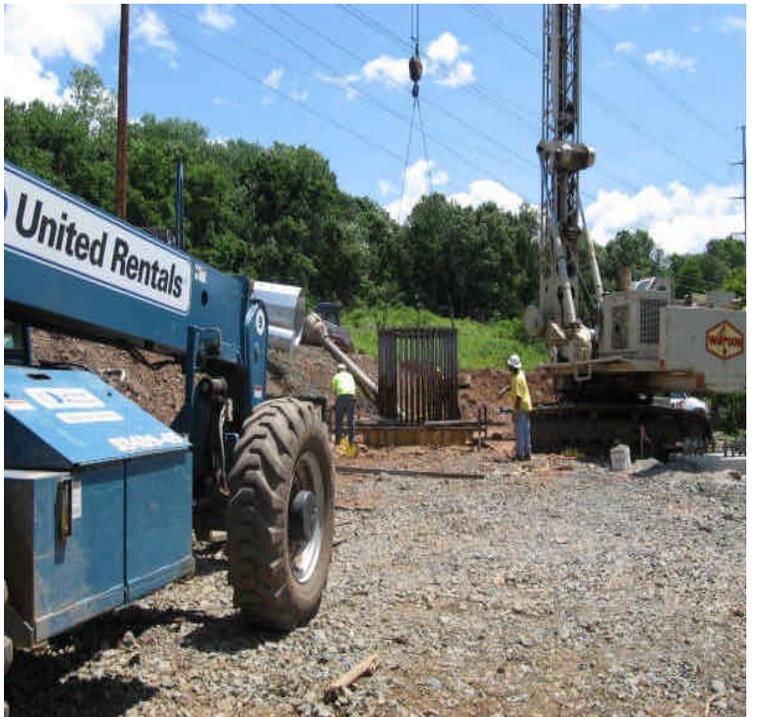
Foundation installation was occurring in the ROW south of East Meriden SS.

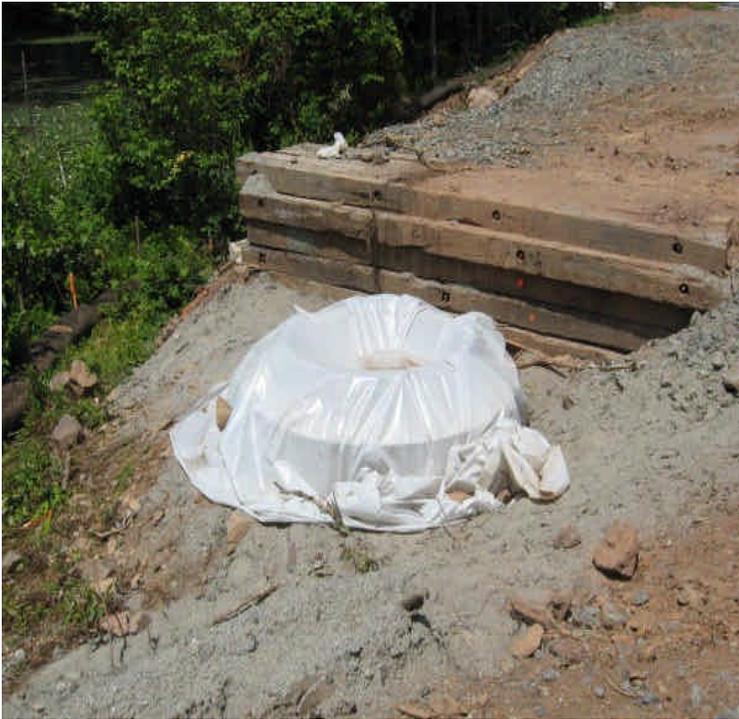
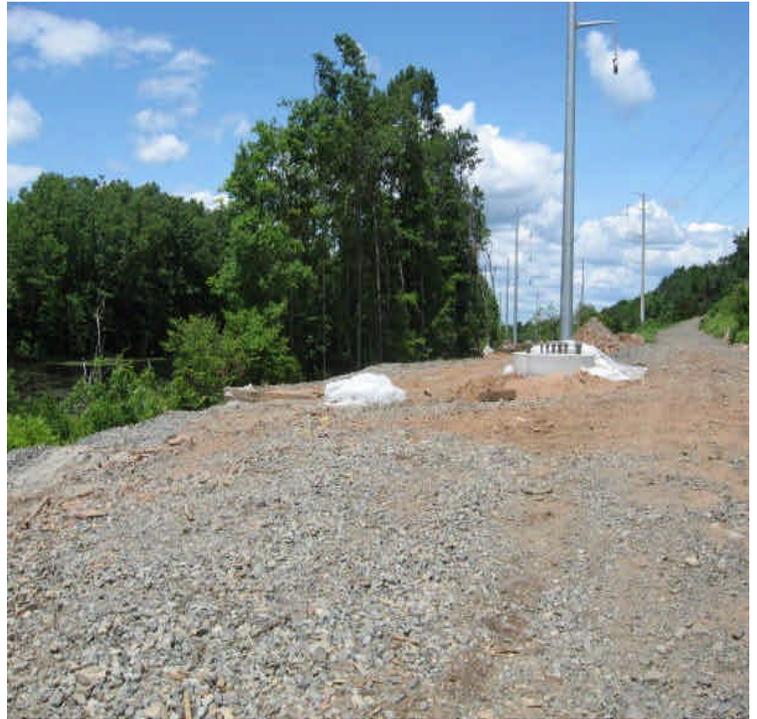
Both photos show views of foundations installed west of East Meriden SS. Ensure that controls are adequate to contain run-off to the adjacent pond.

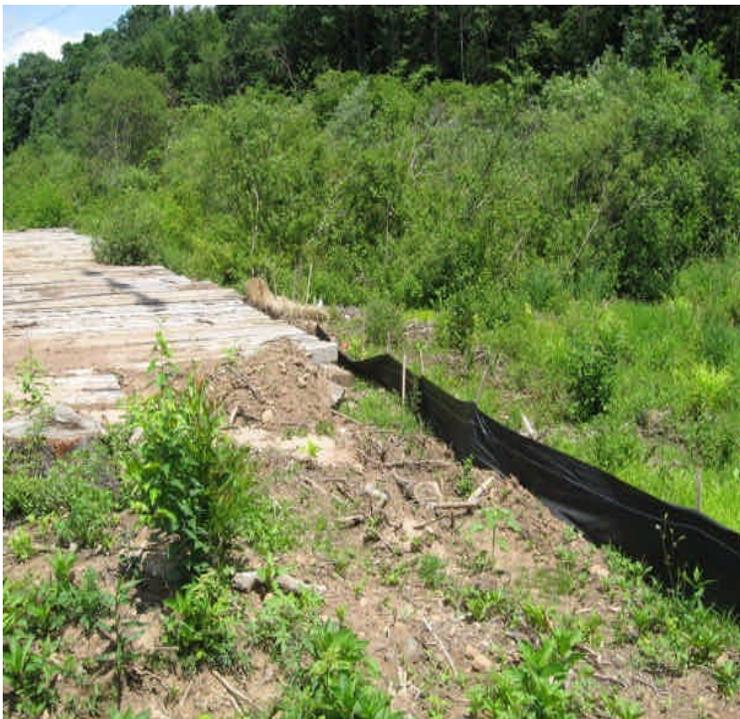
Timber mats and controls are in place off High Hill Road.

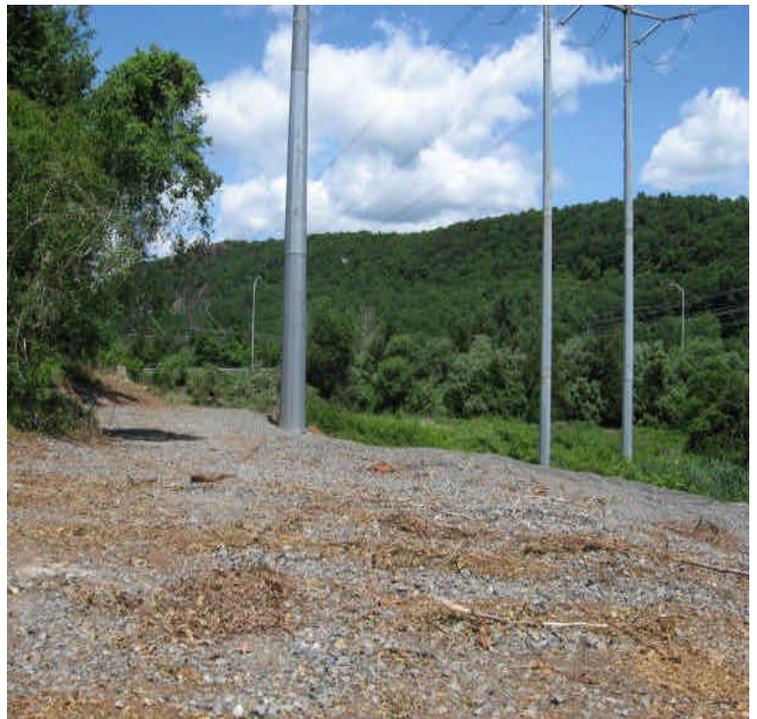
Pole structure installed north of East Main Street.
