Docket No. 272 – Development and Management Plan Inspection

Segment 1b (Royal Oaks Bypass) Inspection

Date: July 9, 2007

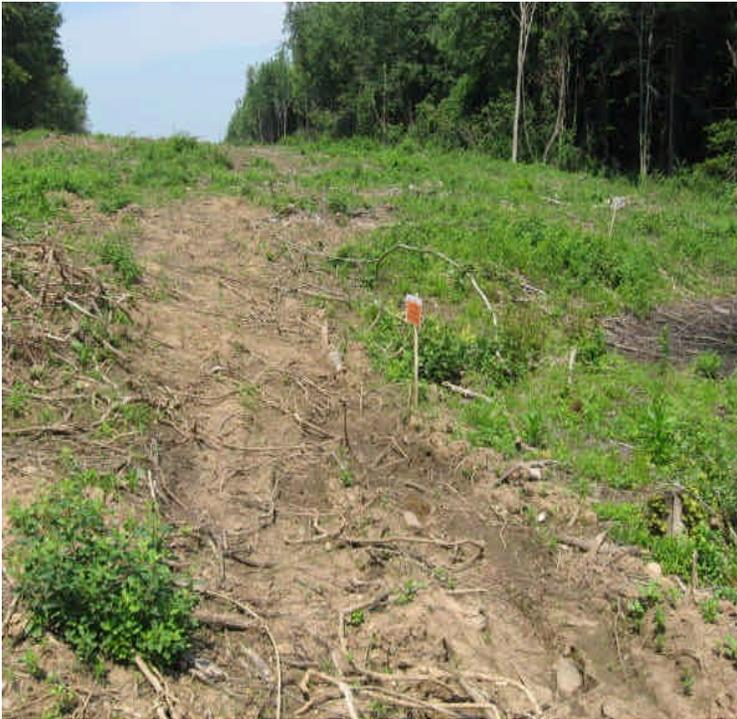
Water was no longer flowing into the pond from the equipment ruts created between Rte 17 and Black Walnut Drive. Controls are still needed. Also, confirm that the “entering wetland” sign is actually at the boundary and not within the wetland.

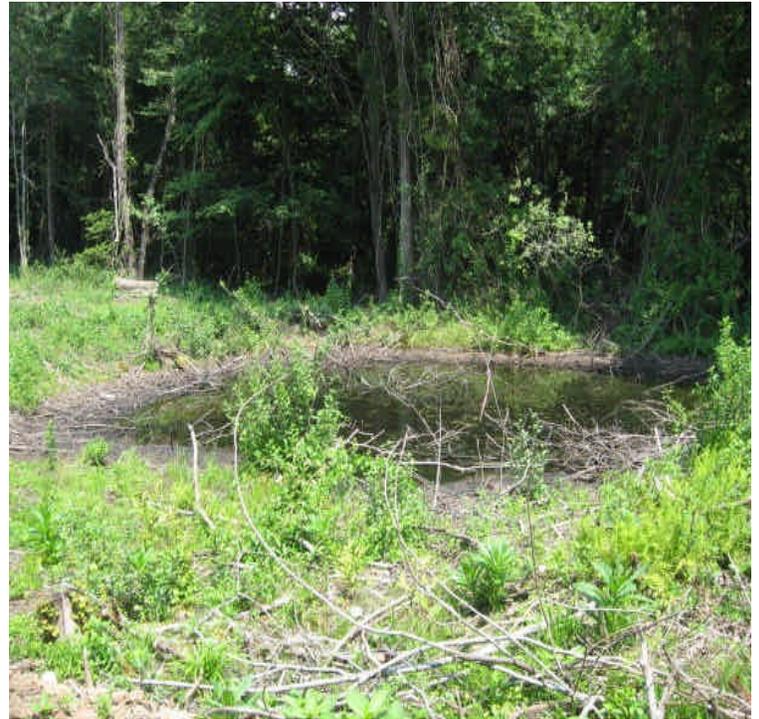
Pond within the ROW below rutted crossing is clear. The water level is receding with the hot weather.

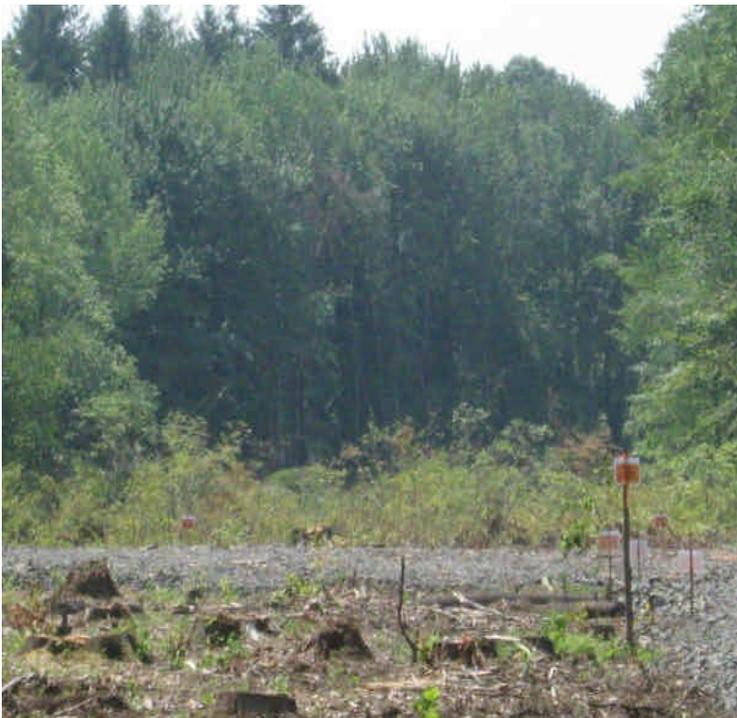
View of the sensitive area crossing in the ROW that was recently cleared via helicopter and low impact techniques. Stumps and low growing vegetation were retained to stabilize soils.

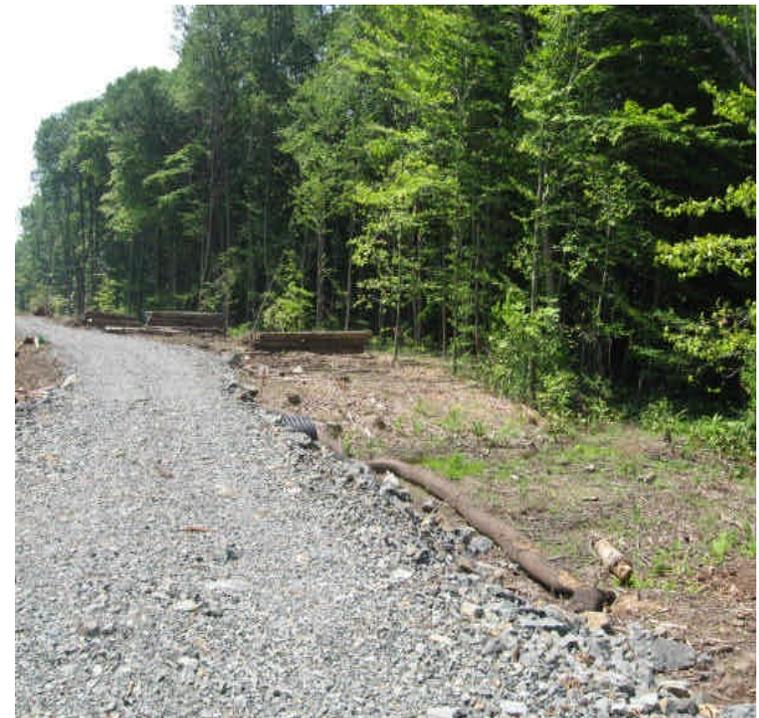
View of fiber roll installed along the access road. Continue to monitor to ensure controls are adequate.
