**Docket No. 272 – Development and Management Plan Inspection**

**Segment 1b (Royal Oaks Bypass) Inspection**

**Date:** July 23, 2007

**Location:** Segment 1b (Royal Oaks Bypass)

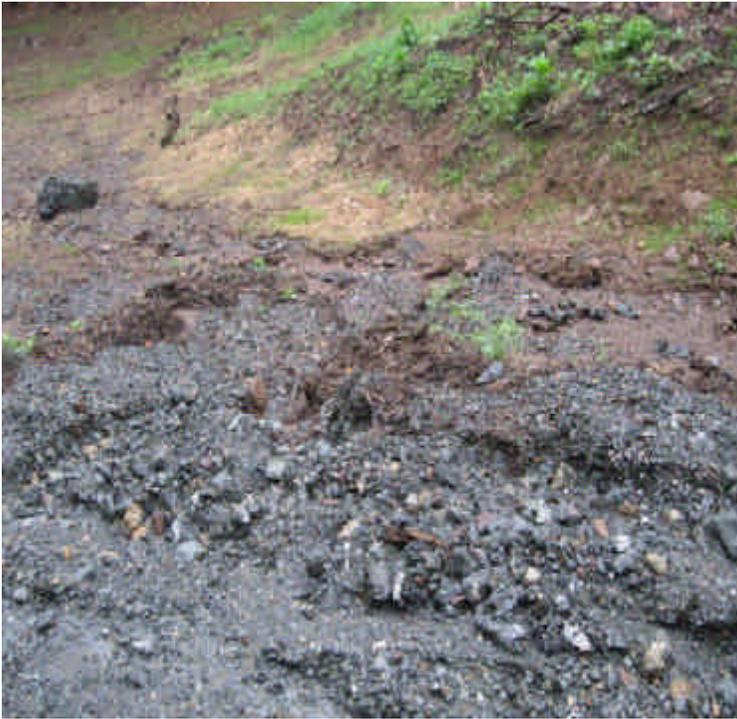
**Ruts/washouts are occurring along a steep slope in the access road off Black Walnut Drive.**

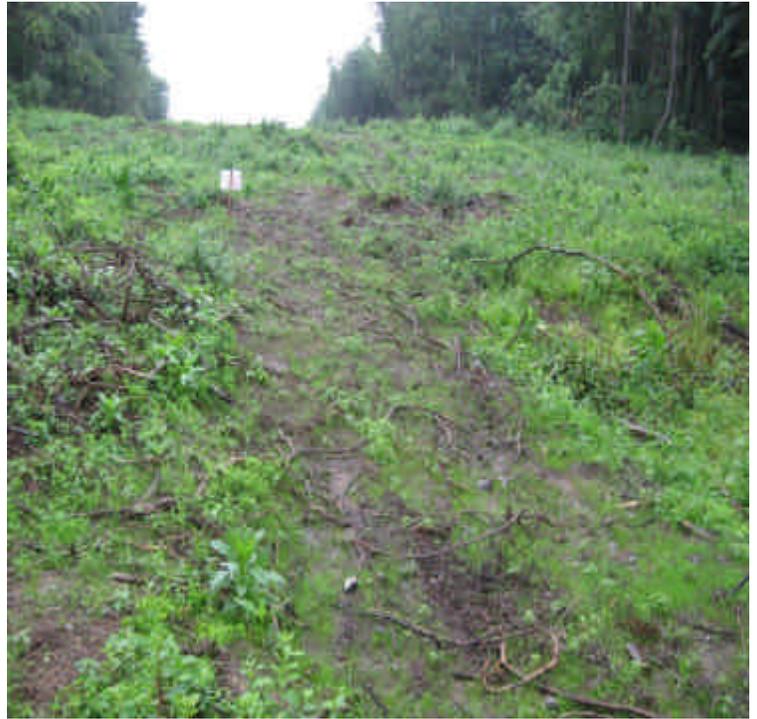
**Water was no longer flowing into the pond from the equipment ruts created between Rte 17 and Black Walnut Drive. Seed had been applied to the area and some vegetative growth was noted. Add controls as needed.**

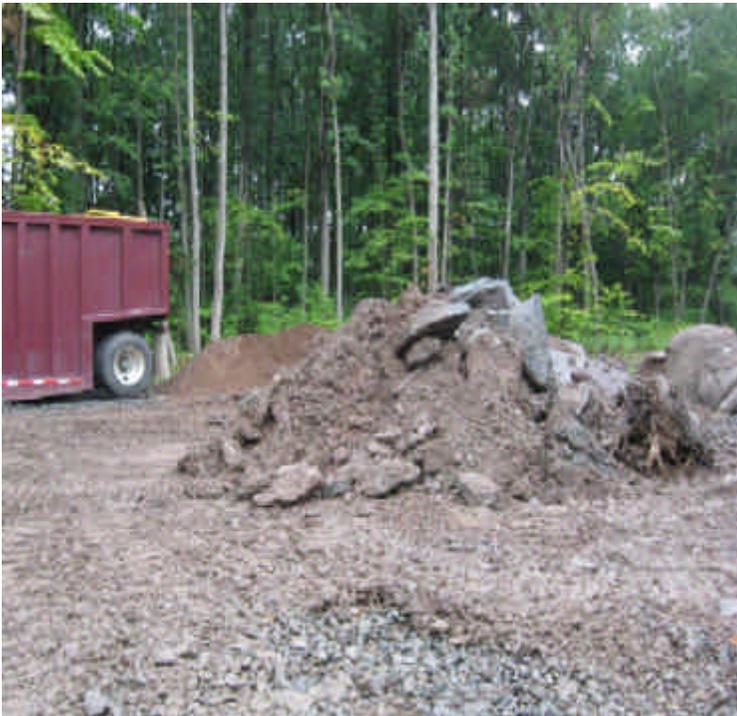
**Soils from drilling were being stockpiled near the shipping and receiving yard. Add controls downgradient if the stockpiles will remain or remove as soon as possible.**

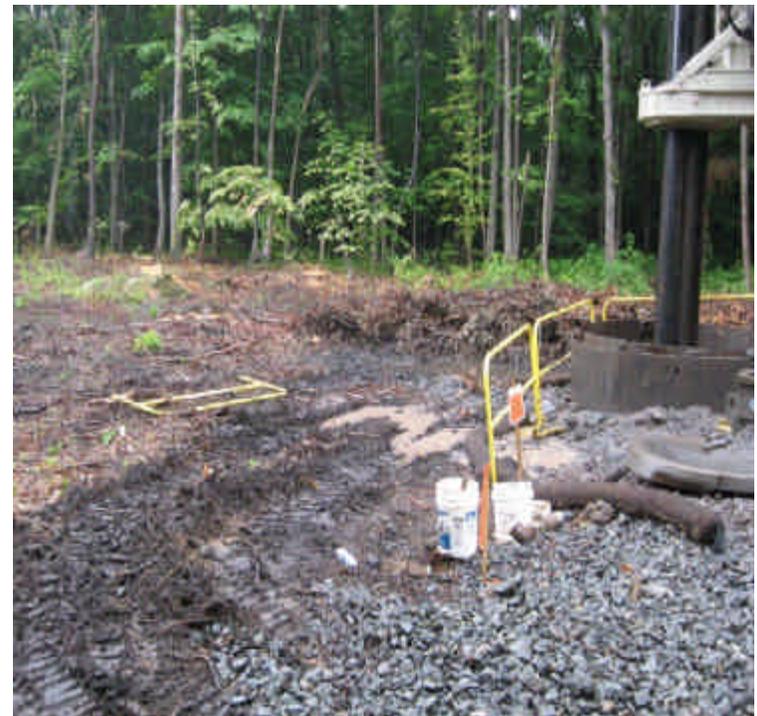
**Foundation drilling was occurring within the watershed protection area. Turbid run-off was contained.**

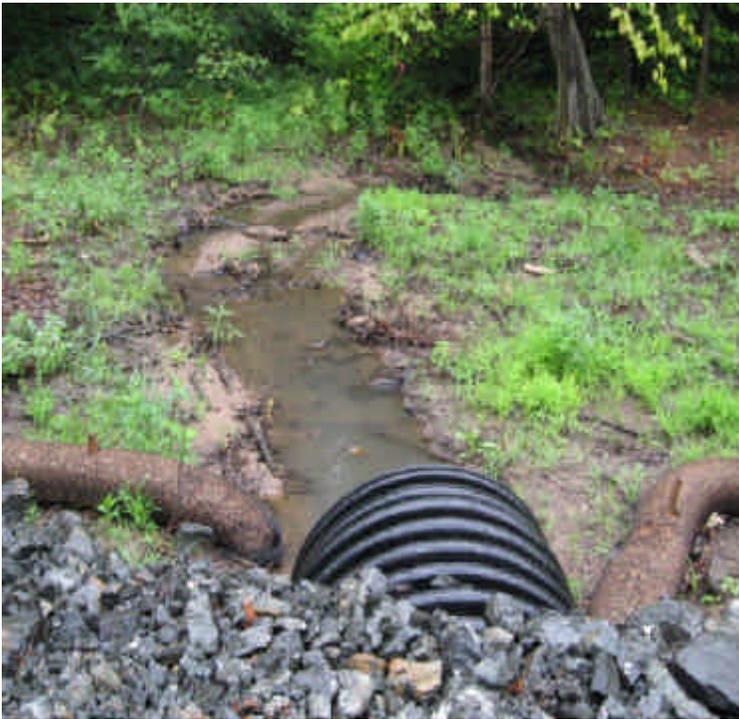
**The water flowing from a culvert installed under the access road near the shipping and receiving yard was slightly turbid. Some minor sediment accumulation was also noted.**

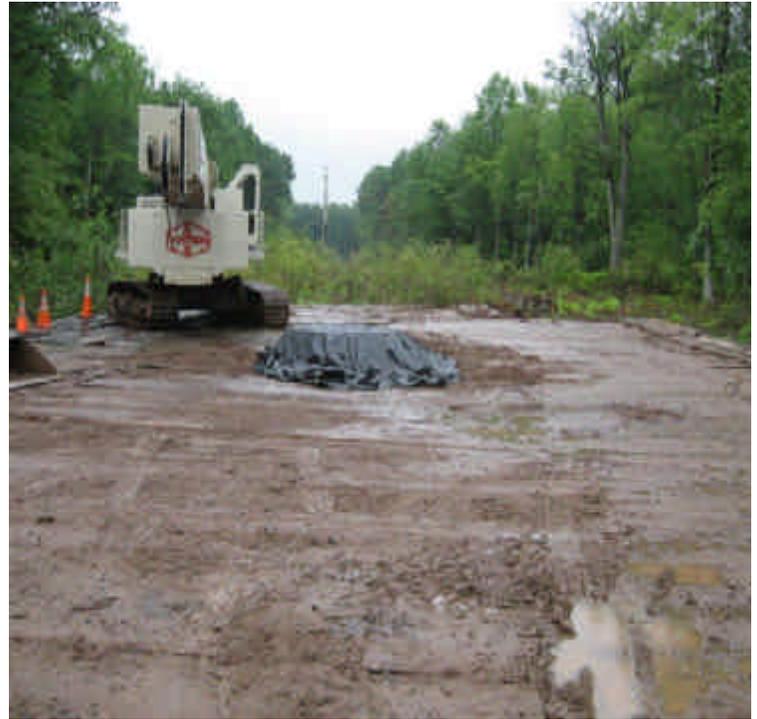
**Foundation installed west of Rte 17 near Little Lane. Equipment was parked on mats within the watershed protection area. Equipment should be relocated as soon as possible. Avoid storage in the protected area.**

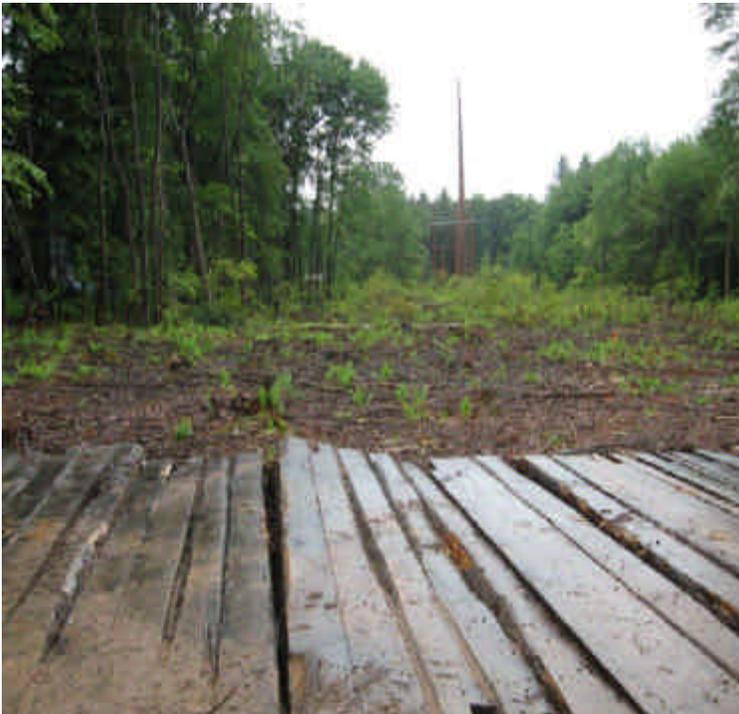
**Looking south toward the intersection with 1A work off Little Lane. Some vegetative growth was noted. Remove timber mats from wetlands as soon as work/access is complete to allow vegetative cover to return here.**

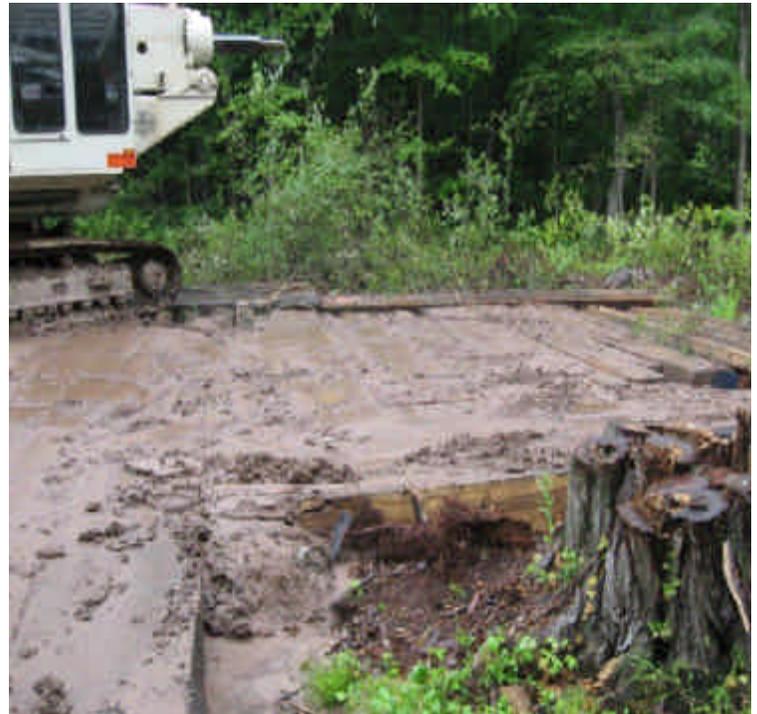
**Excess soils/tracking from drilling should be removed from the timber mats to the extent feasible.**
