Docket No. 272 – Development and Management Plan Inspection

Segment 2a Inspection

Date: July 24, 2007

Location: Segment 2a – Beseck Switching Station to Cheshire/Hamden Town Line

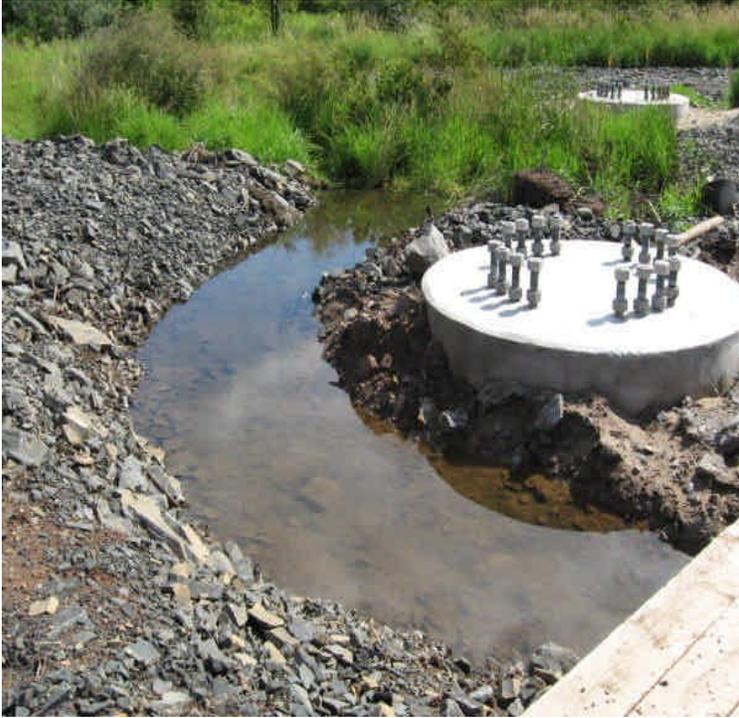
The channel that was previously blocked by a foundation has been restored/diverted to re-establish hydrology.

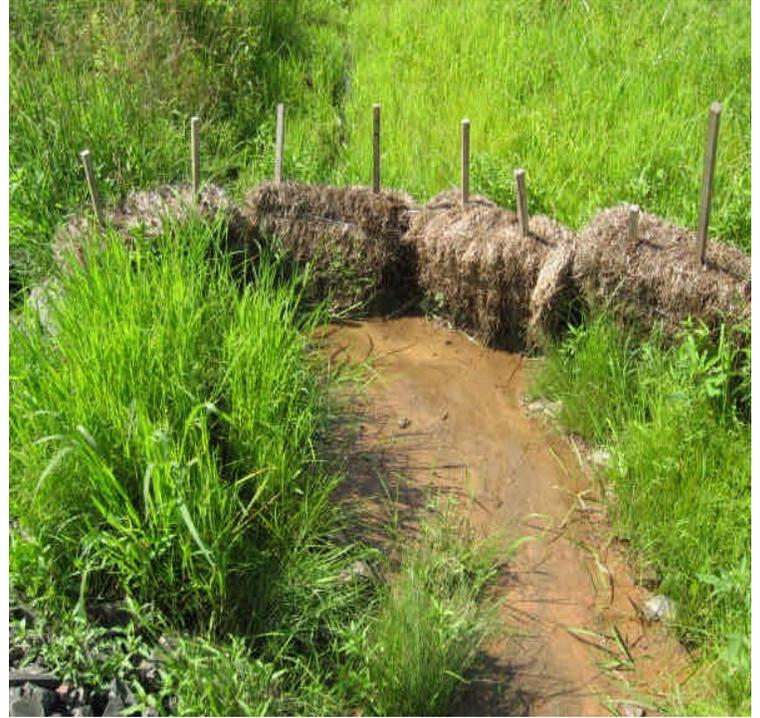
Sediment was appropriately filtered by a haybale check-dam within wetlands off Carpenter Lane. Remove sediment when feasible to restore capacity.

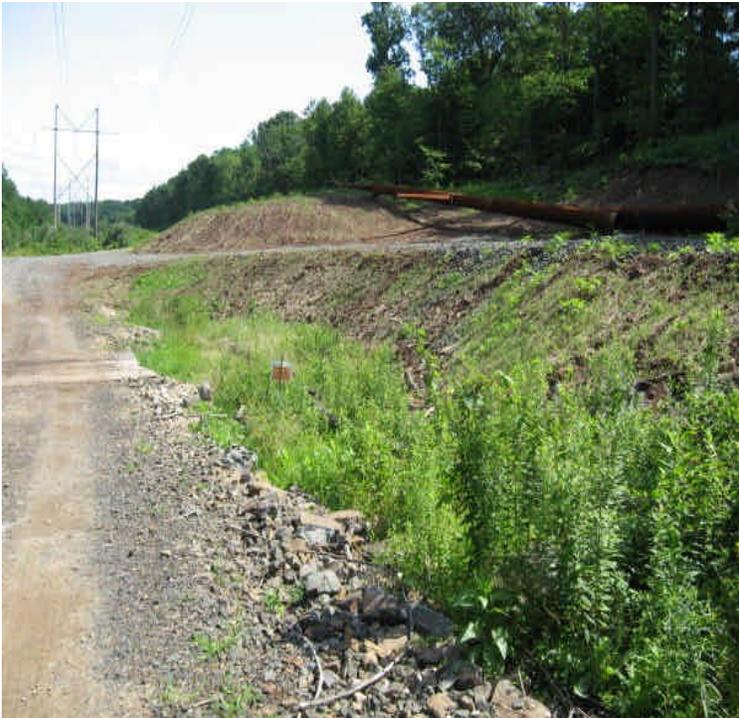
Grass growth noted at the slopes adjacent to the wetland crossing off High Hill Road.

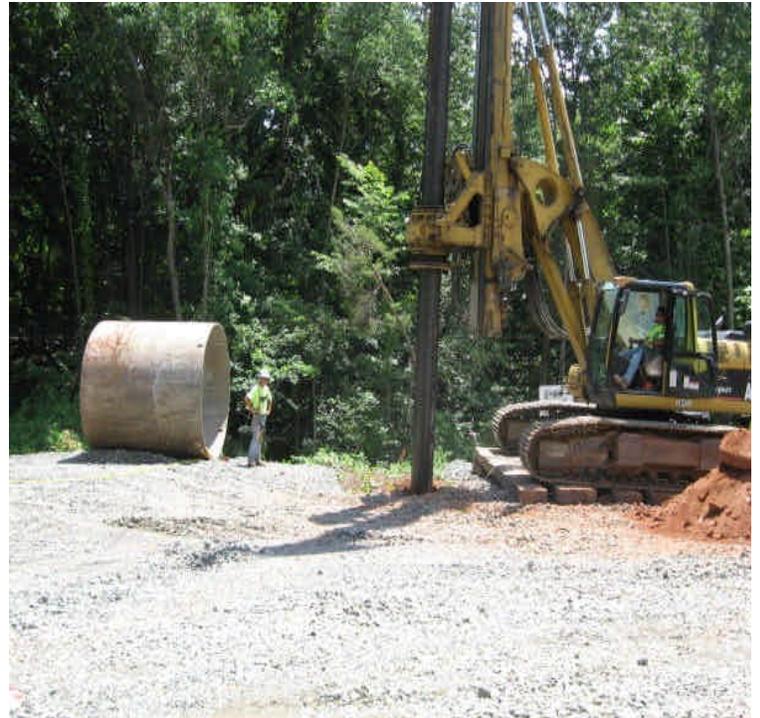
Foundation drilling was occurring off Woodhouse Ave.

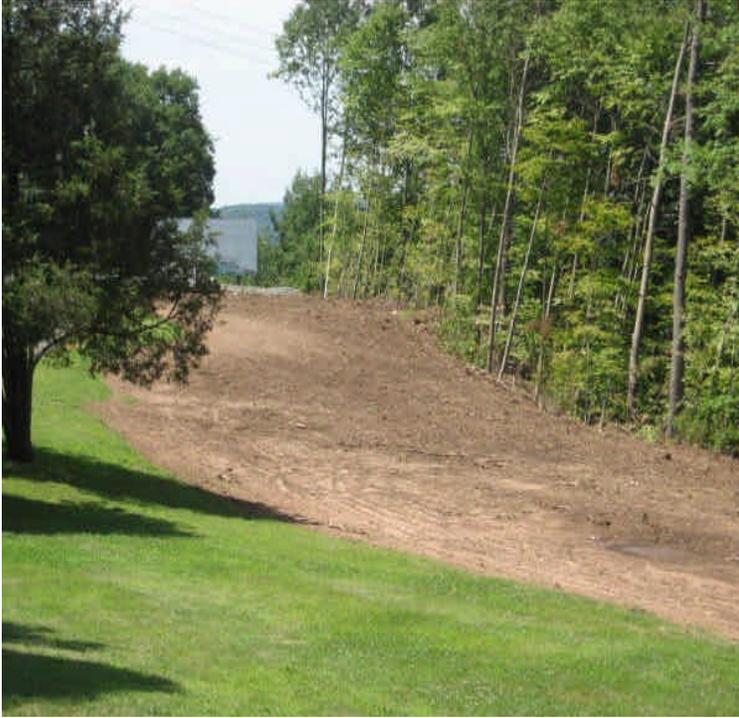
Graded area off Harrison Rd. The area is waiting for an application of hydroseed.

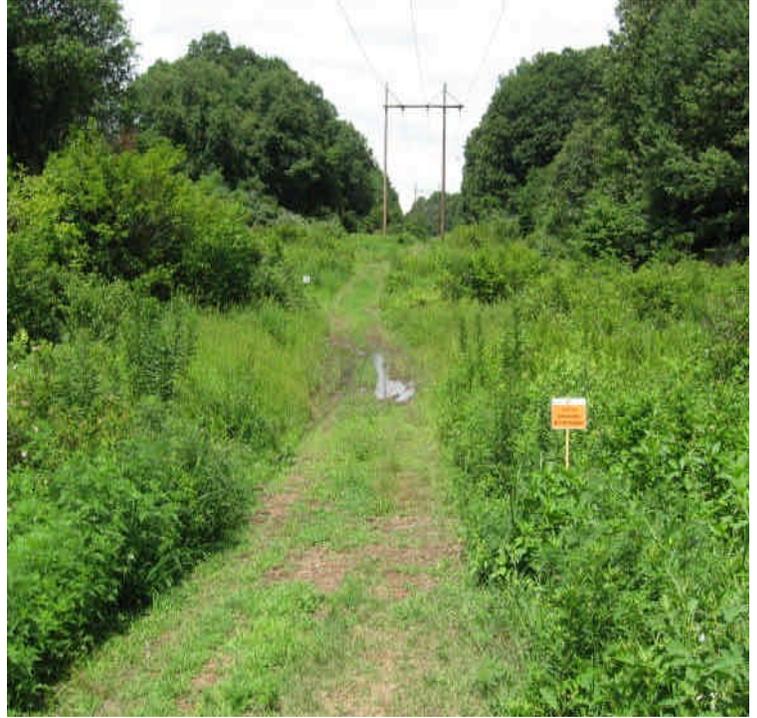
Wetland crossing off Pond Hill Road. Controls will be needed prior to equipment crossing and disturbance.

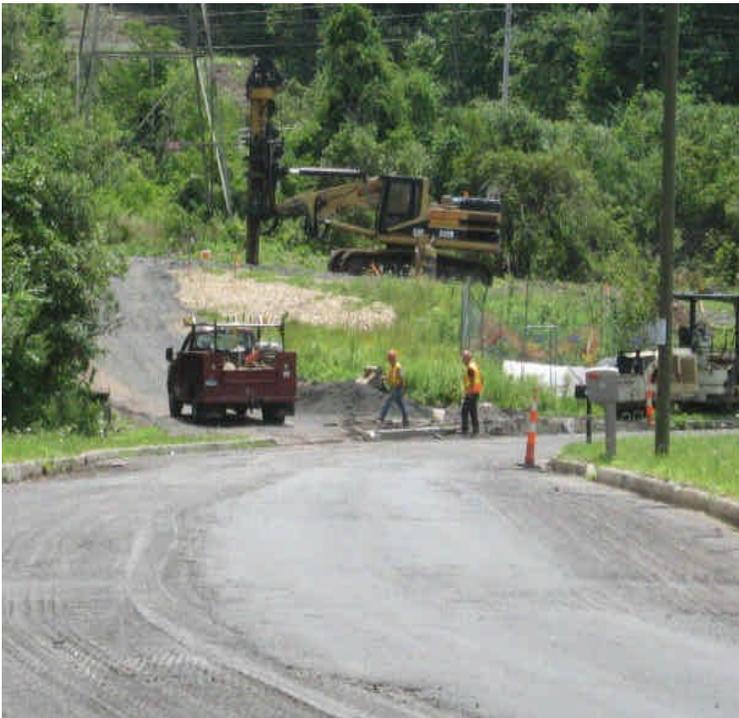
Crews were replacing damaged curbing that had been noted since the winter along Old Farms Road.

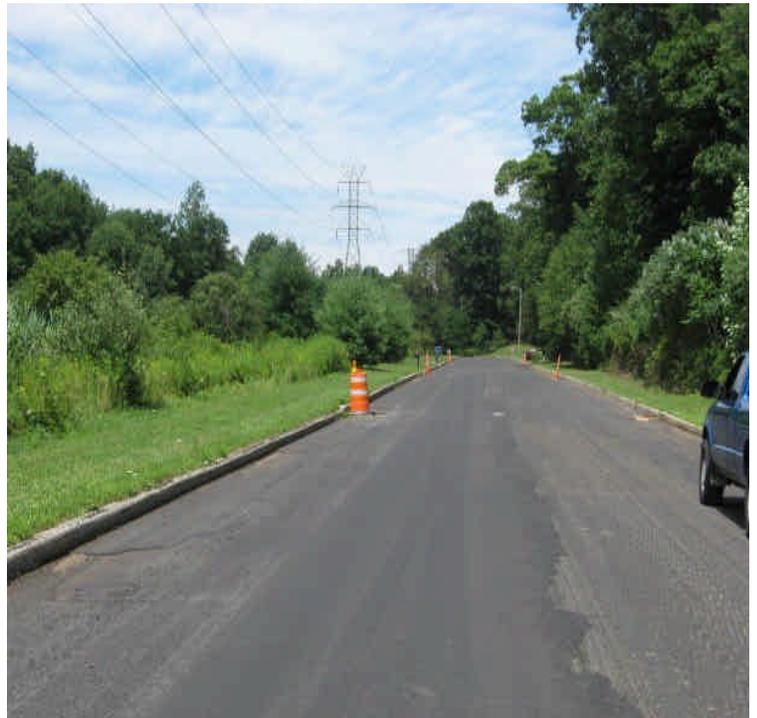
Crews were repaving the roadway along Old Farms Rd.
