Docket No. 272 – Development and Management Plan Inspection

Segment 3 Underground Line

Date: July 5, 2007

Location: East Devon Substation to the Housatonic River Crossing

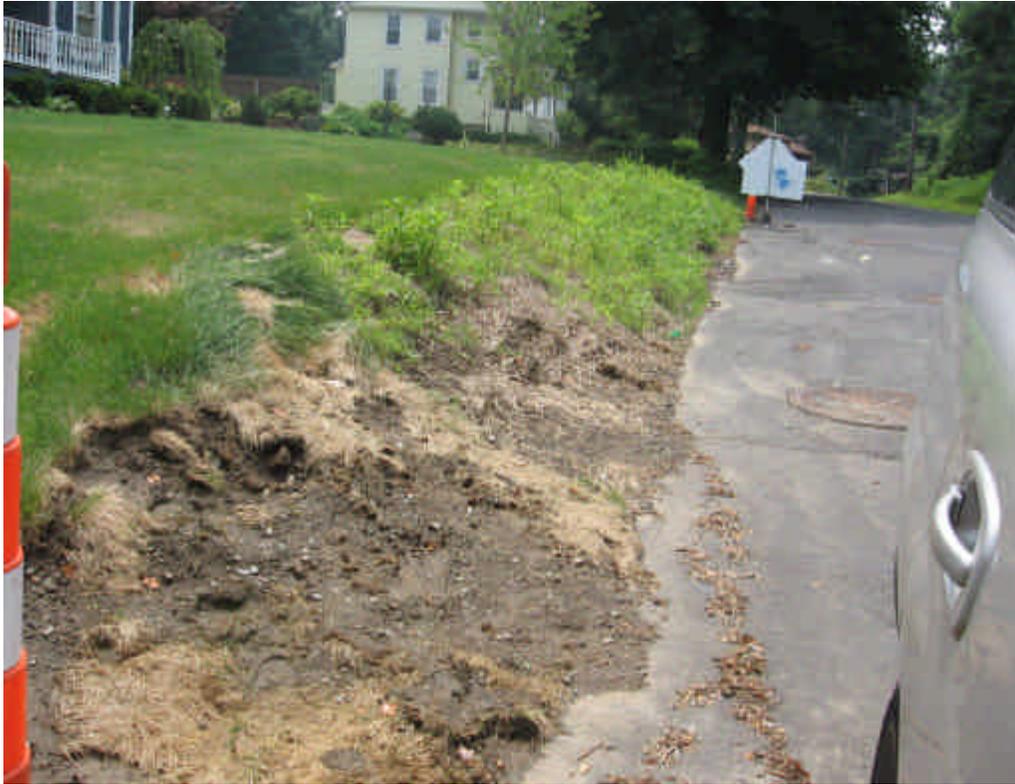
Areas of Inspection	Observation	Recommended Action	Corrected Action
Milford lay-down yard	<p>Soil on the slope near vault #3 was exposed as trenching activities resumed here. 7/5/07</p> <p>Material (gravel) was overtopping the established storage binds, beyond the perimeter controls of the yard. (noted since 4/25) 5/7/07</p>	<p>Install erosion controls to prevent soil migration during storm events. 7/5/07</p> <p>Contain material within established storage area and limits of yard. Contractors stated the materials will be removed when the area is restored. 5/7/07</p>	<p>Needs attention</p> <p>Contractors stated that the materials will be removed when the yard is restored.</p>
Inland Wetland and Watercourse encroachment and mitigation	<p>Inland Wetland resource areas are located near station # 1053, 1051, and from #1012 to 1021. Stations #1117 to 1118 are located in a resource area. 7/5/07</p> <p>Wetland flagging was also noted along the trench work between station #1049-51. Portions of the vegetation in this area have been cleared due to other activity. 7/5/07</p>	<p>Monitor resource areas to ensure that non-permitted encroachment or impacts do not occur 7/5/07</p> <p>None at this time. 7/5/07</p>	<p>NA</p> <p>NA</p>

Trenching activities have resumed leading up to vault #3. Exposed soil should be contained/stabilized when feasible to prevent migration during storm events.

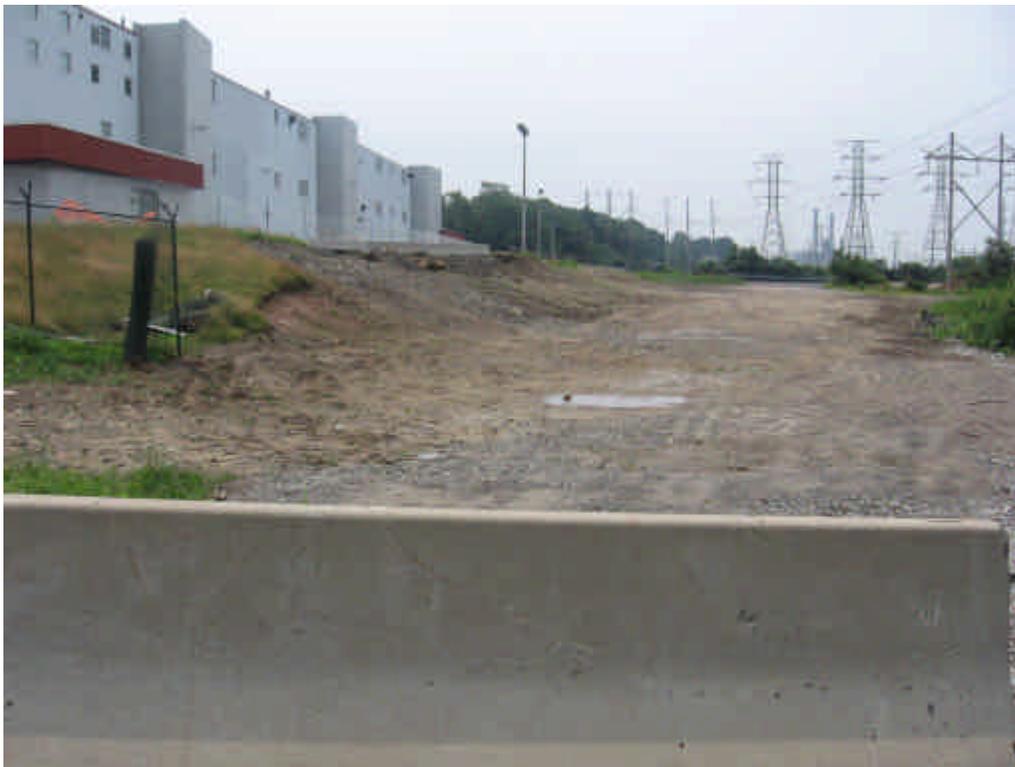
The steepest slope near sta. #1080 remains exposed. The area should be stabilized as soon as feasible.
