Docket No. 272 – Development and Management Plan Inspection

Segment 3 Underground Line

Date: July 19, 2007

Location: East Devon Substation to the Housatonic River Crossing

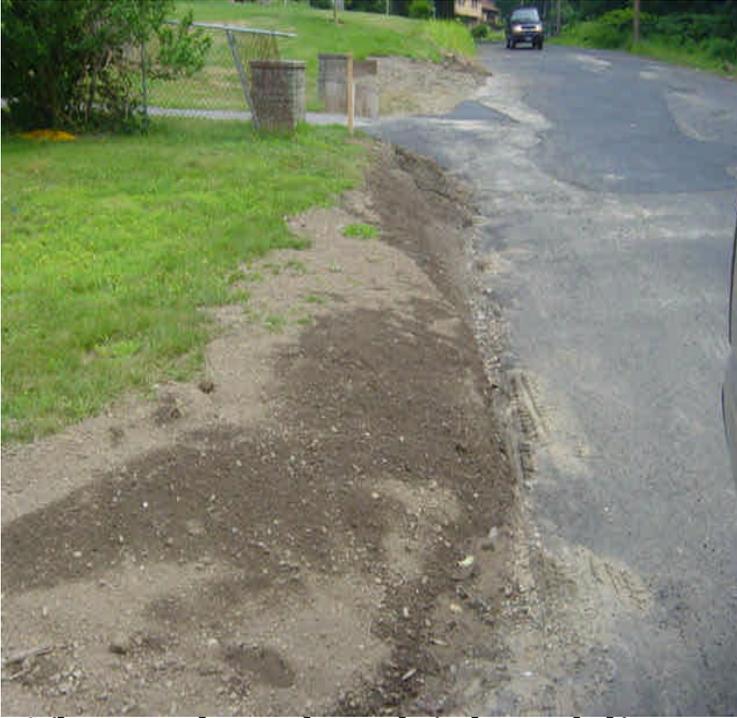
Soils are exposed near vault #3, and rains have resulted in some erosion and run-off. Controls should be installed or the soils should be stabilized to reduce sedimentation.

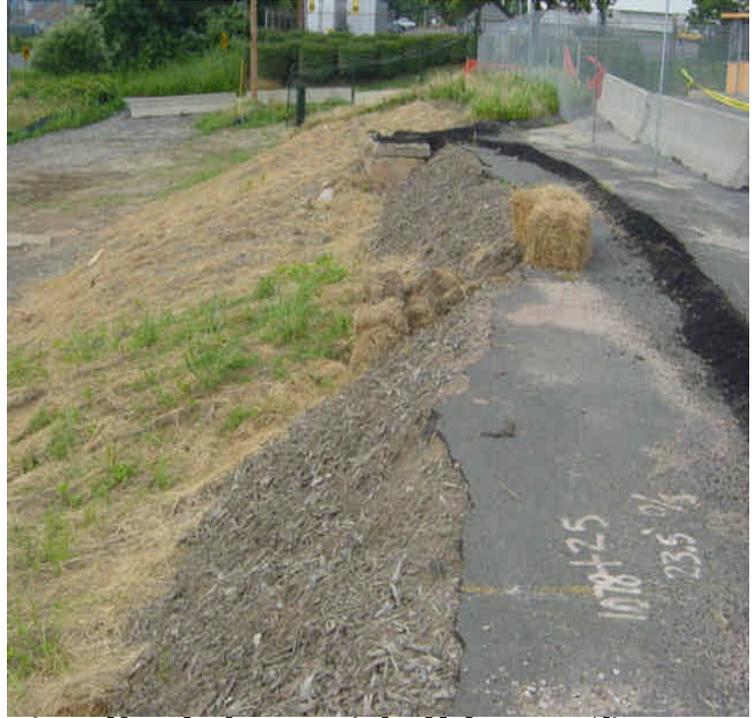
Hay mulch and wood chips are in place on the steepest slope near sta. #1080. However, some areas are not fully stabilized with vegetative cover. 7/19/07	Implement measures to permanently stabilize the entire area. See erosion control section for more details. 7/19/07	A berm was installed to divert stormwater. Continue to monitor.
Dewatering	Dewatering activities were not observed during this week's inspection. 7/19/07	None. If dewatering needs to occur, ensure that it is contained appropriately and filtered before released to adjacent areas. 7/19/07	NA
Blasting	No blasting has been proposed. 7/19/07	None 7/19/07	NA
Spills and Material Storage	Reserve spill cleanup materials/kits were observed in the storage yard. 7/19/07	Continue to bring spill kits to active work sites. 7/19/07	NA
	Dried concrete washout	If M/N project	Needs evaluation.

A paved berm has been proactively added to prevent/divert run-off from eroding the bank near sta. #1080 until it has time to stabilize. Ensure that the diverted run-off is not affecting neighboring areas.

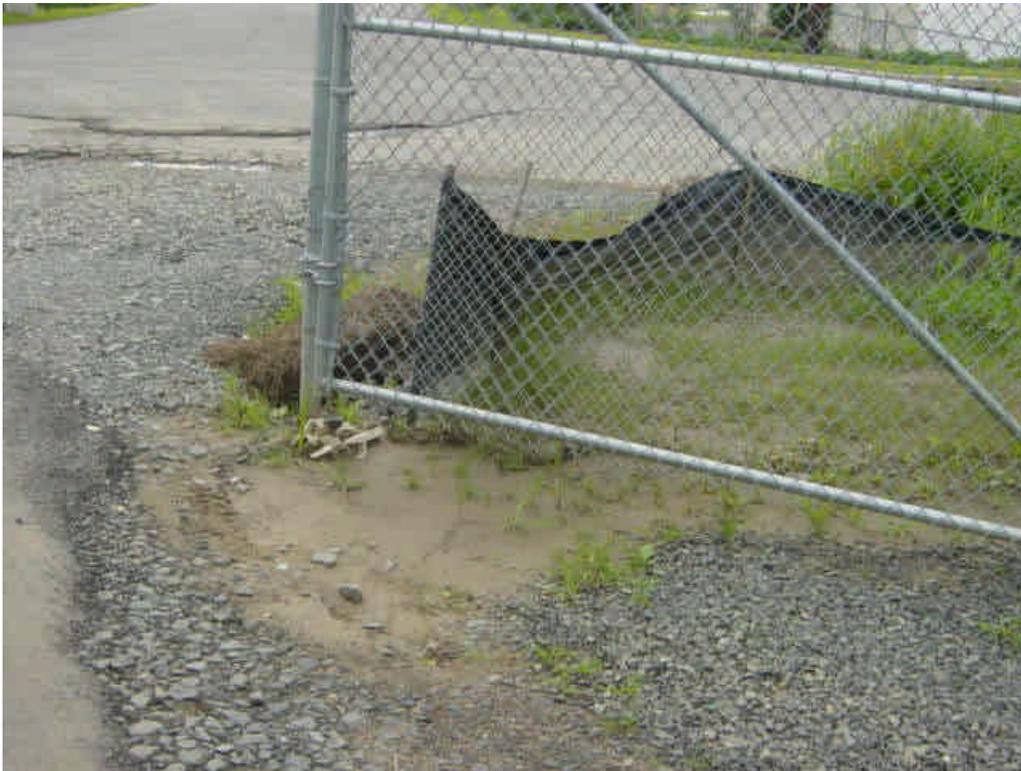
Fine sediment continues to accumulate at the entrance to the Milford lay-down yard. The area adjacent to the catch basin is vegetated which helps to filter the sediment and some controls are in place. However, consider installing more controls along the flow path as feasible.
