Docket No. 272 – Development and Management Plan Inspection

Segment 3 Underground Line

Date: July 25, 2007

Location: East Devon Substation to the Housatonic River Crossing

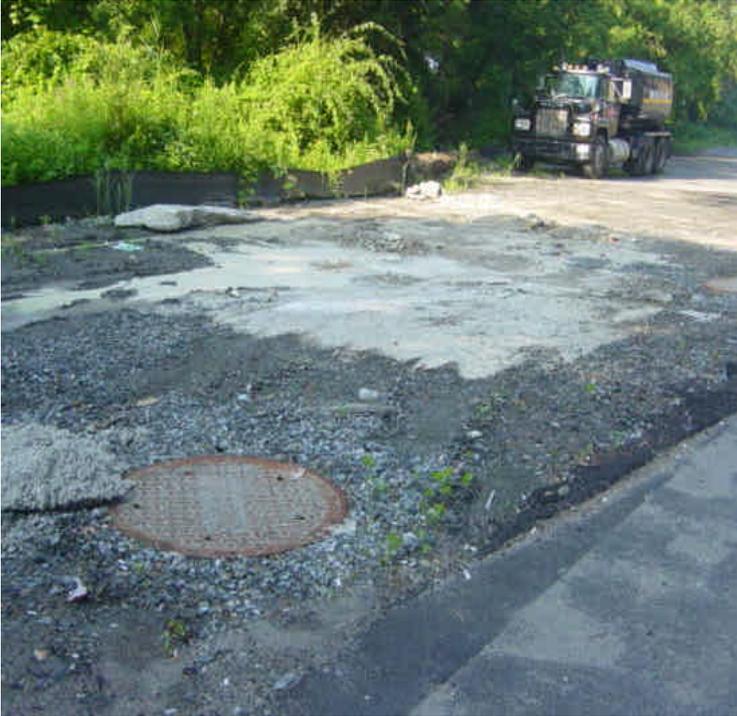
Both photos were taken near sta. #1017. Left: Concrete washout remains. M/N contractors have stated that the washout is not from project related activities and is the result of other construction activities in the area. Right: Silt fence is compromised in this area but M/N work areas are stable. If project work is complete here, controls should be removed. If activities will return to this location in the future, re-establish the silt fence.

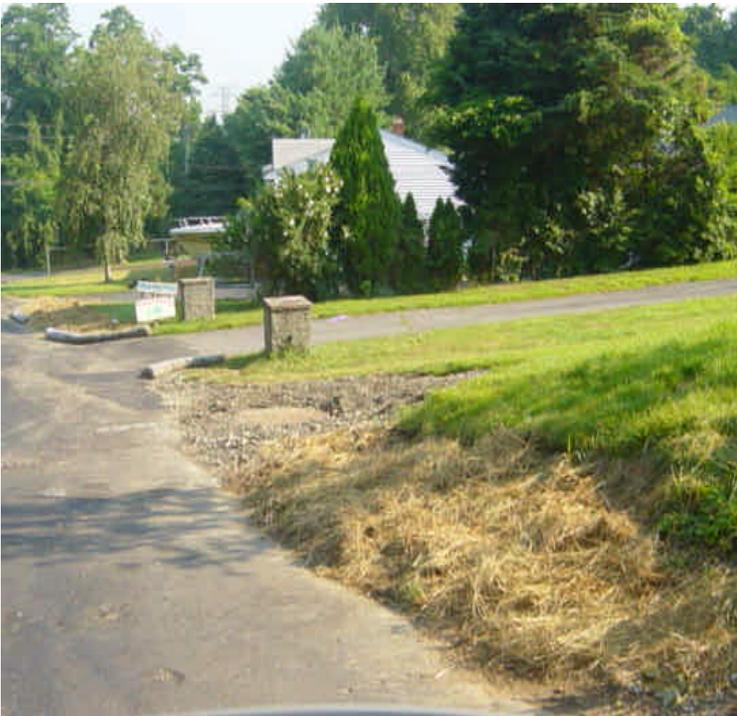
Exposed soils at sta. #1049 have been temporarily stabilized with hay mulch and gutter buddies.

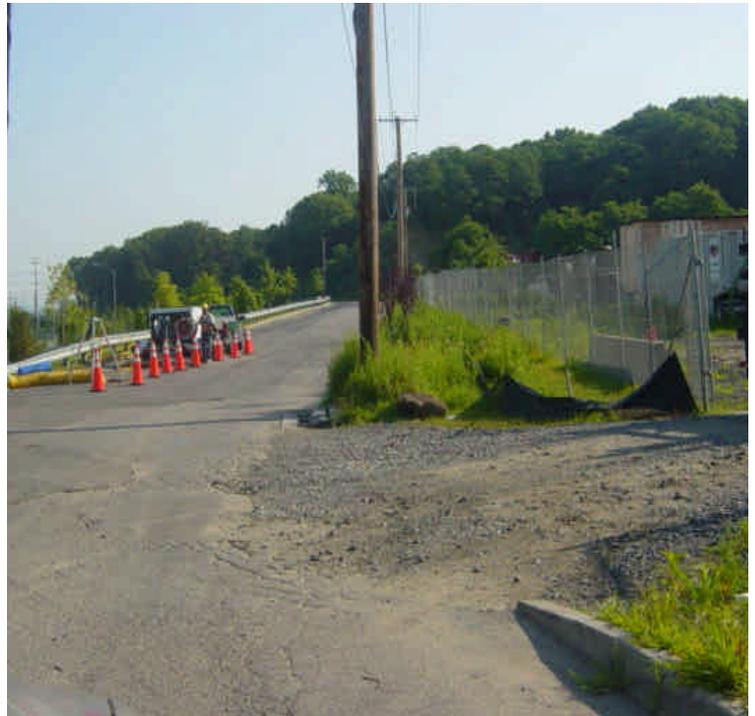
Stone from the construction entrance at the Milford lay-down yard on Shelland St. is migrating into the roadway.

Milford lay-down yard	The stone from the entrance to the yard is migrating out onto Shelland St. 7/19-7/25/07	Sweep rock back out of Shelland St. so that it is located entirely within the yard boundaries. 7/19-7/25/07	Needs attention when feasible.
	No issues with tracking were noted at the yard. 7/25/07	Continue to monitor and maintain as necessary. See erosion and sediment control section. 7/25/07	No issues noted but needs regular attention.
Vault Openings and	No active work on vaults	None. 7/25/07	NA
