Docket No. 272 – Development and Management Plan Inspection

Segment 4a Underground Line

Date: July 19, 2007 (evening inspection)

Location: Singer Substation to Fairfield/Westport Town Line

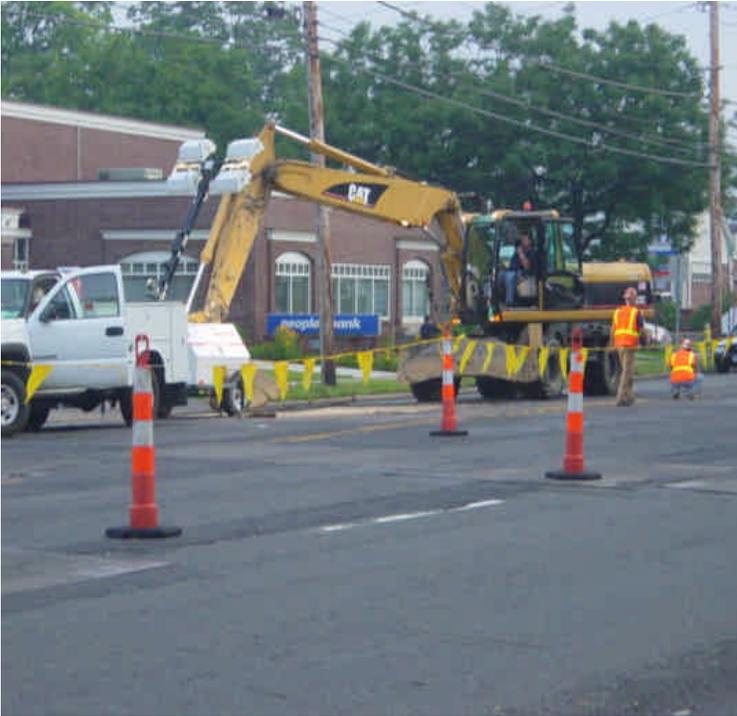
View of crews preparing for paving activities at sta. #582.

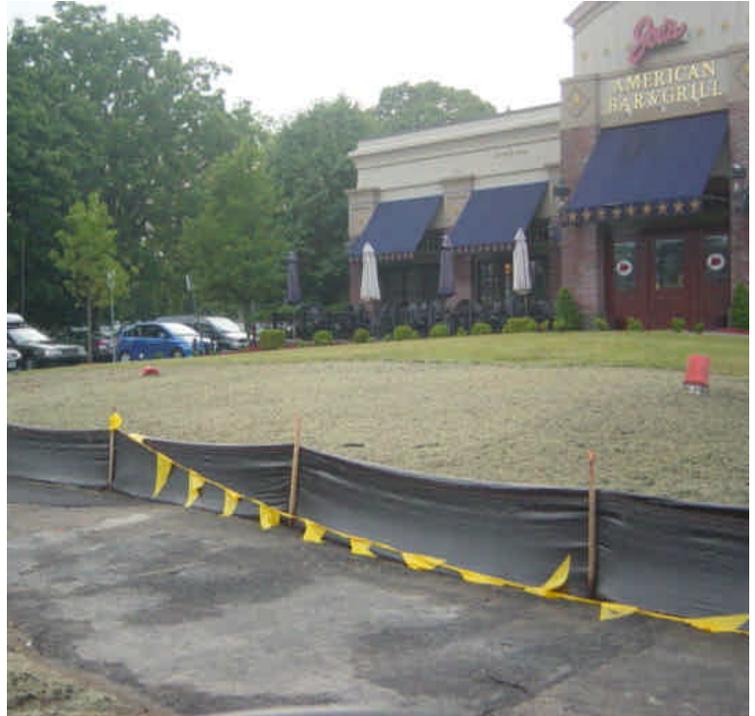
Exposed soils at vault #36 have been hydroseeded and mulched. Grass was starting to germinate.

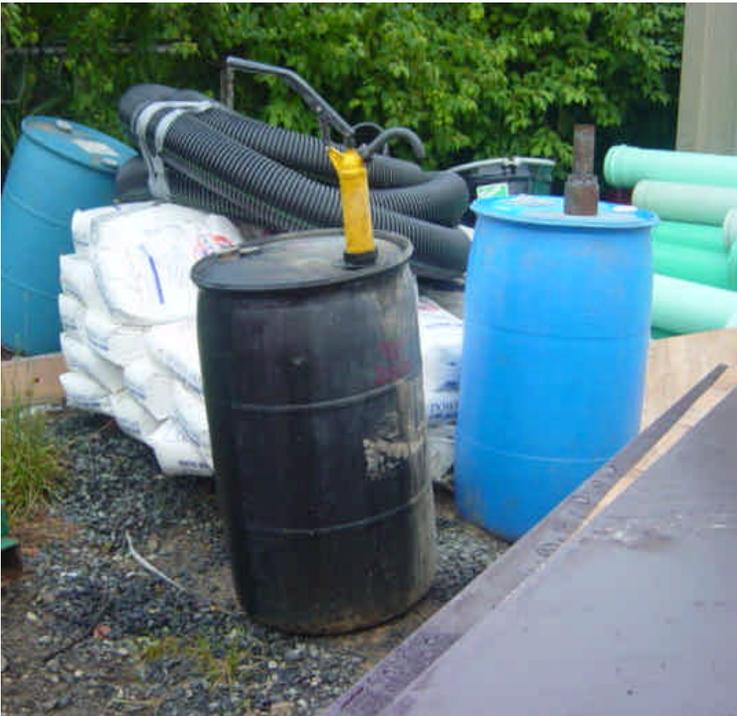
Bio-diesel fuel is being stored within the King's Highway lay-down yard, on the side of the yard immediately adjacent to the watercourse. Relocate and store the drum with the other well-contained fluid filled materials. Keep over 100 feet from sensitive areas whenever feasible.

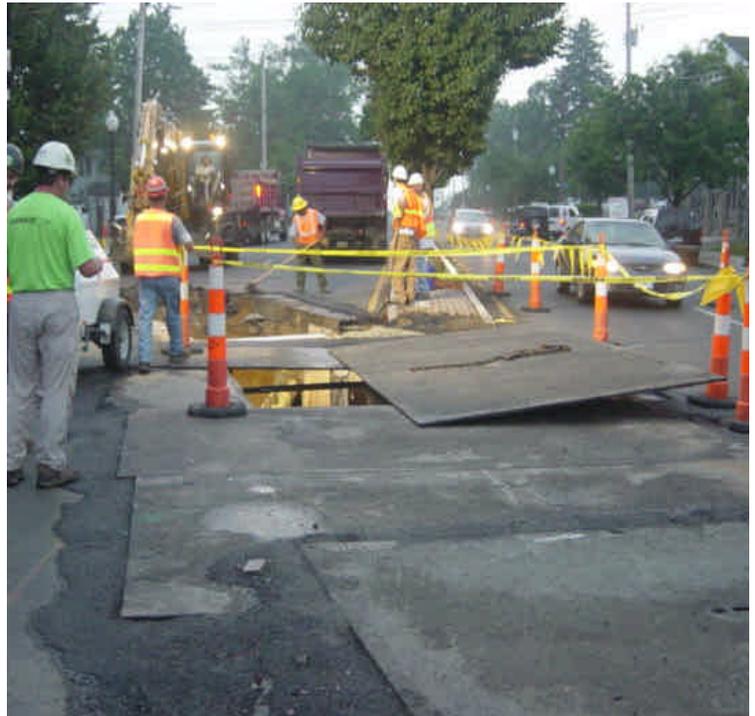
Crews were proactively sweeping spoil/sediment from trenching from the roadway, back into the trench.
