Docket No. 272 – Development and Management Plan Inspection

Segment 4a Underground Line

Date: July 25, 2007

Location: Singer Substation to Fairfield/Westport Town Line

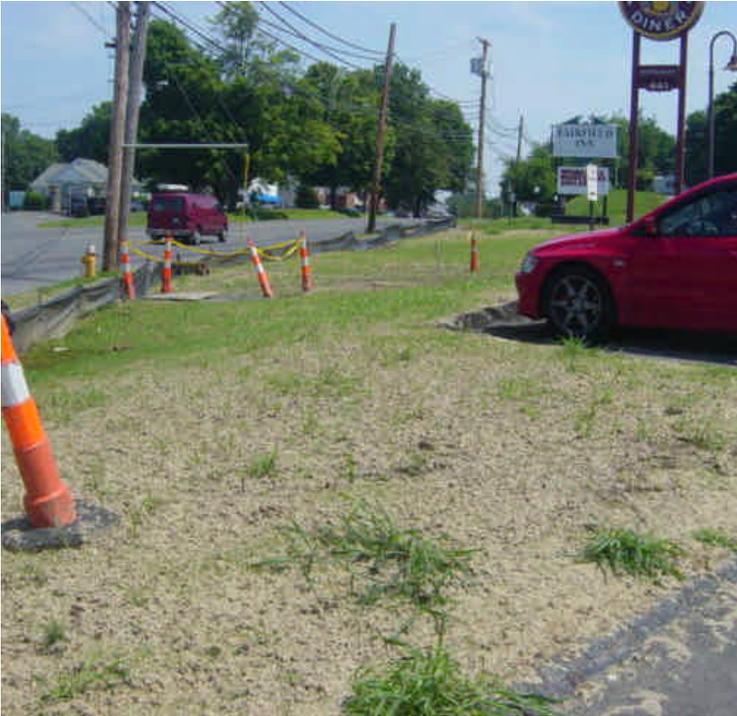
Vegetation is beginning to establish at sta. #611.

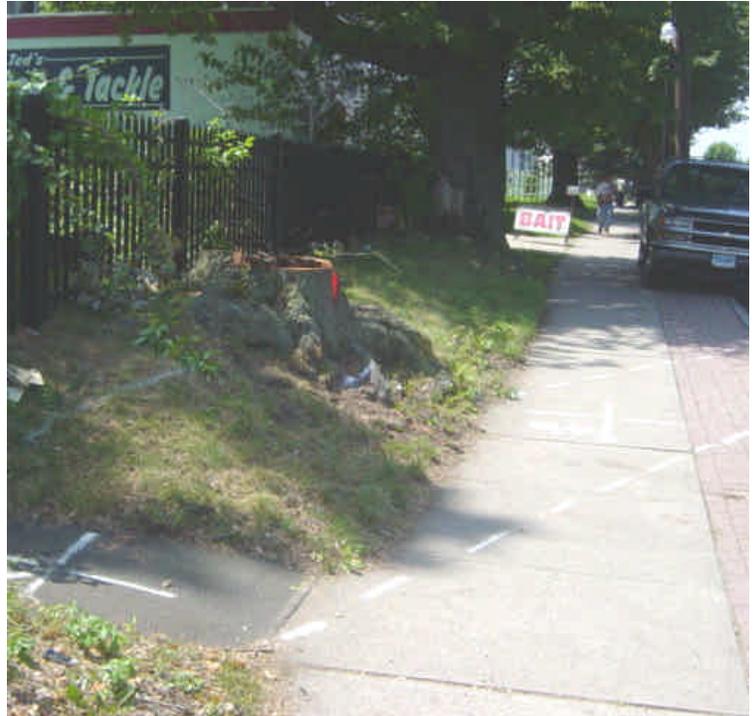
A large tree has been removed near vault #42 in preparation for trenching activities in this location.

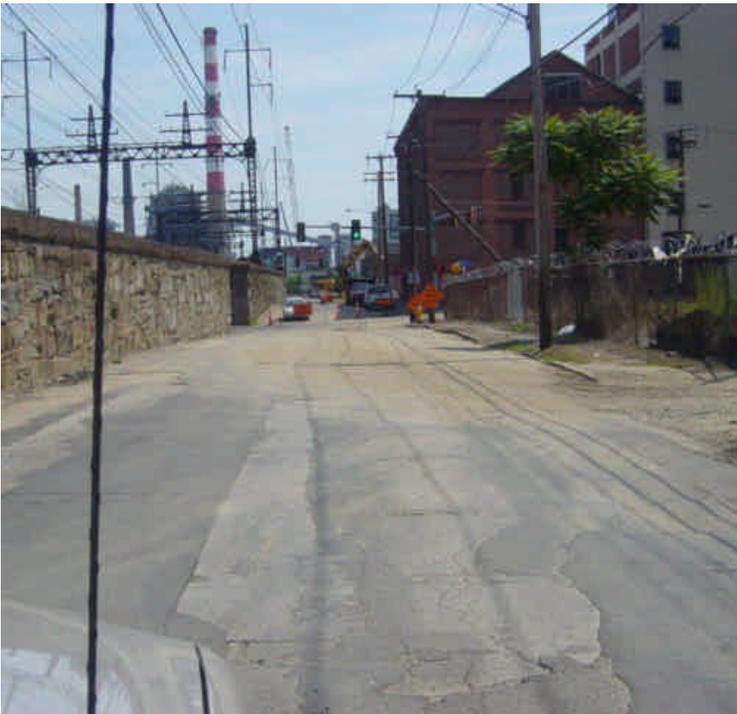
Sediment tracking and sediment accumulation in the catch basins are regularly observed at the Railroad and Myrtle Ave. intersection. Sediment is originating from a stockpile yard identified as being associated with the Glenbrook Cable project. This is not covered under this D&M plan. 7/25/07	Noted for the record since contractors stated the sediment is not related to this project. 7/25/07	NA
Kings Highway Lay-down Yard (Off Kings Highway, near Rt. 1 rotary)	Perimeter erosion controls remain in place at the yard. 7/25/07	Continue to monitor and maintain the perimeter silt fence as necessary. 7/25/07	NA
Inland Wetland and Watercourse encroachment and mitigation	The Kings Highway lay-down yard is located adjacent to potential resource areas and a concrete lined waterway. 7/25/07	See erosion control section. 7/25/07	NA

Photo of sediment tracking on Railroad Ave. near its intersection with Myrtle Ave. This was not a result of project related activities.

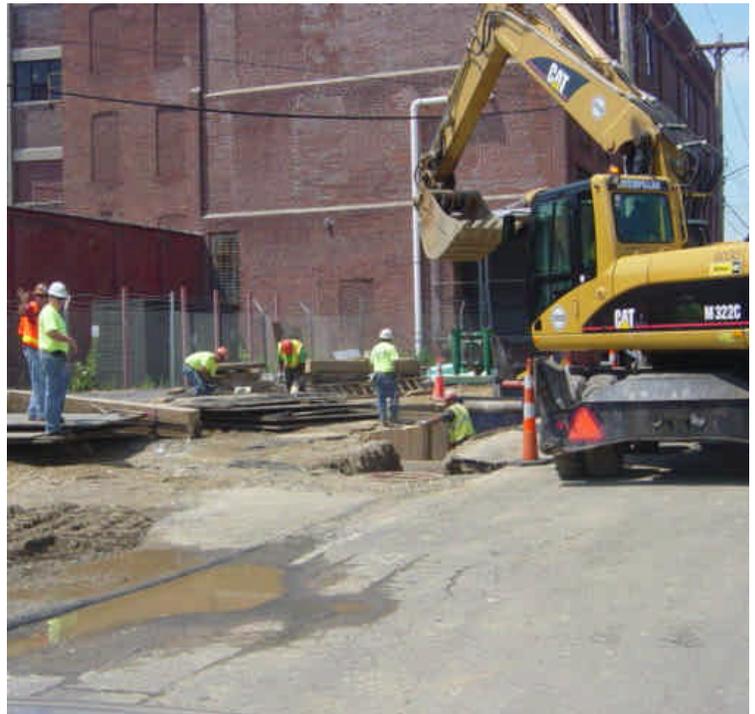
Trenching activities were being conducted at sta. #788.
