Docket No. 272 – Development and Management Plan Inspection

Segment 4b Underground Line

Date: July 13, 2007

Location: Fairfield/Westport Town Line to Westport Avenue in Norwalk

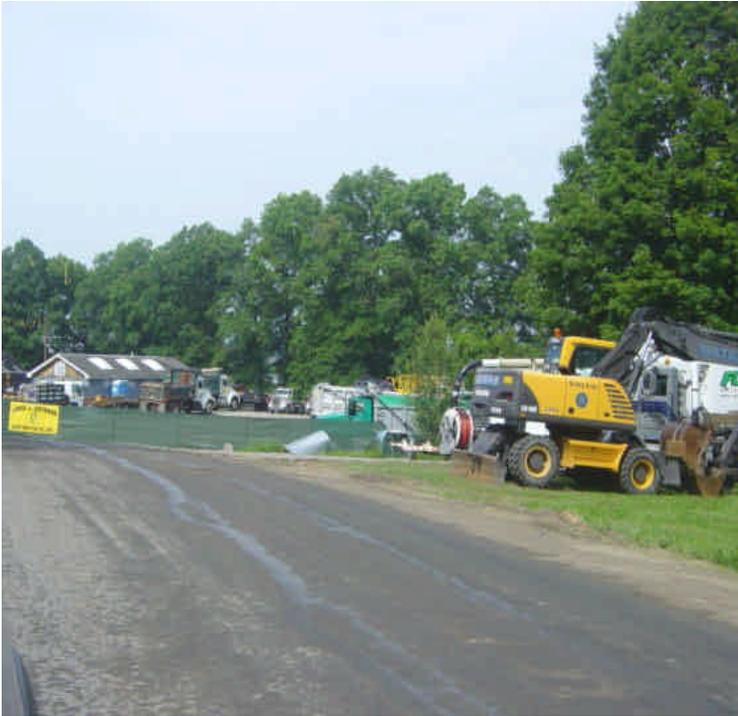
Construction equipment was noted again, stored outside the fenced limits of the Sherwood Island lay-down yard. Determine if this is within the yard agreement.

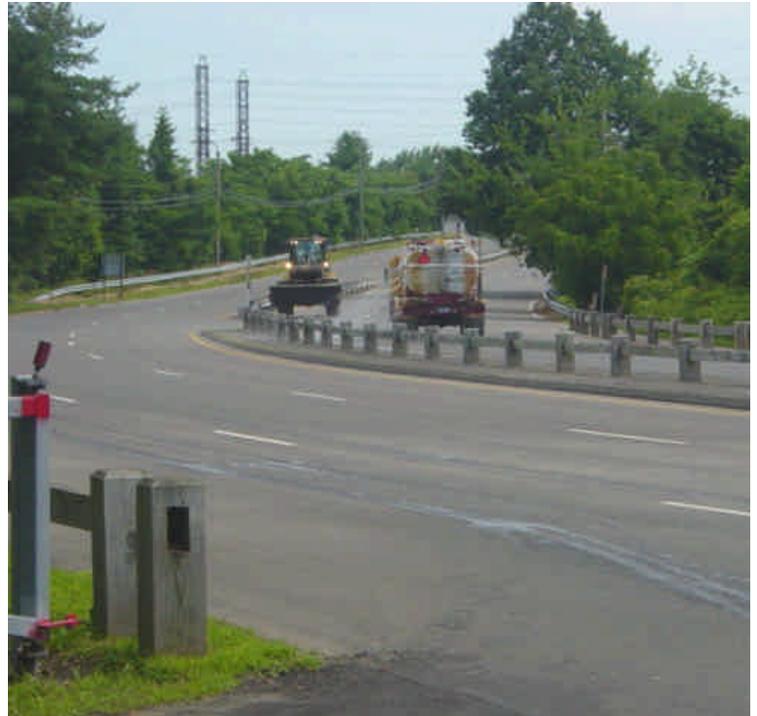
Crews are sweeping the roadway near the Sherwood Island lay-down yard to reduce sediment tracking. A water truck helps to control dust.

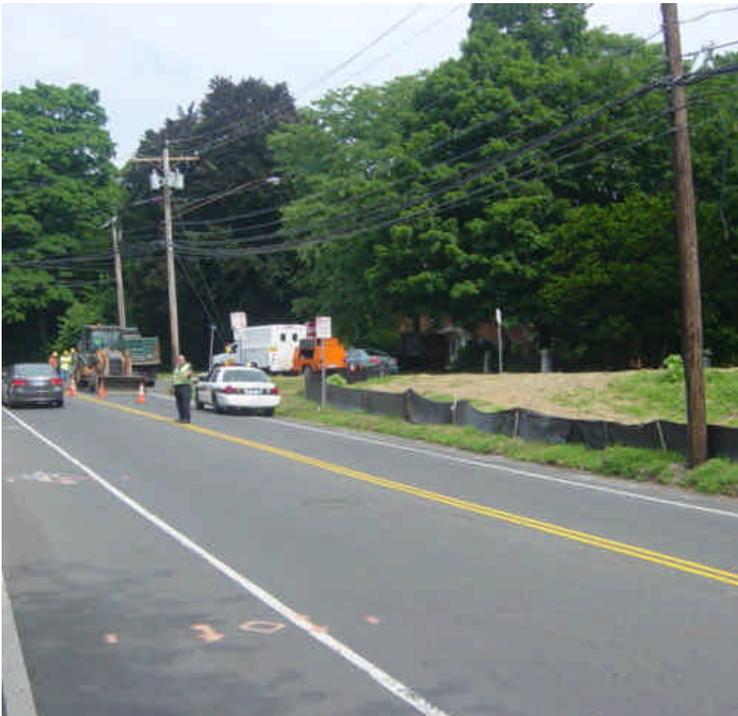
Trench work has begun near vault #5. The gully that had previously formed along the slope has since been backfilled and the silt fence was completely repaired.

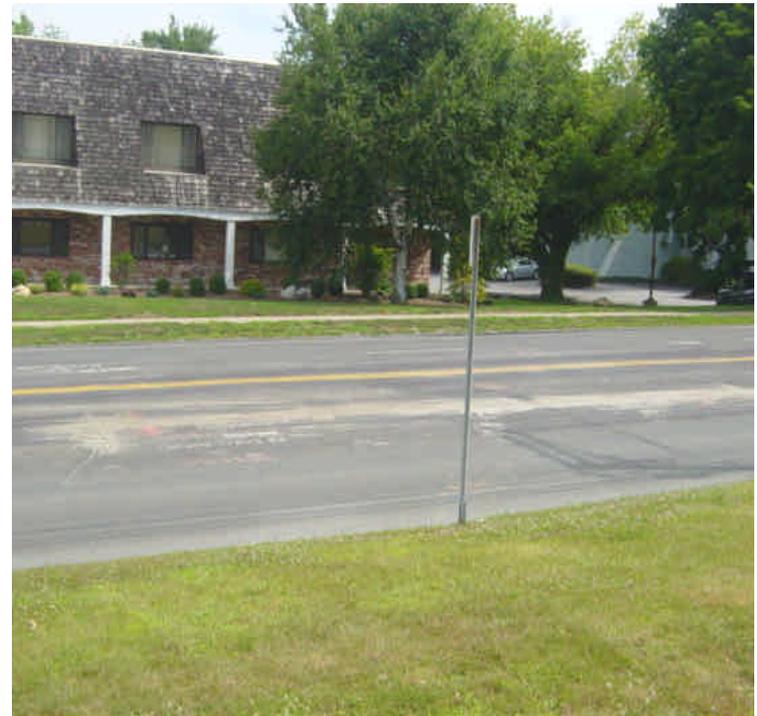
Saw cutting was recently performed near sta. #364+50 and some some of the dried slurry/dust remains along the roadway. Prevent slurry from entering catch basins and sensitive areas by quickly attending to it as it is generated.

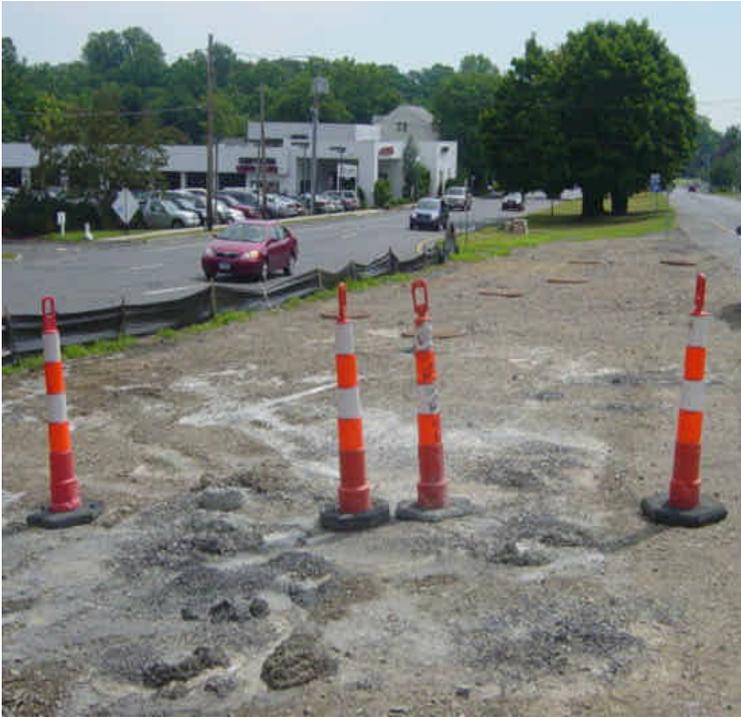
Concrete slurry appears to have been deposited near the backfilled area of vault 19. Concrete washouts should be performed in a contained area.

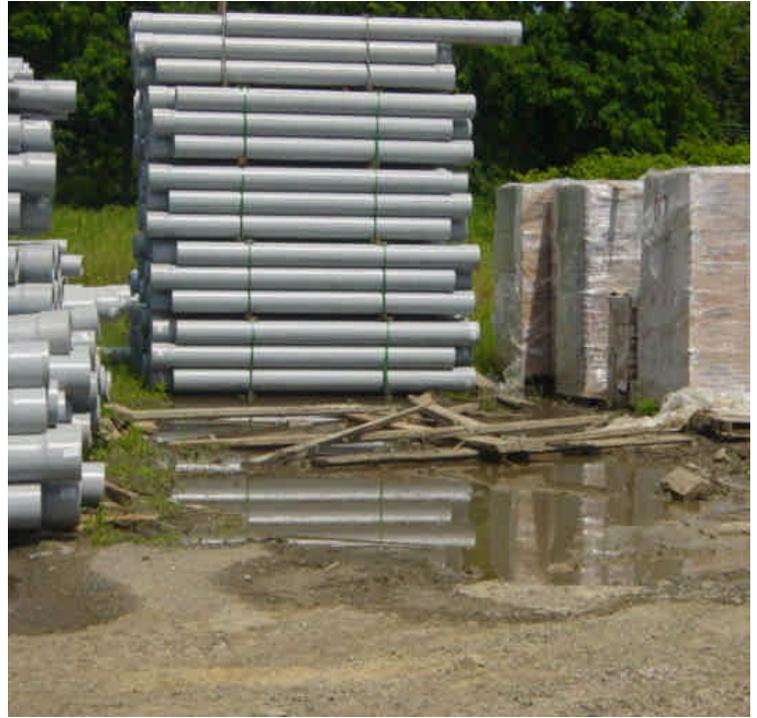
Concrete washout appears to have been deposited in several locations within the King Highway lay-down yard, near gravel and other material stockpiles. Concrete washouts remain in the yard but should be performed in a designated area to minimize unnecessary impacts.

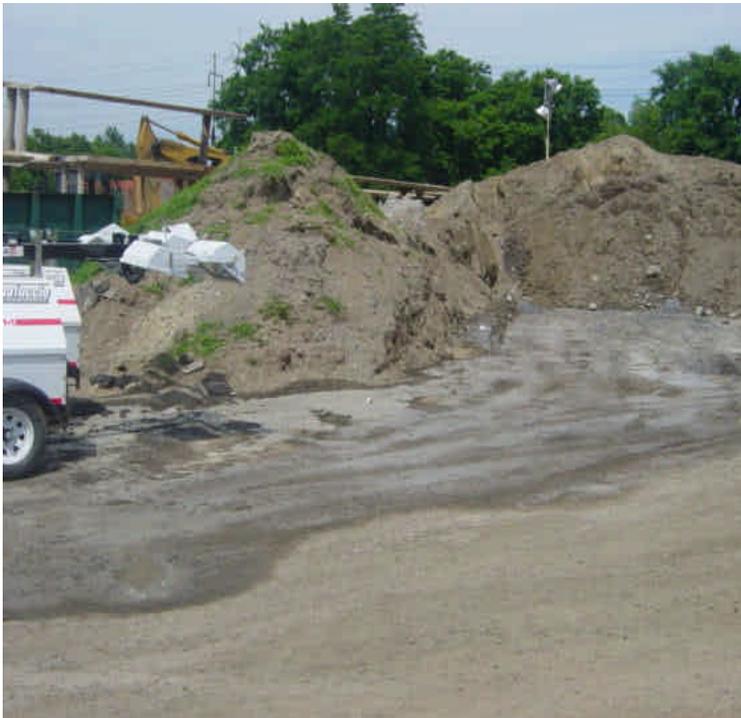
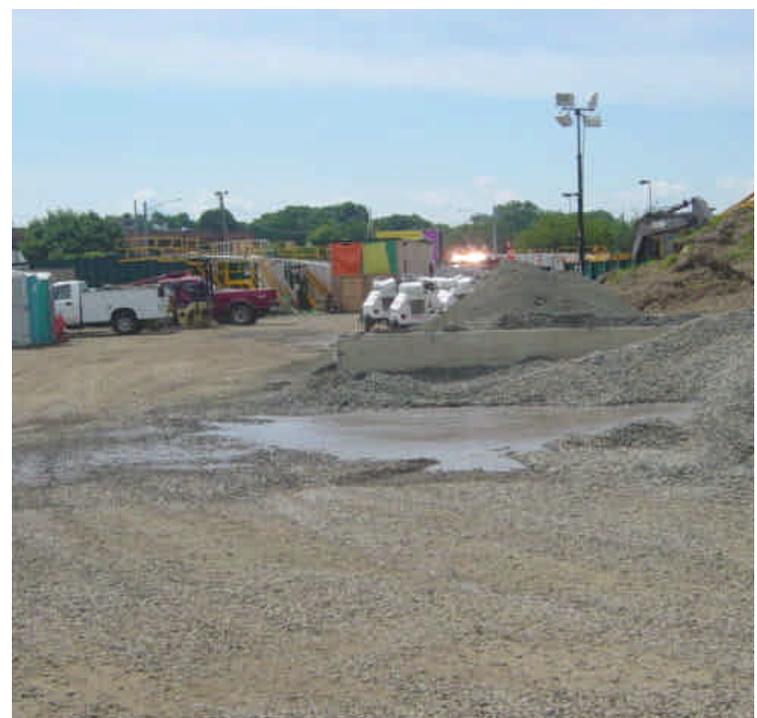
Both photos show the King's Highway lay-down yard where concrete washout appears to have been deposited in several locations, near gravel and other material stockpiles. Concrete washouts remain within the yard but should be performed in a contained/designated area to minimize unnecessary impacts. Concrete slurry should be removed and properly disposed of.
