Docket No. 272 – Development and Management Plan Inspection

Segment 4b Underground Line

Date: July 19, 2007 (evening inspection)

Location: Fairfield/Westport Town Line to Westport Avenue in Norwalk

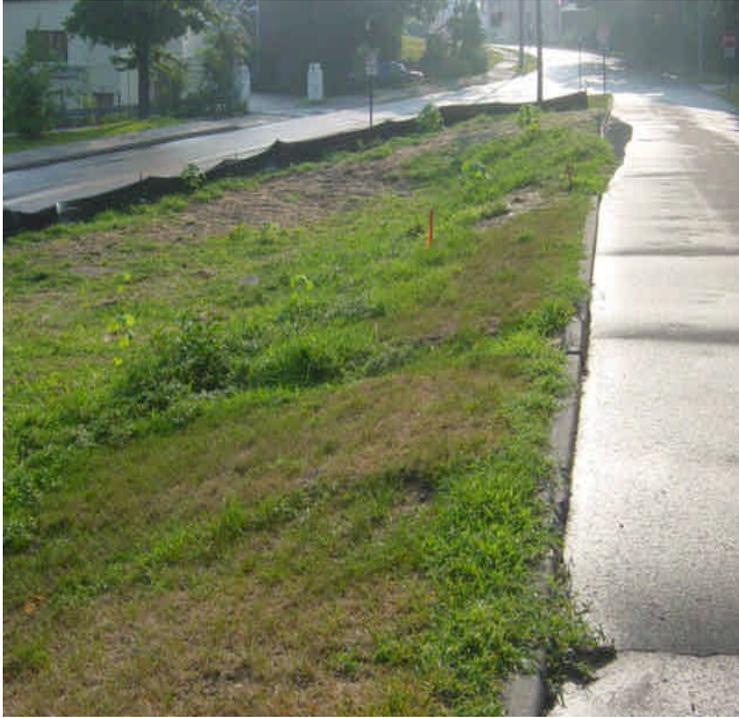
A bituminous concrete berm has been installed to divert stormwater run-off that was previously entering the vault #5 area.

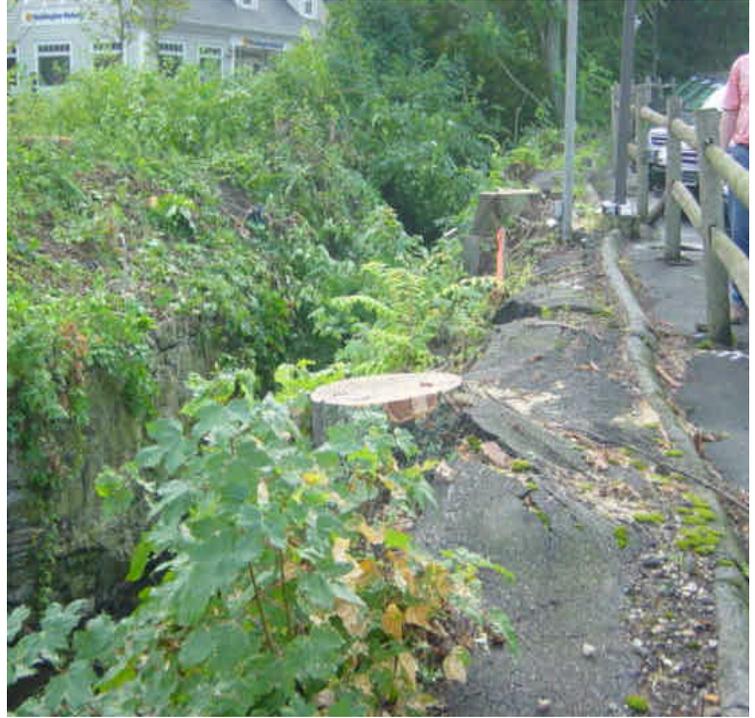
Large trees and shrubs were cut on either side of Stoney Brook in preparation for the stream crossing.

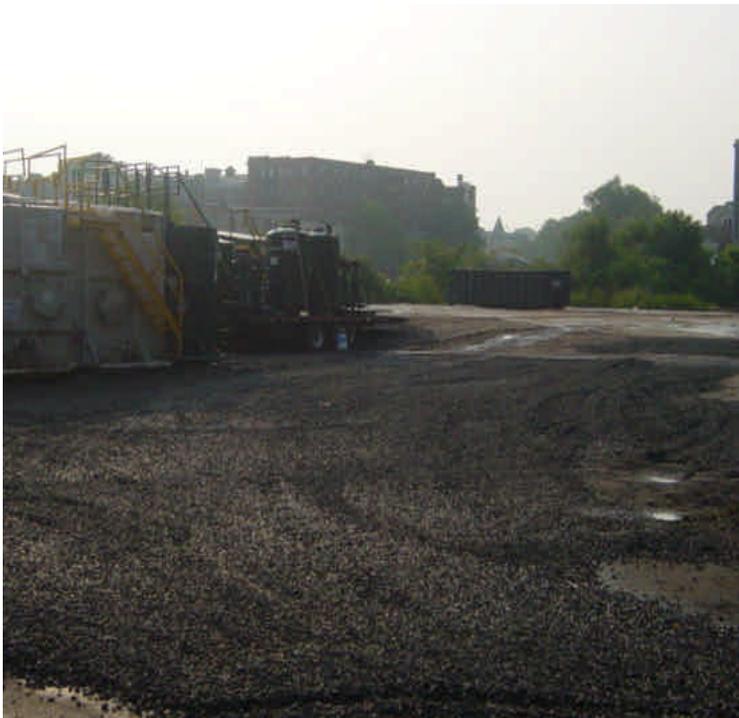
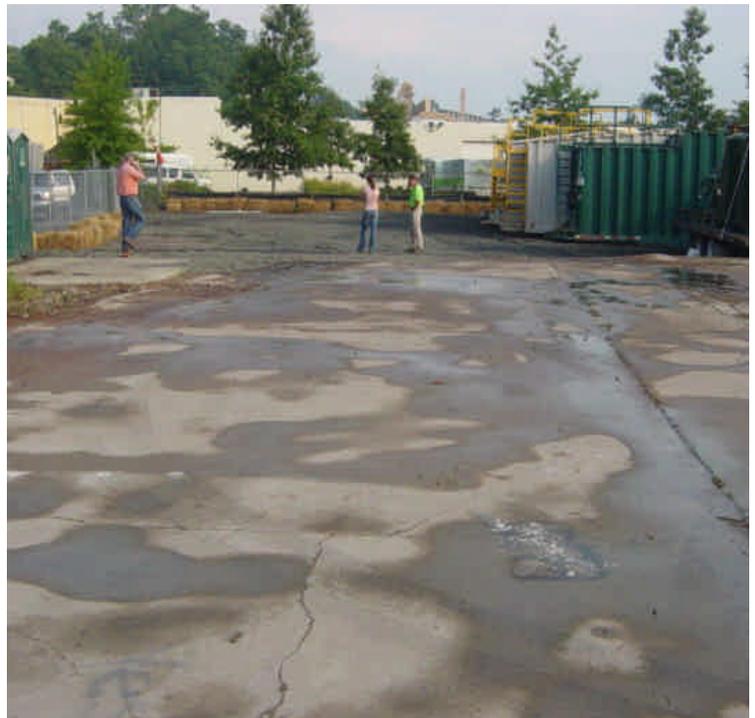
Both photos are of the Norwich lay-down yard at 6 Smith St. Contractors are currently setting-up the yard with perimeter fencing and erosion controls, stone surface, frac tanks, dumpsters and portable facilities. The Norwalk River is located immediately to the west of the yard.

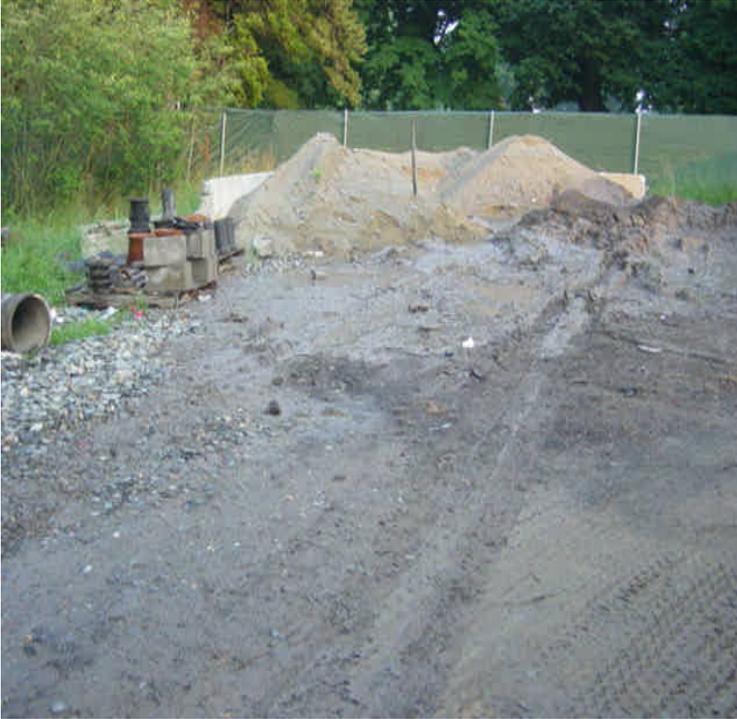
A slurry that appears to be from the sweeper was deposited in the back corner of the Sherwood Island lay-down yard. Monitor the area for sedimentation/migration and place controls if needed.

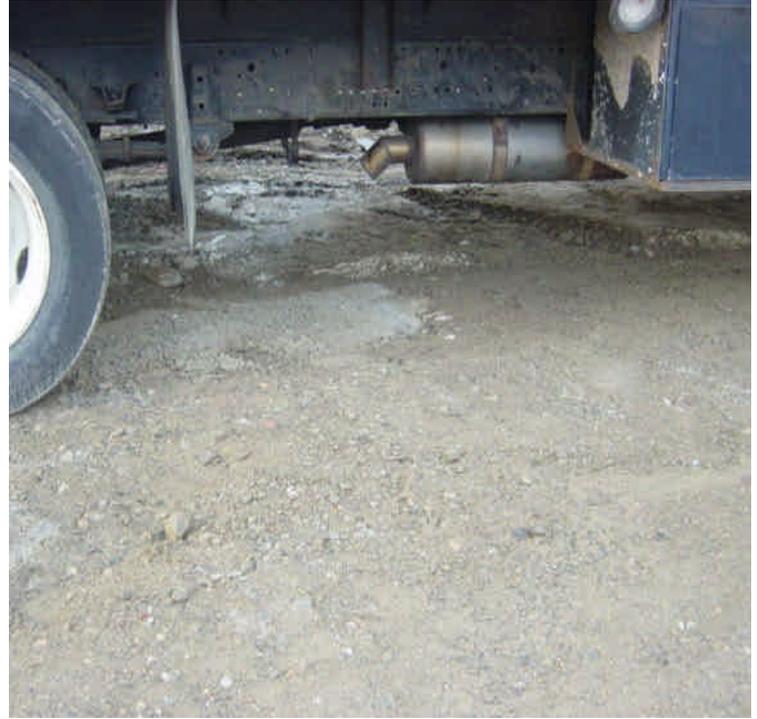
All but a small portion of concrete washout was removed near vault #19.

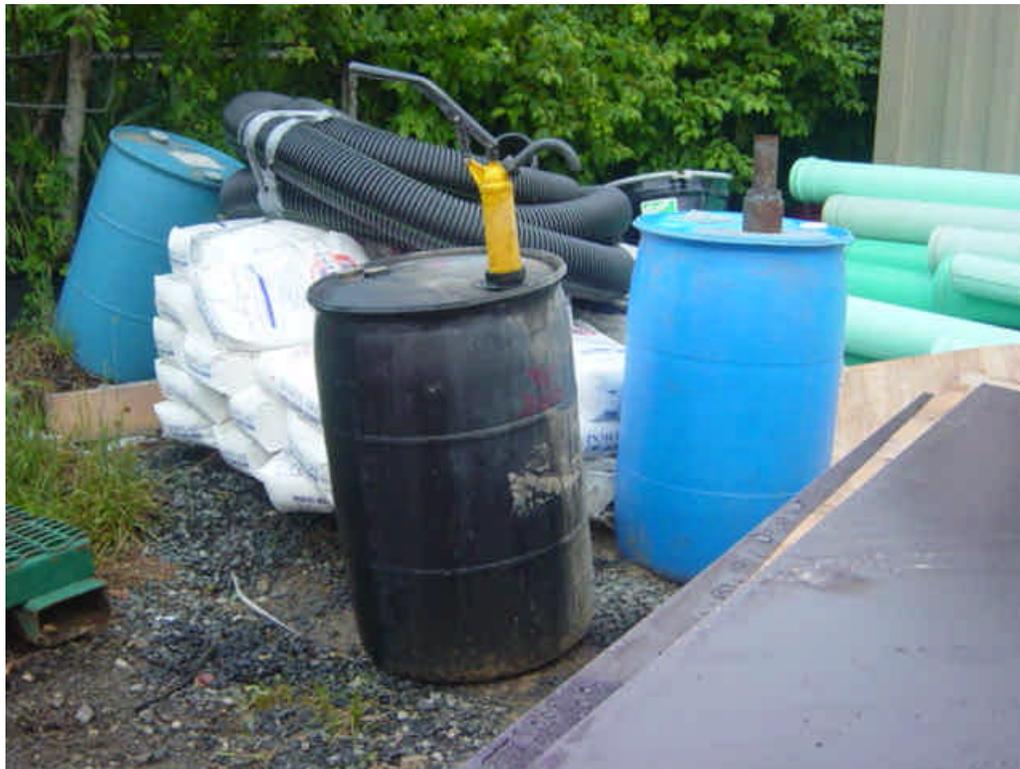
Bio-diesel fuel is being stored within the King's Highway lay-down yard, on the side of the yard immediately adjacent to the watercourse. Relocate and store the drum with the other well-contained fluid filled materials. Keep over 100 feet from sensitive areas whenever feasible.
