Docket No. 272 – Development and Management Plan Inspection

Segment 4b Underground Line

Date: July 25, 2007

Location: Fairfield/Westport Town Line to Westport Avenue in Norwalk

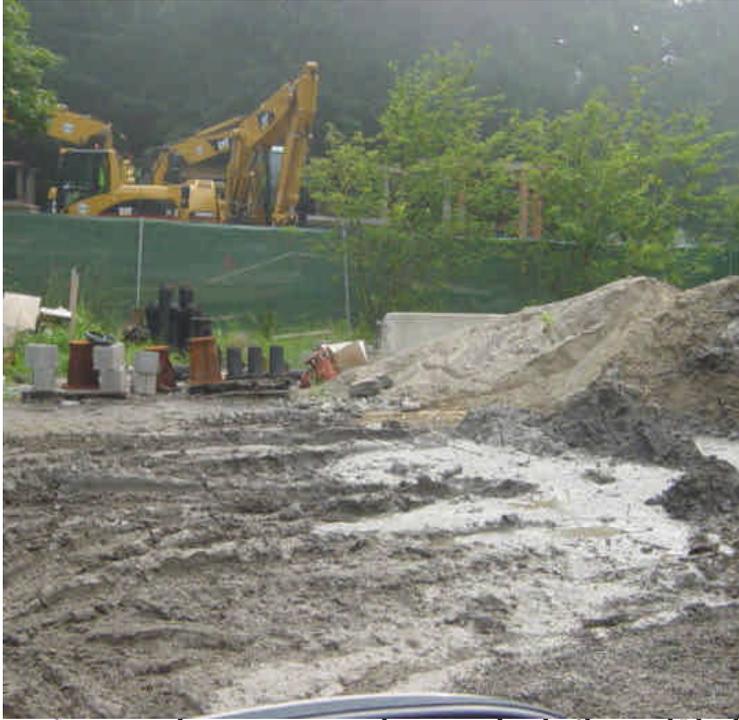
Sweeper washout remains in one location within the Sherwood Island lay-down yard. Monitor the area for sedimentation/migration and place controls if needed.

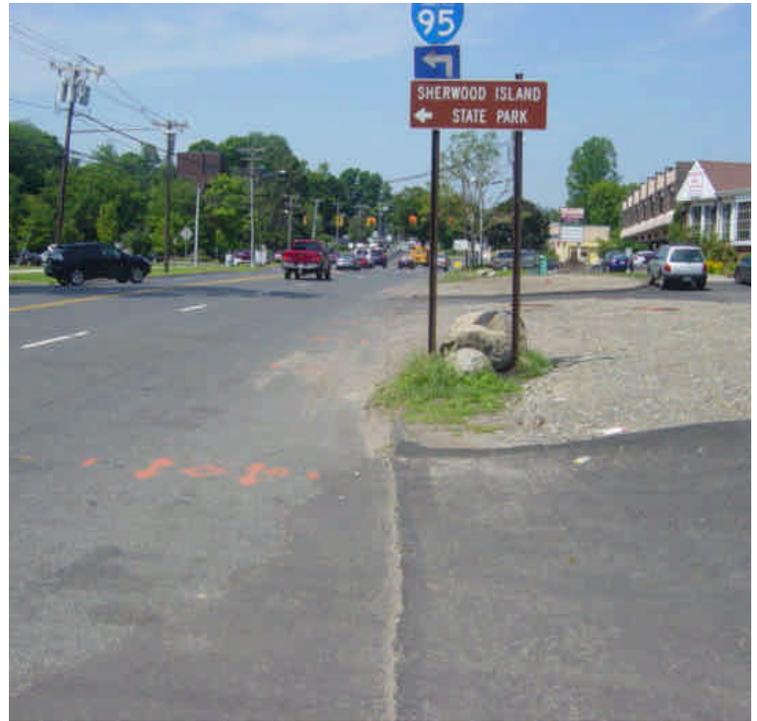
Slight sediment tracking/migration was noted into the roadway from the vault #20 location.

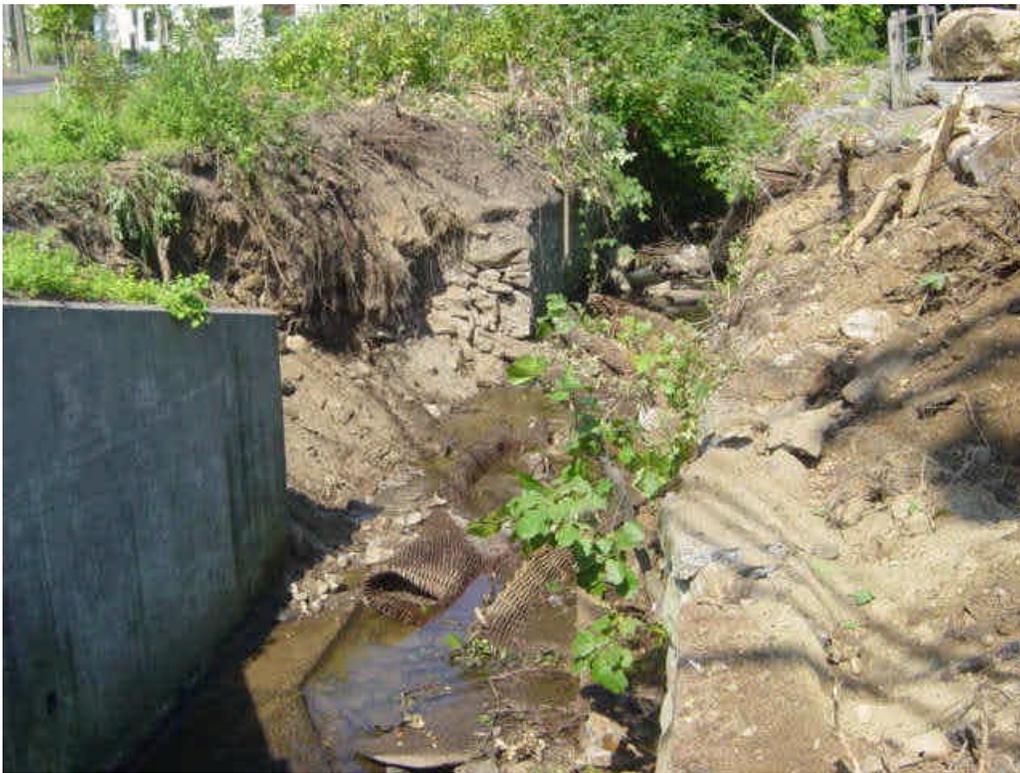
The area immediately adjacent to Stony Brook (sta. #217) was being grubbed in preparation for stream crossing activities. The grubbing included the removal of a portion of the stonewall that armored the banks. Soils were exposed and the stream was not diverted or protected from construction activities at the time of the inspection. 7/25/07	Cleared trees have been approved for removal in accordance with the D&M plan, however, the grubbing took place out of sequence. See the Erosion Control and Inland Wetlands sections for more details. 7/25/07	NA
Dewatering	Dewatering activities were not being conducted at the time of the inspection. 7/25/07	None. 7/25/07	NA
Blasting	No blasting has been proposed. 7/25/07	None 7/25/07	NA

The mature tree root system was grubbed and soil was disturbed before the flow at Stony Brook was diverted through the construction area. This was a deviation from the approved construction sequence in the D&M Plan. Minor soil and debris from construction activities were observed within the channel. Contractors were immediately informed and began to rectify the situation.
