Docket No. 272 – Development and Management Plan Inspection

Segment 1a Inspection

Date: June 18, 2007

Location: Segment 1a – Scovill Rock Switching Station to Chestnut Junction, Oxbow Junction to Beseck Switching Station (excluding Royal Oak Bypass), and Black Pond Junction to Beseck Switching Station

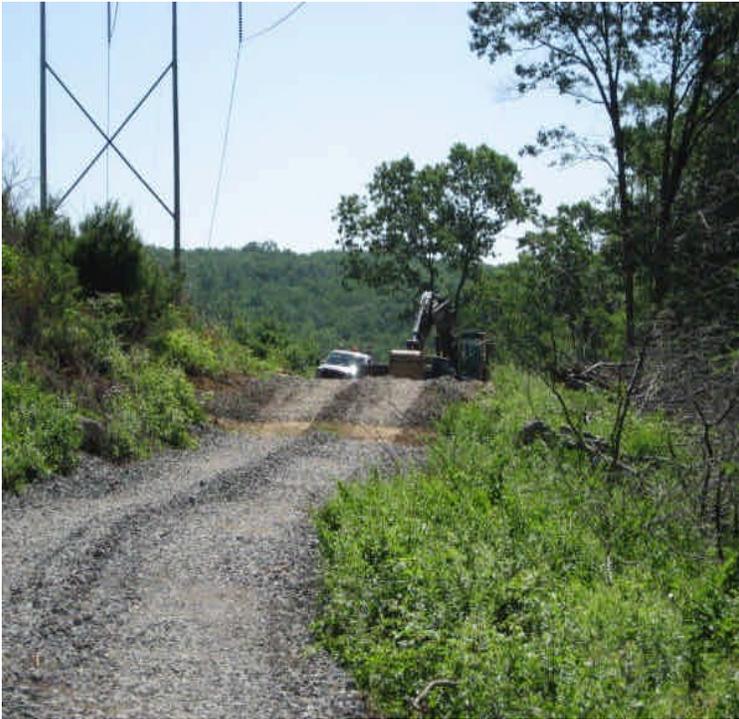
Access road installation was occurring west of Scovill SS off Rte 9.

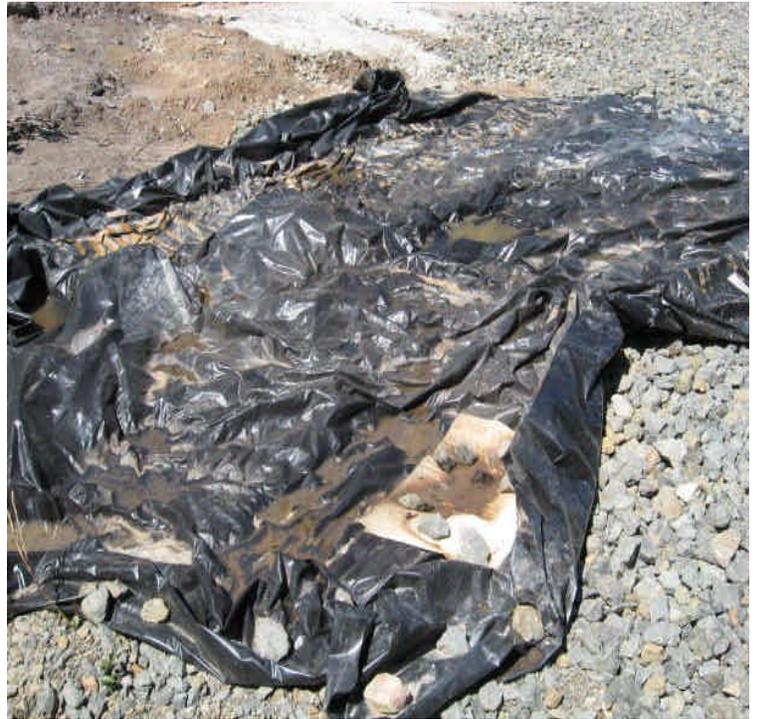
Spill containment controls remaining from a leaking drill rig off off Haddam Quarter Rd. The drill rig was removed from the area. Controls and any affected soil should also be removed.

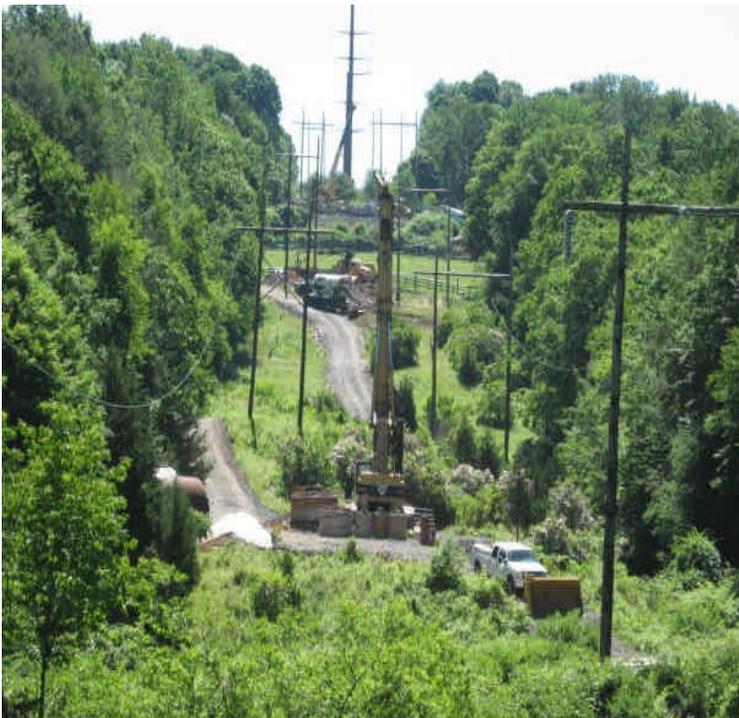
New foundation drilling was occurring off Johnson Lane.

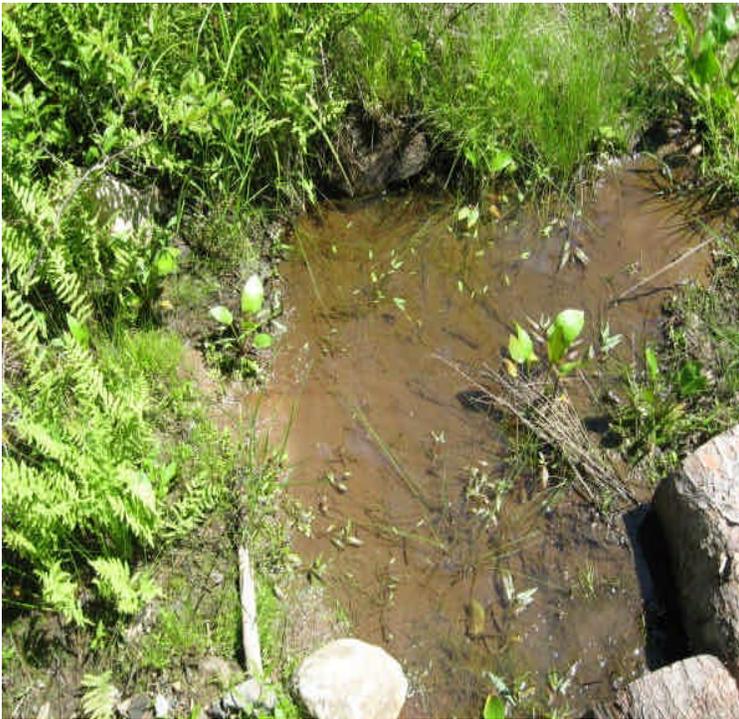
Ponded water adjacent to the timber mat crossing off Johnson Ln. Continue to prevent turbidity and sedimentation here to the extent possible as it provides good amphibian breeding habitat.

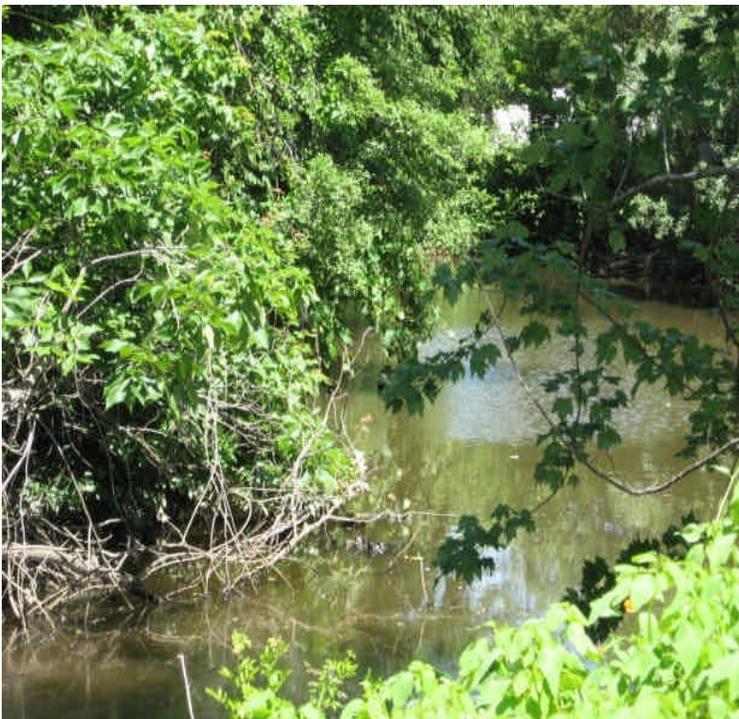
Suspended sediment in the pond adjacent to the contractor receiving yard has largely settled out.

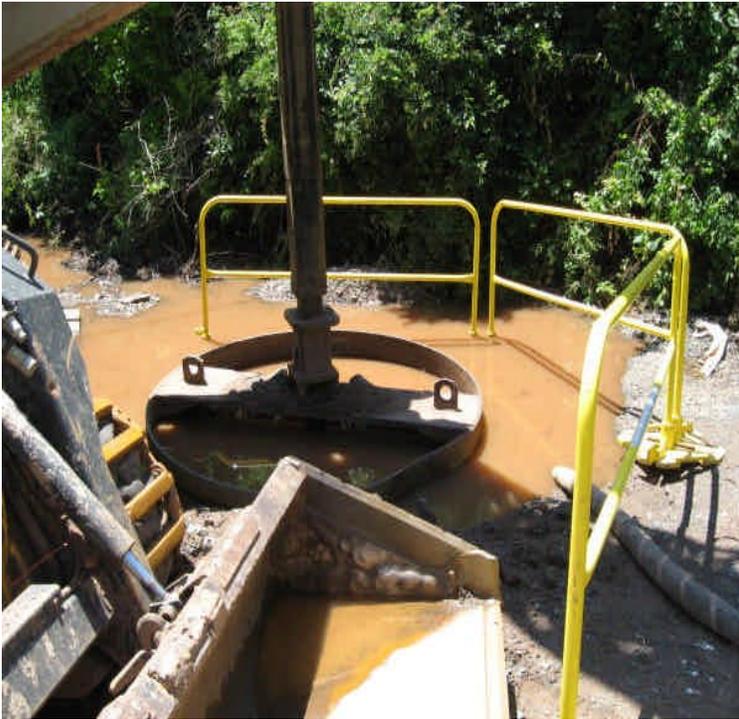
Drilling has stopped off Durham Road. Controls and dewatering containment are needed as turbid water was flowing off-site.

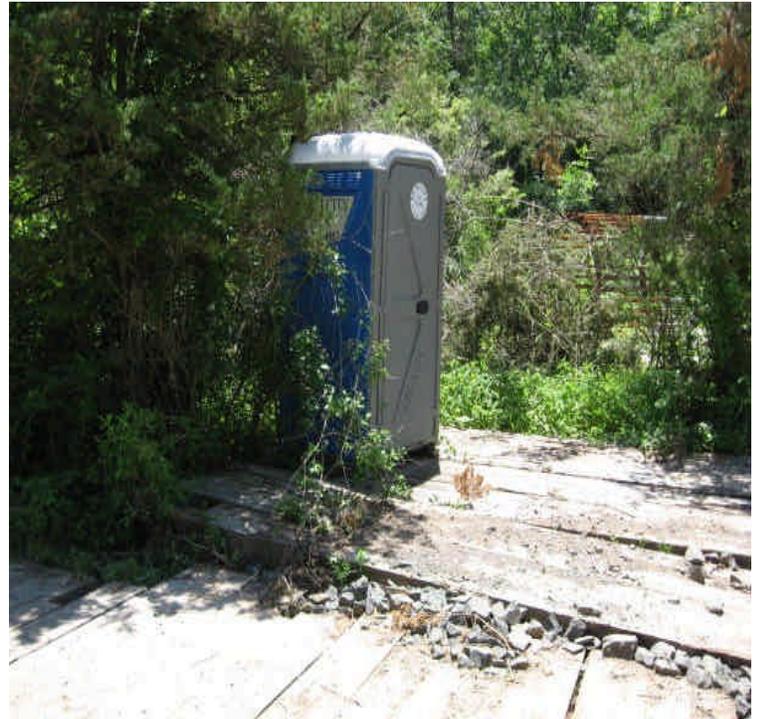
Portable sanitary facility located immediately adjacent to the wetlands off Durham Road. It should be relocated to an appropriate location in case of a tip or spill.

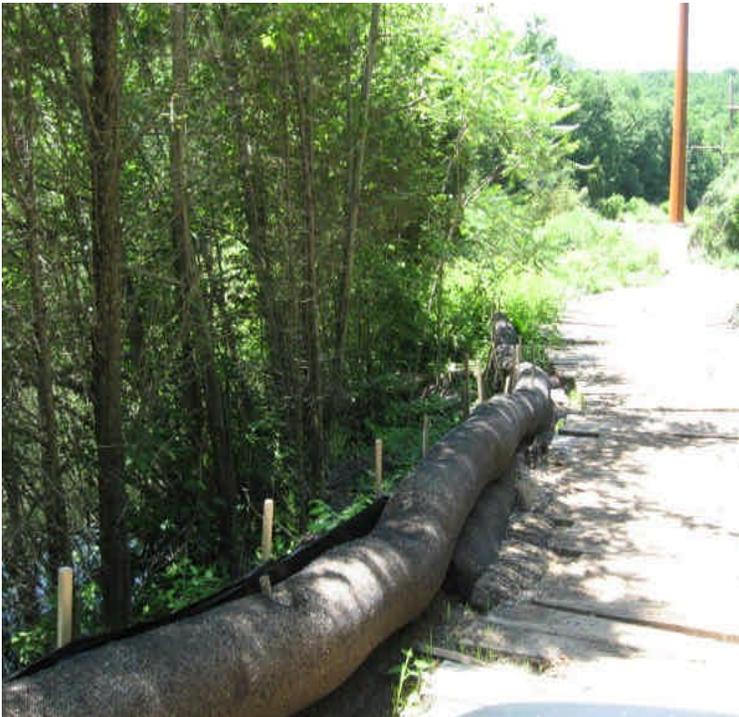
View of fiber rolls at the wetland crossing at the base of the slope off Powder Hill Rd.

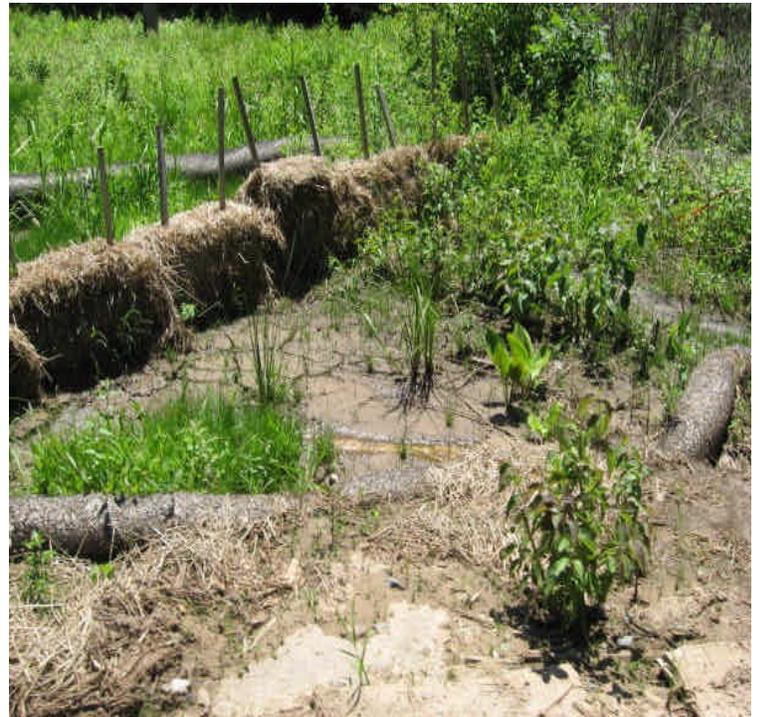
Sediment accumulation from previous heavy rains could be seen in wetlands west of Powder Hill Rd. now that standing water receded. Where accumulated sediment is more than 2" deep, it should be carefully removed from wetlands by hand.

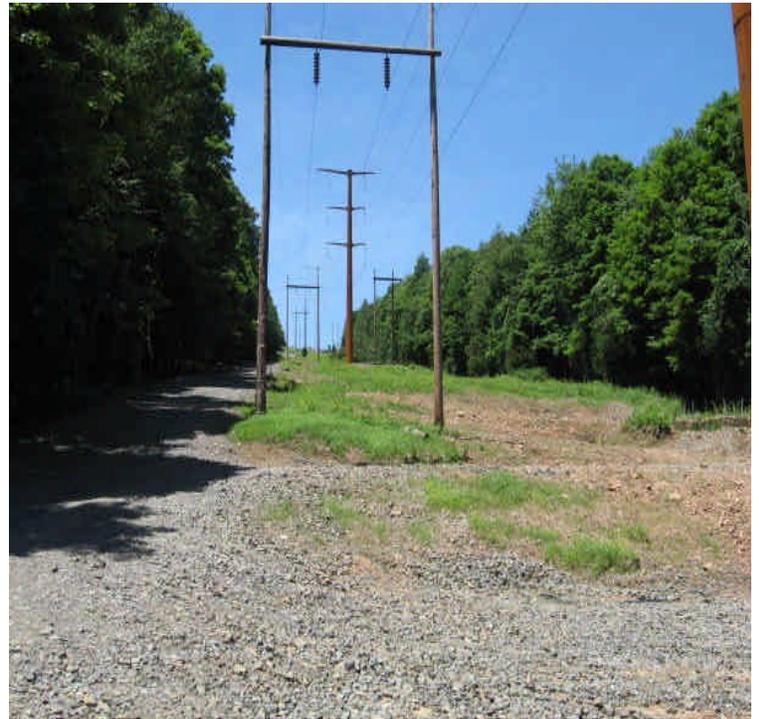
Grass growth was noted along the slope of Beseck Mt. Continue to provide restoration in exposed soil areas.

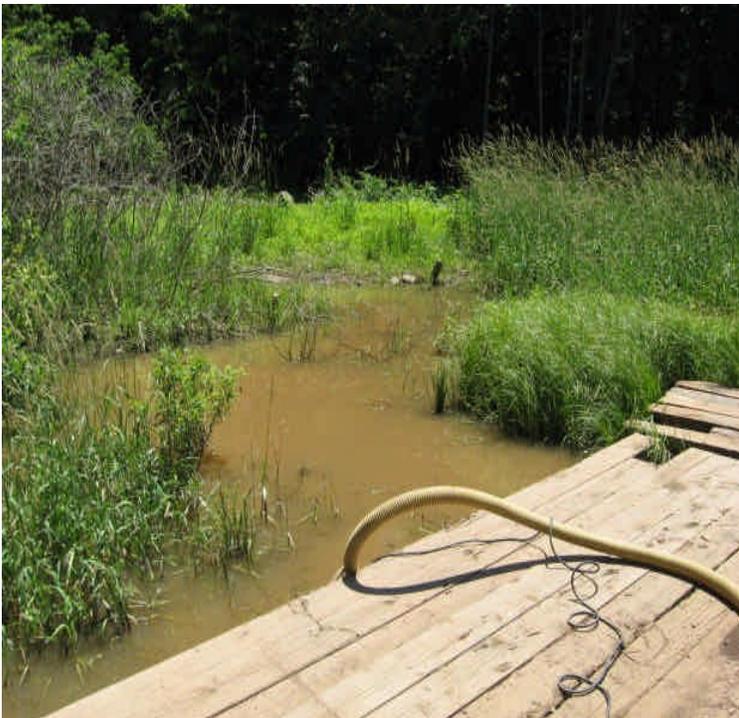
Turbid water present within the wetlands east of Beseck SS. A hose was noted the wetlands but activity was unclear. The source of turbidity needs to be identified and controlled.

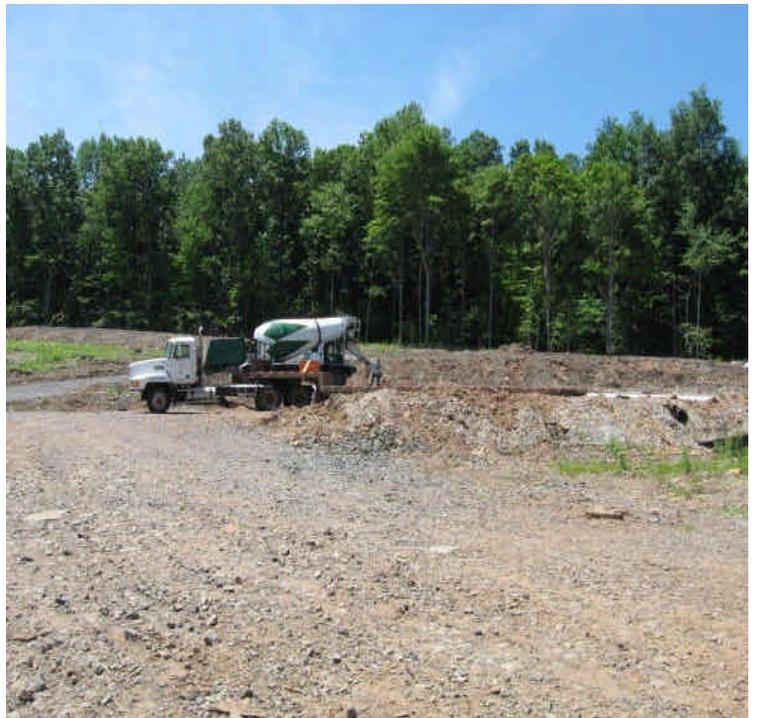
Foundation installation noted north of Beseck SS.

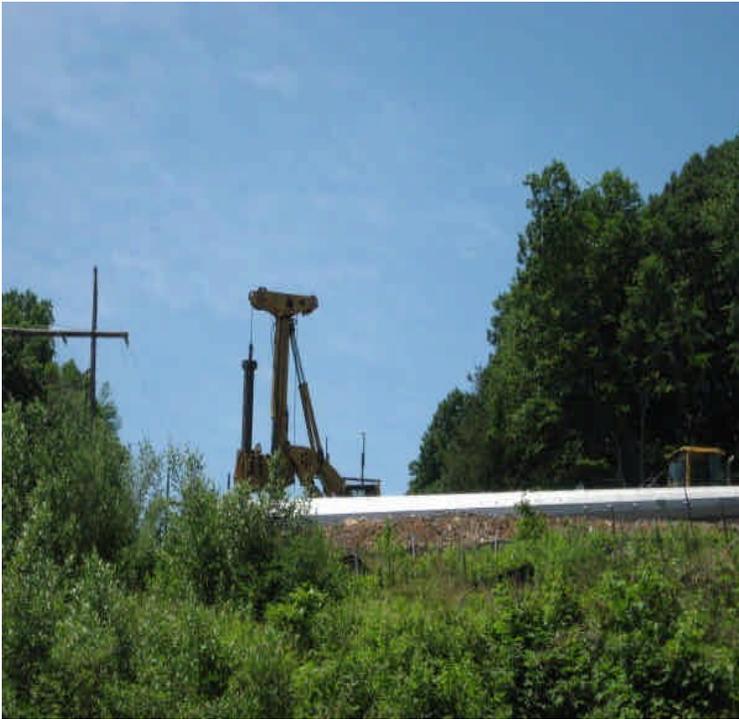
View of foundation drilling north of Beseck SS.

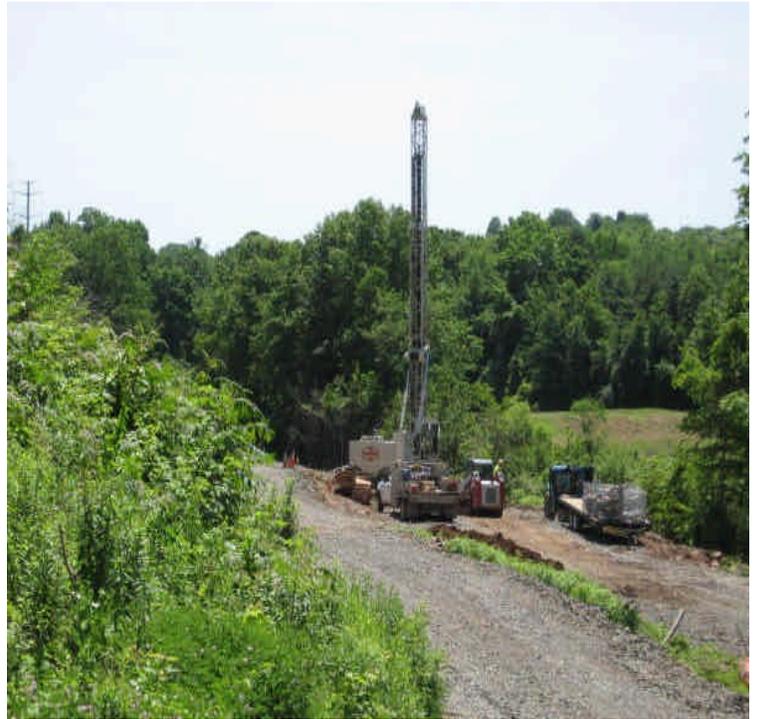
Foundation drilled north of East Meriden SS. Additional controls may be needed as work is immediately adjacent to a pond/wetland.

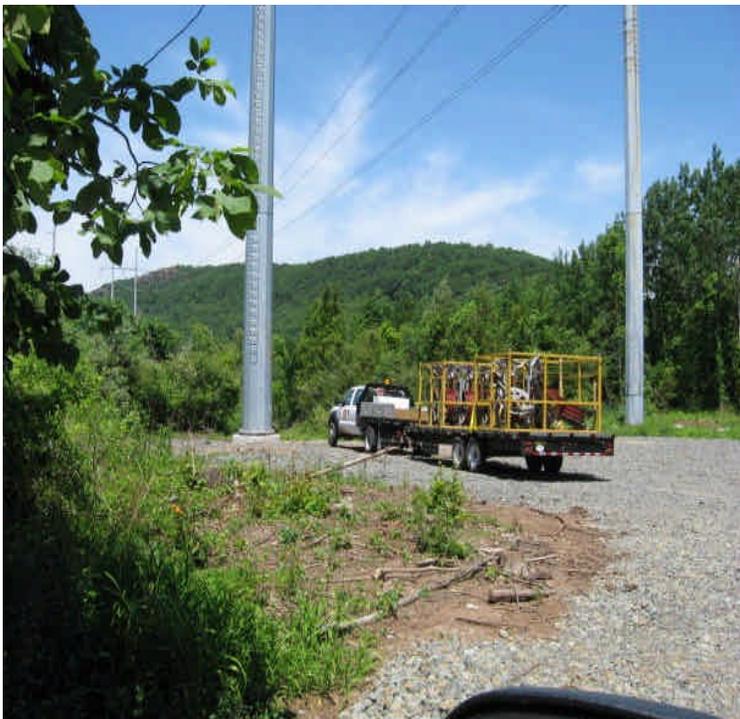
Line pulleys being installed south of East Main St.

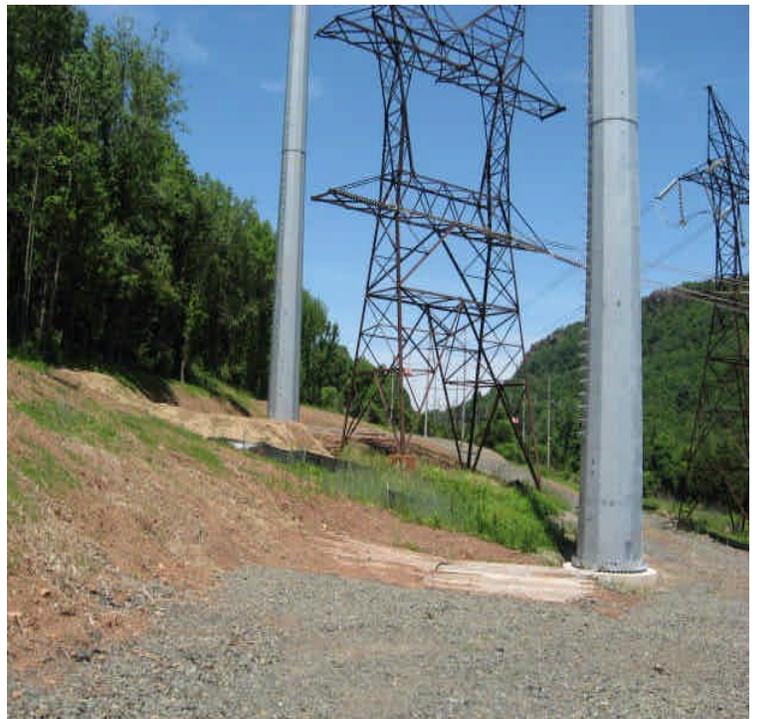
Two new structures installed at Black Pond Junction.
