Docket No. 272 – Development and Management Plan Inspection

Segment 1a Inspection

Date: June 25, 2007

Location: Segment 1a – Scovill Rock Switching Station to Chestnut Junction, Oxbow Junction to Beseck Switching Station (excluding Royal Oak Bypass), and Black Pond Junction to Beseck Switching Station

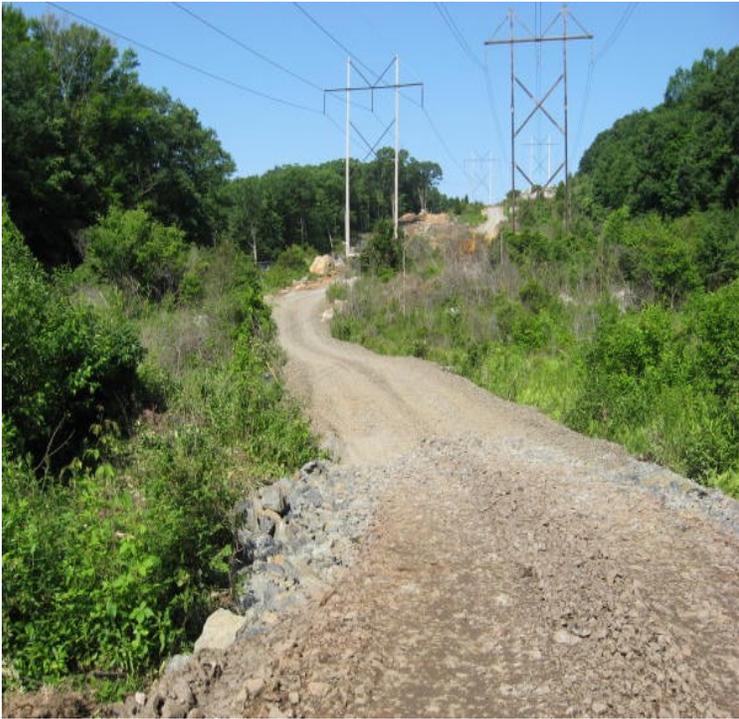
Access road installation/upgrade west of Scovill SS off Rte 9.

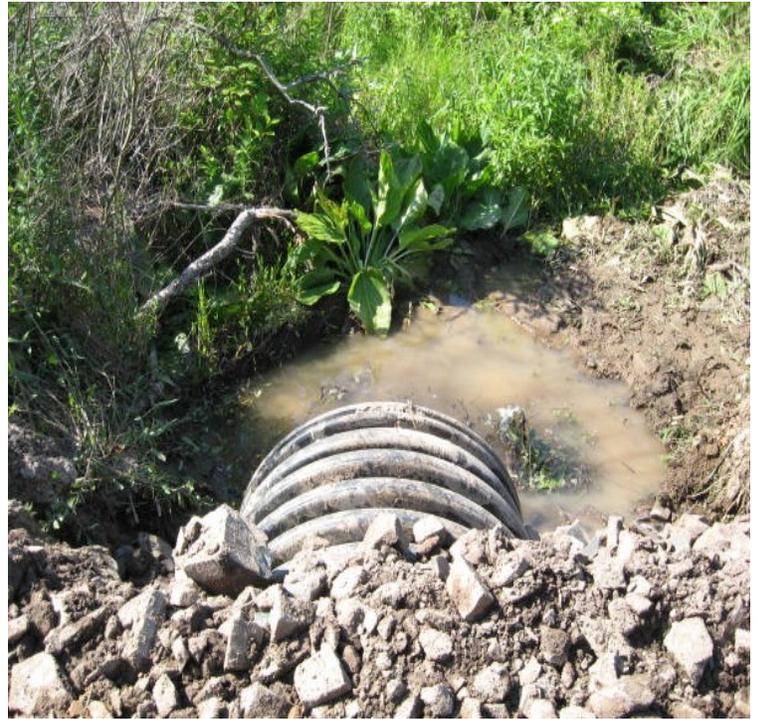
New culvert installed west of Scovill SS off Rte 9. Turbid water was noted from culvert installation. Controls should be installed along the road upgradient of the flow.

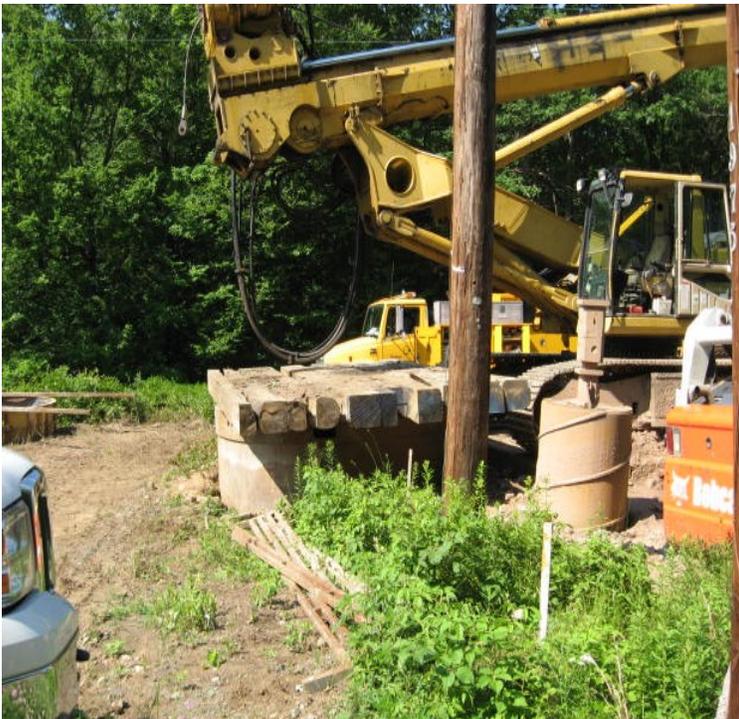
New foundation drilling continues off Johnson Ln.

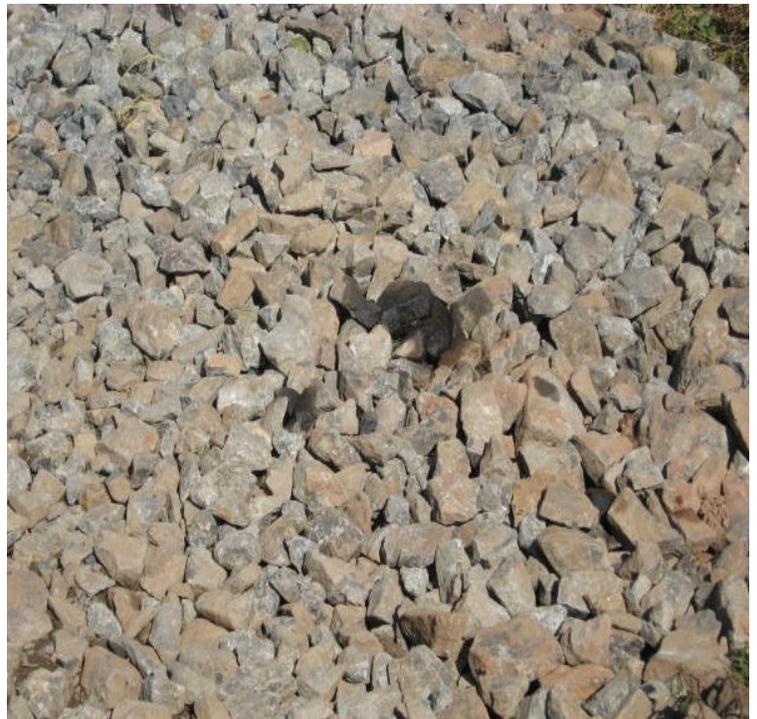
Small drip stain noted from equipment working off Johnson Ln.

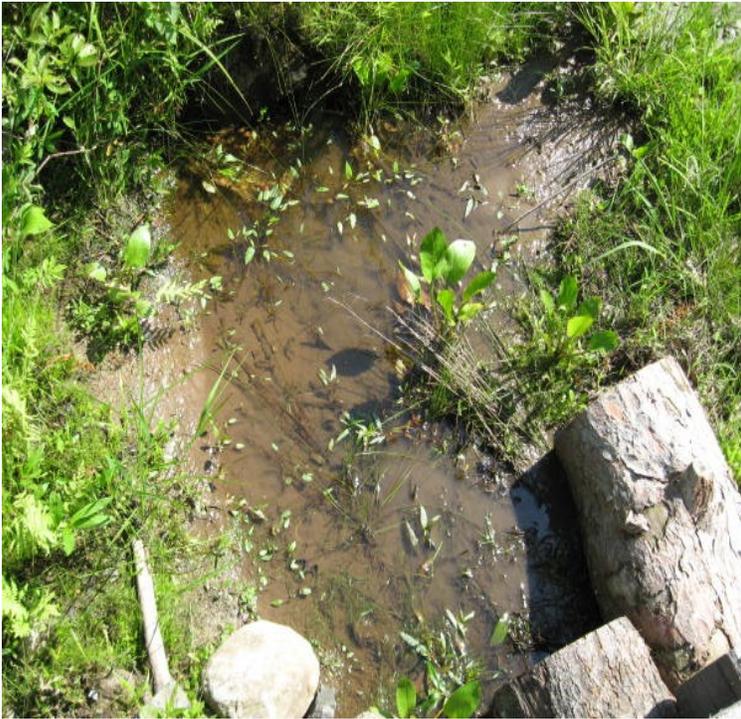
Ponded water adjacent to the timber mat crossing off Johnson Ln. Continue to prevent turbidity and sedimentation here to the extent possible as it provides good amphibian breeding habitat.

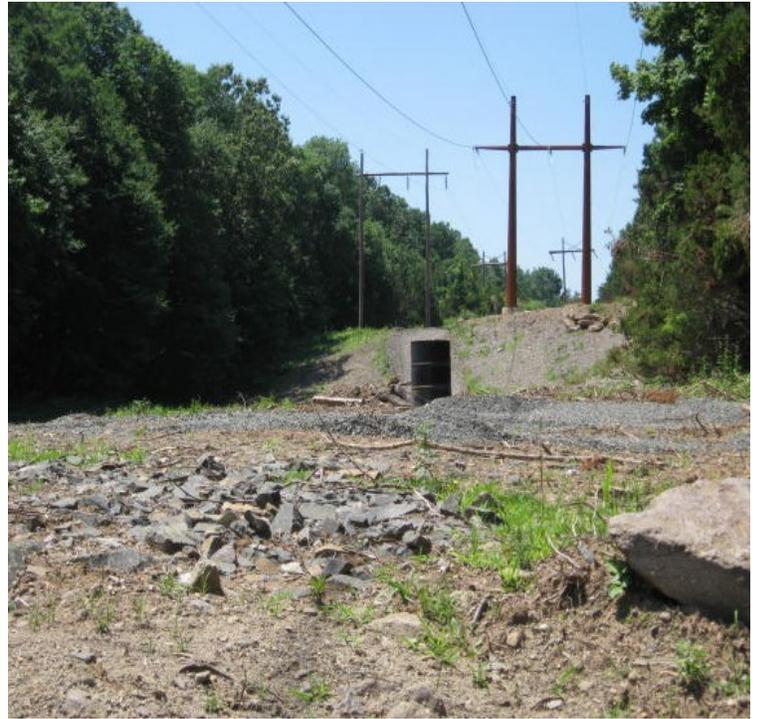
The 55-gallon drum was moved from the 1B bypass to the 1A ROW off Black Walnut Drive. Clarify the origins of this barrel and dispose of as necessary.

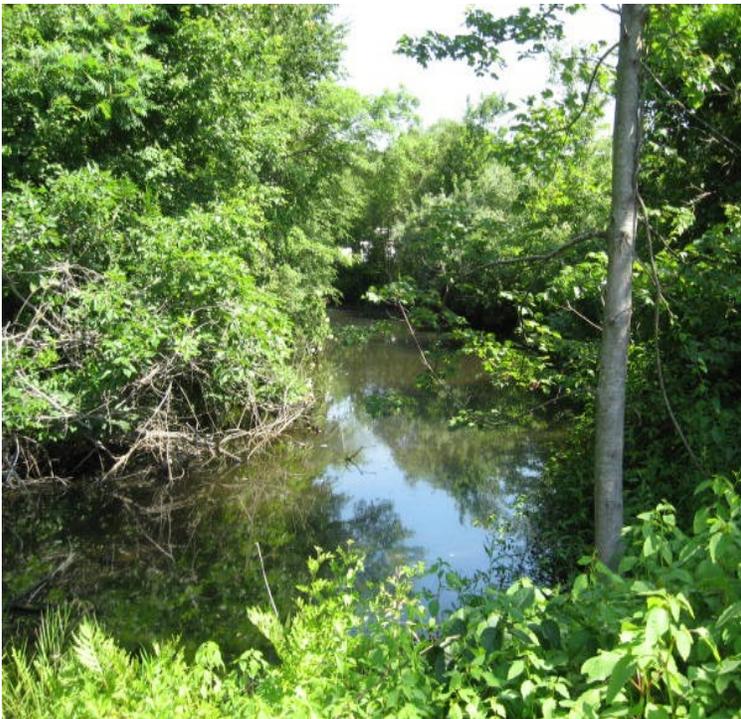
Suspended sediment in the pond adjacent to the contractor receiving yard has largely settled out.

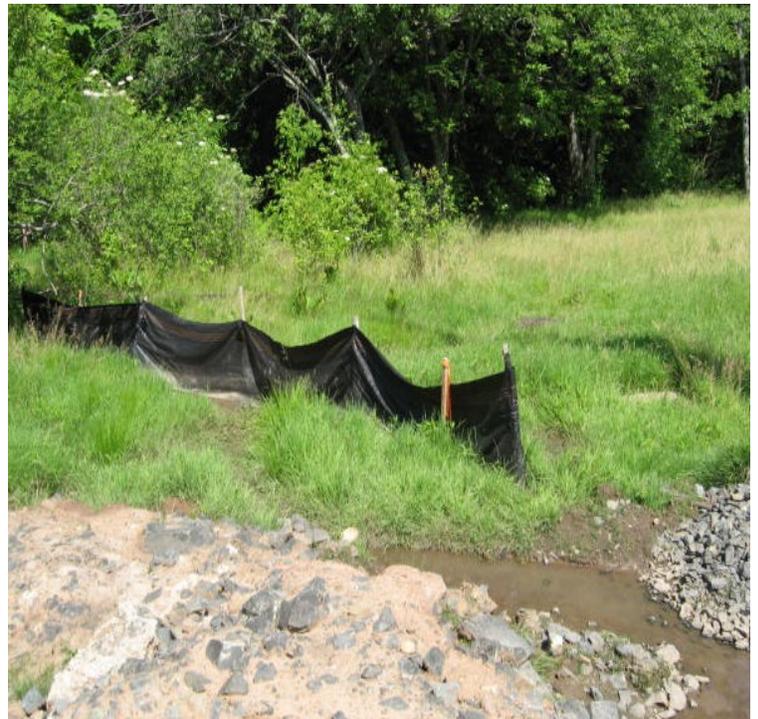
View of controls near the wetland crossing at Little Lane. Run-off was filtered by silt fence before flowing off-site

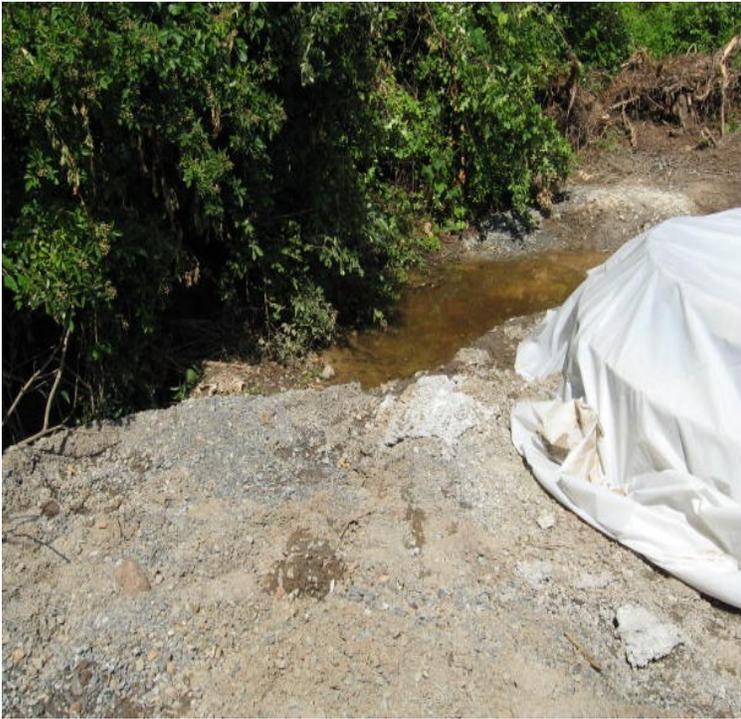
Foundation was poured off Durham Road. Water had receded but controls still appear to be necessary downgradient from the work.

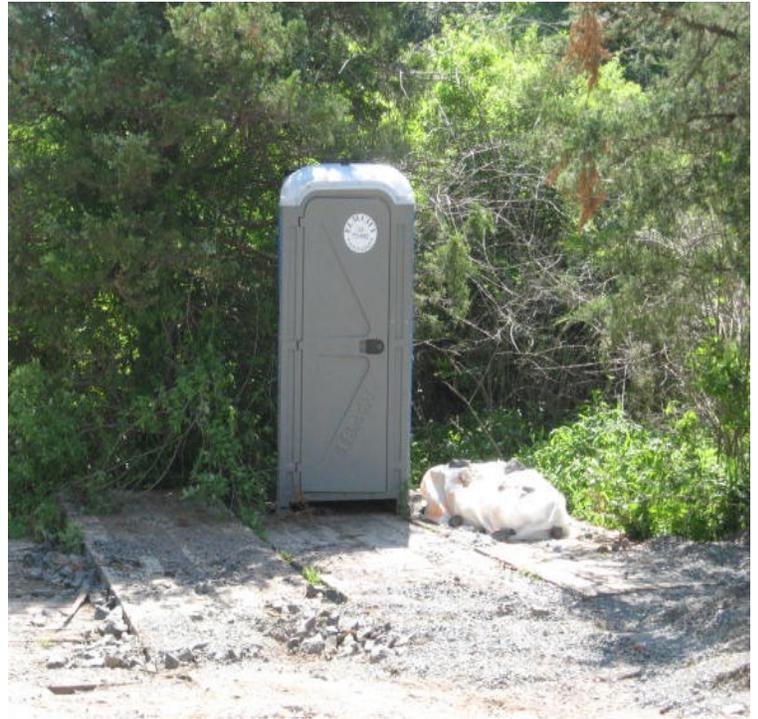
Portable sanitary facility located immediately adjacent to the wetlands off Durham Road. It should be relocated to an appropriate location in case of a tip or spill.

Durham Rd.	Portable sanitary facility has been located at the edge of the wetlands. 6/11-6/25/07	Remove sanitary facility from wetland edge and attempt to keep 100 ft away in case of a tip or spill. 6/11- 6/25/07	Needs attention
Black Pond Junction to Beseck SS	Some equipment and supplies are being stored here. A large spill kit is stored onsite. 6/25/07	Always store equipment and supplies away from sensitive areas. Monitor and maintain equipment as needed and provide housekeeping on a regular basis. 6/25/07	NA at this time
Additional Observations	The growing season is here and contractors should continue seeding disturbed areas for temporary stabilization as soon as possible. 6/25/07	Seed areas where work is complete or will be left unworked for longer than 1 month. 6/25/07	Continue seeding disturbed areas.

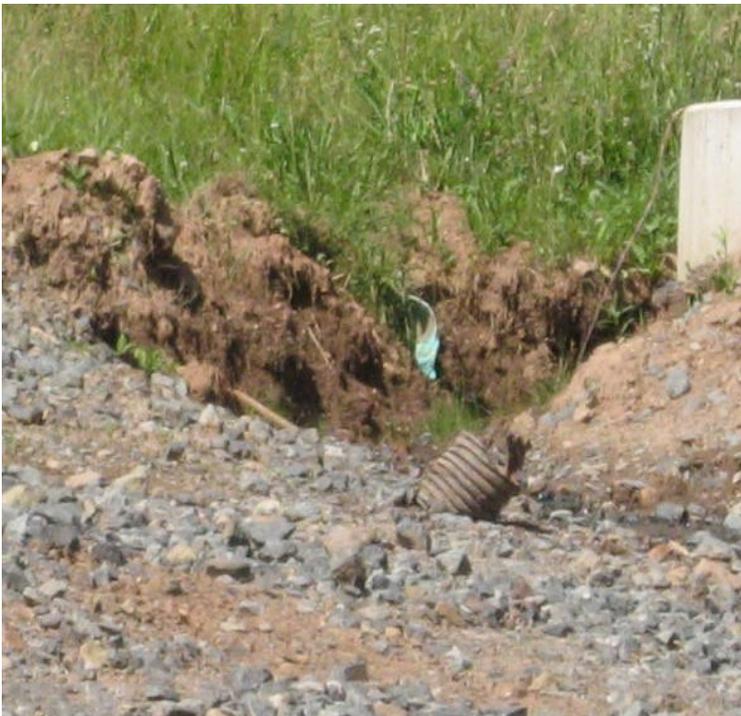
Broken drainpipe off Elihu Drive. Water flows over the disturbed soil area, and into a CB on the roadway.

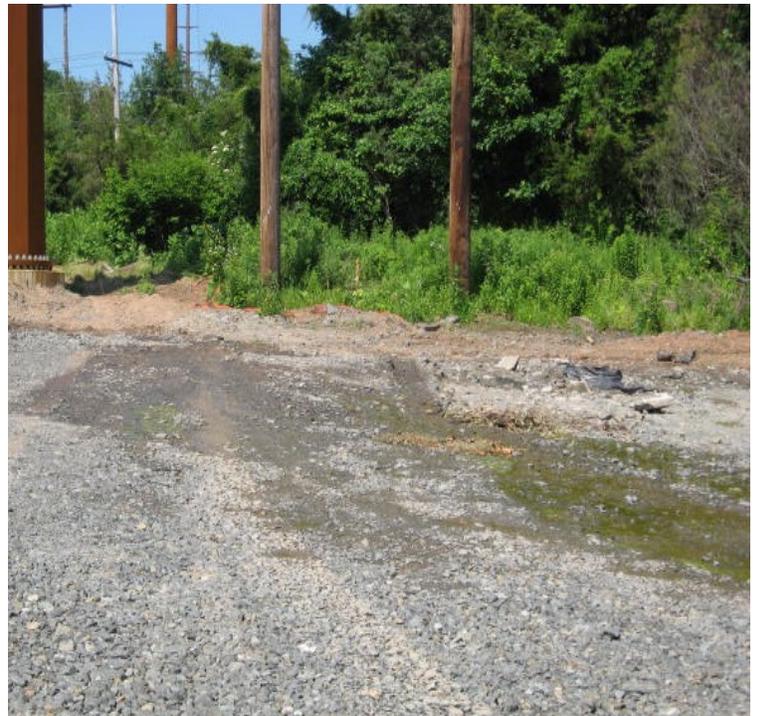
Water flowing across the site at Elihu Drive, picking up sediment, instead of under the crossing through the drainpipe. Repair the pipe if it is project jurisdictional, or add necessary controls.

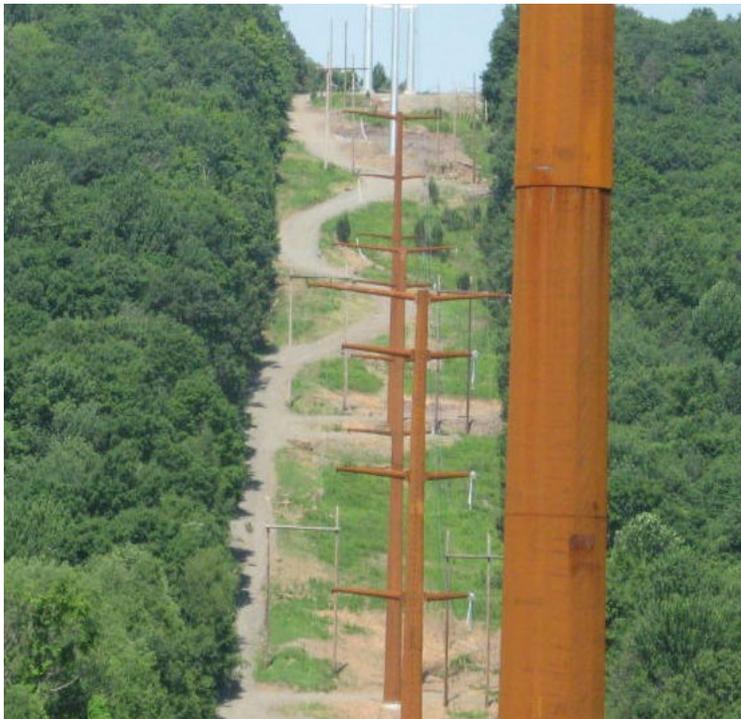
Grass growth observed along the slope at Beseck Mt.

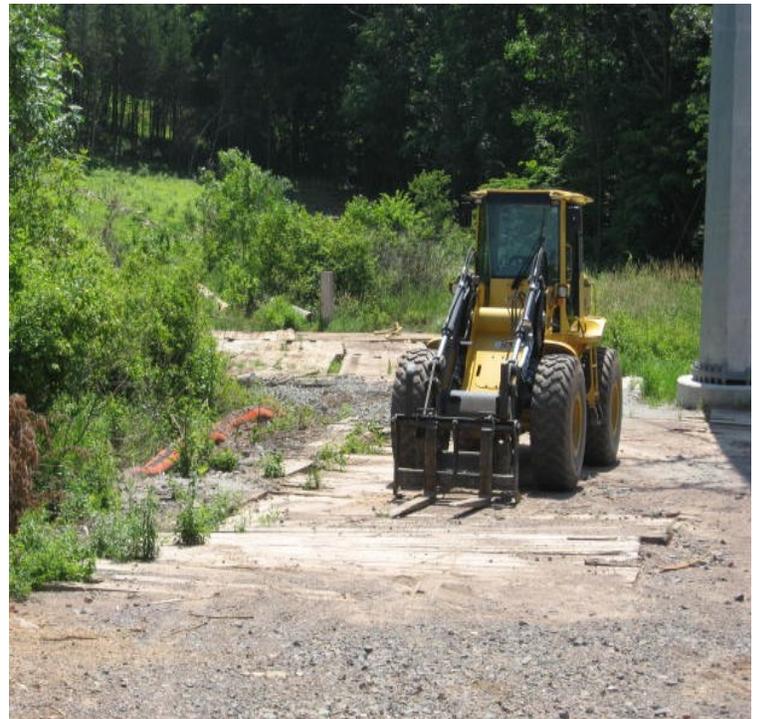
Equipment stored on mats in wetlands east of Beseck SS. Sediment/stone remains at and beyond the old filter sock controls and should be removed.

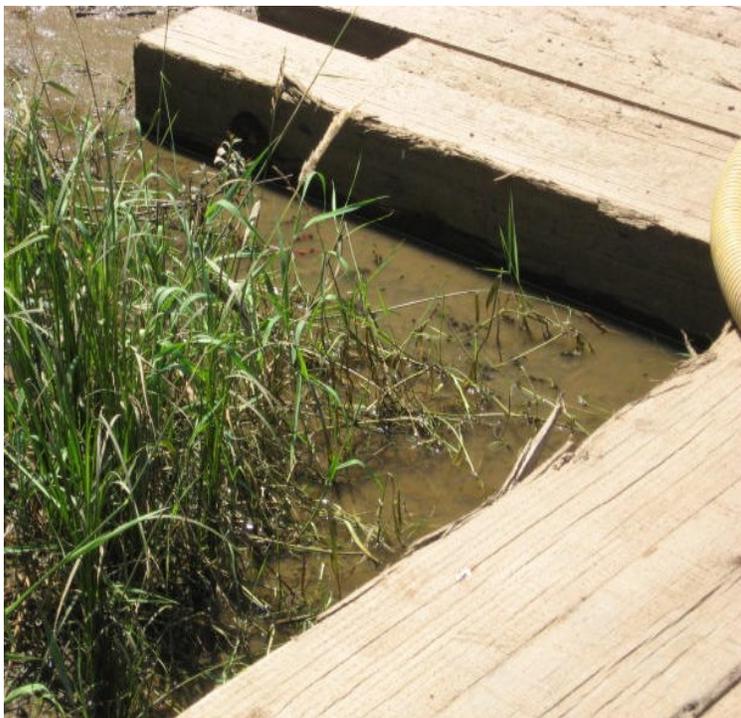
Standing water has receded significantly in wetlands east of Beseck SS. Tadpoles/amphibian breeding was noted here. Limit pumping from wetlands.

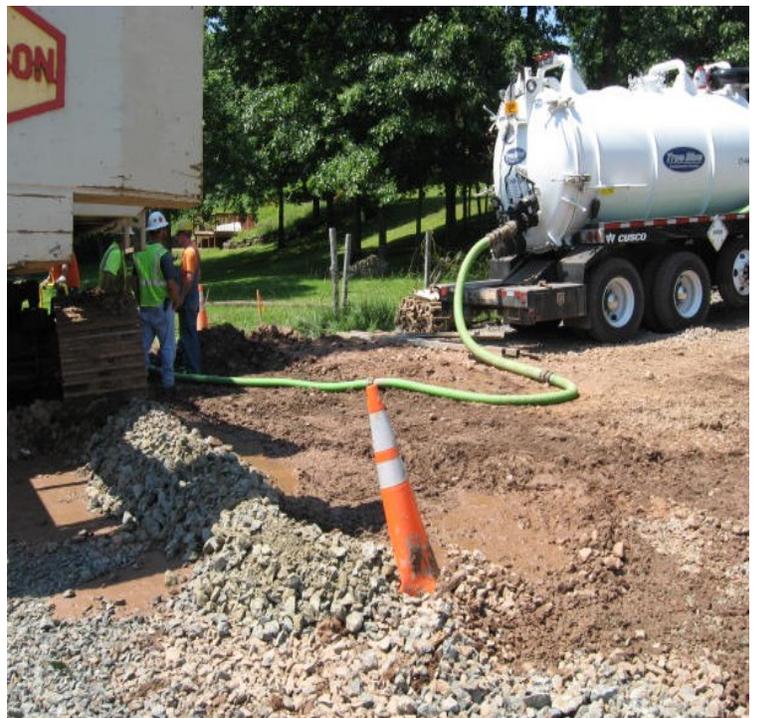
Foundation installation off Fleming Road. Pump truck being used to dewater the excavation. Controls in place along the pond.

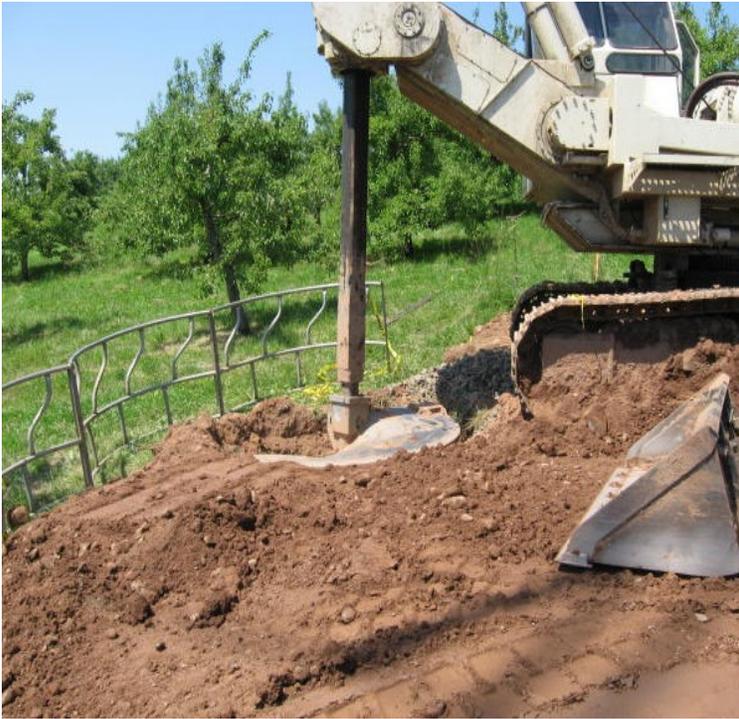
Foundation drilling occurring north of Fleming Road within the orchard.

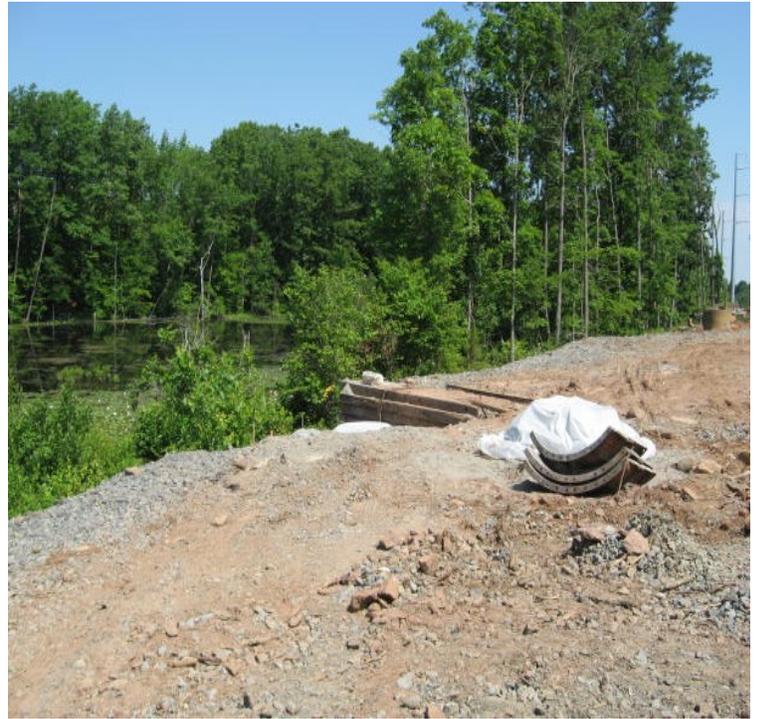
Foundations installed west of East Meriden SS. Ensure that controls are adequate to contain run-off to the adjacent pond.

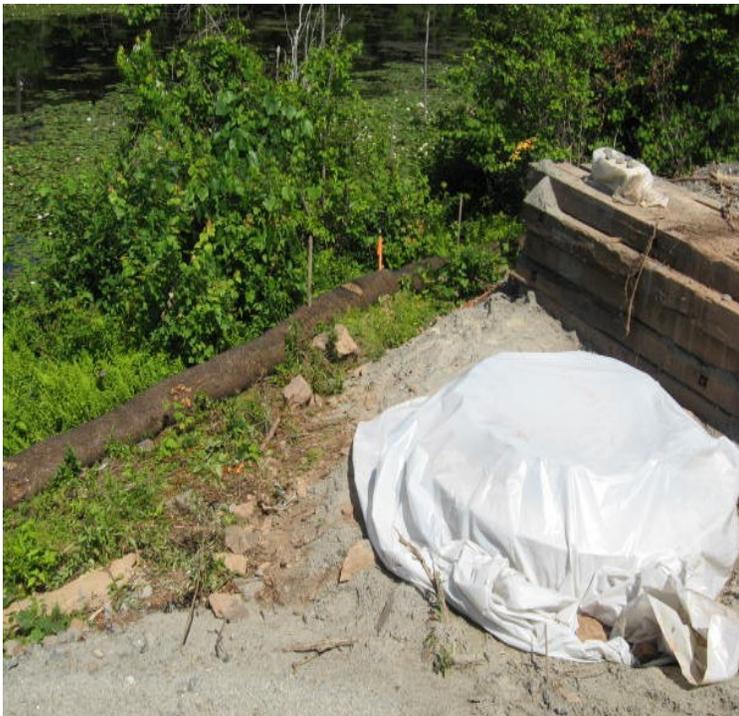
View of new foundation adjacent to the pond west of E. Meriden SS.

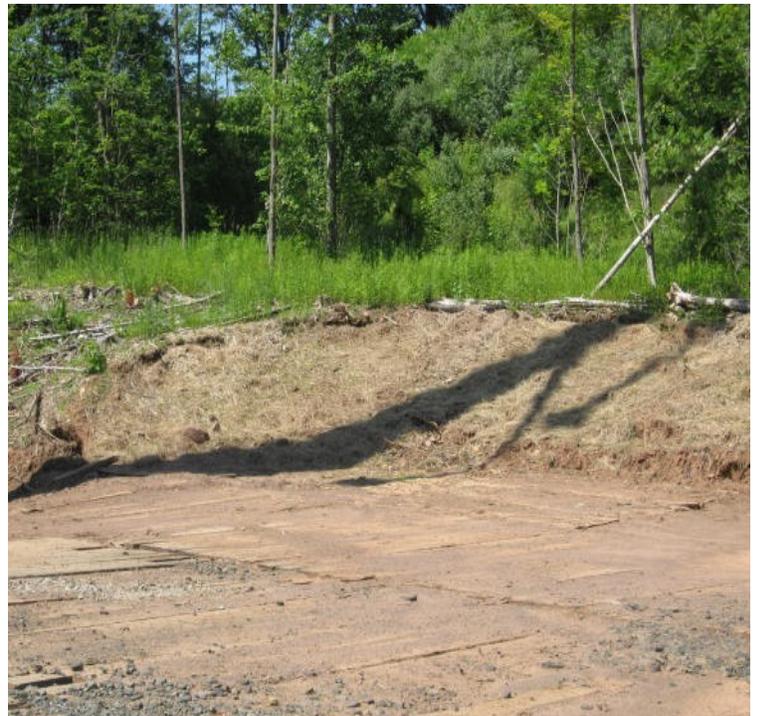
An exposed bank/slope north of E. Meriden SS has been regraded and seeded.
