Docket No. 272 – Development and Management Plan Inspection

Segment 2a Inspection

Date: June 12, 2007

Location: Segment 2a – Beseck Switching Station to Cheshire/Hamden Town Line

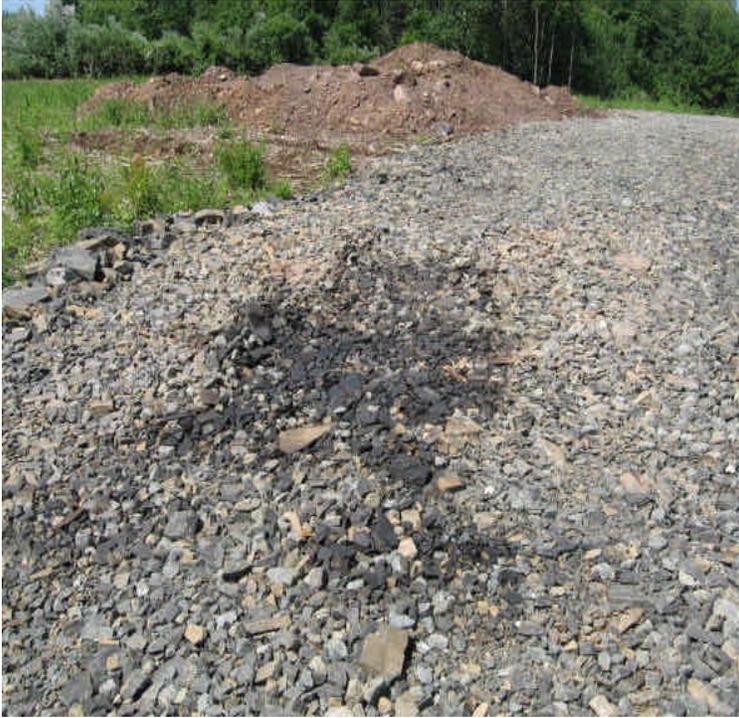
Spill noted off Carpenter Lane. Remove affected stone, identify leaking equipment and repair if not already done.

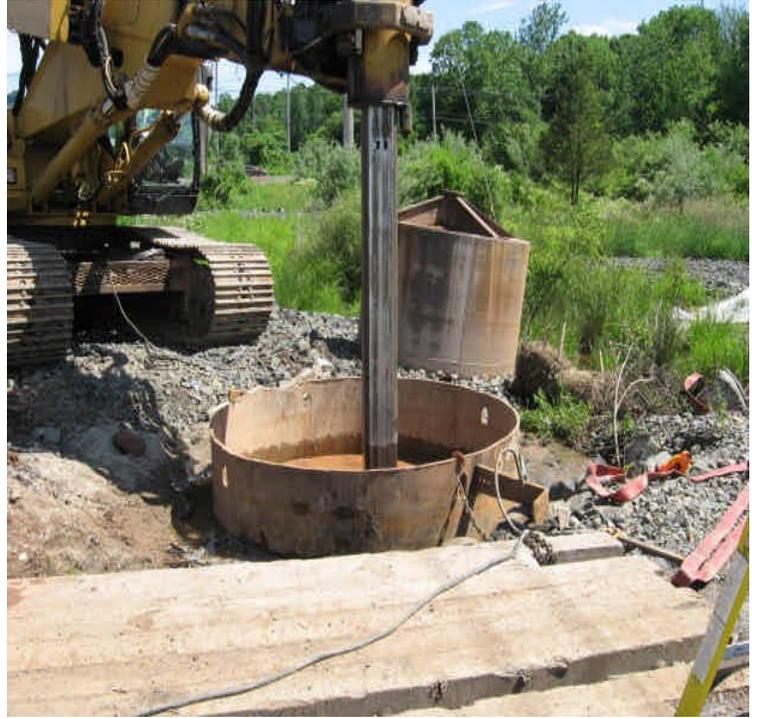
Foundation drilling occurring within wetlands off Carpenter Lane. Ensure that controls at previously installed foundations in this area are adequate and remove any remaining slurry at the wetland.

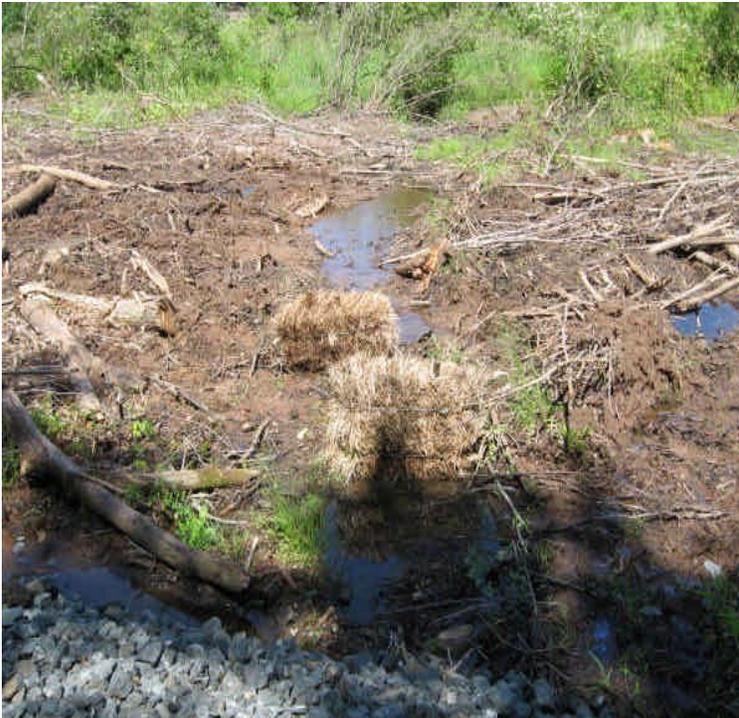
New controls (haybales) were added adjacent to the new stone access road off Powers Road. Ensure controls are adequate to handle all run-off and stabilize exposed soil.

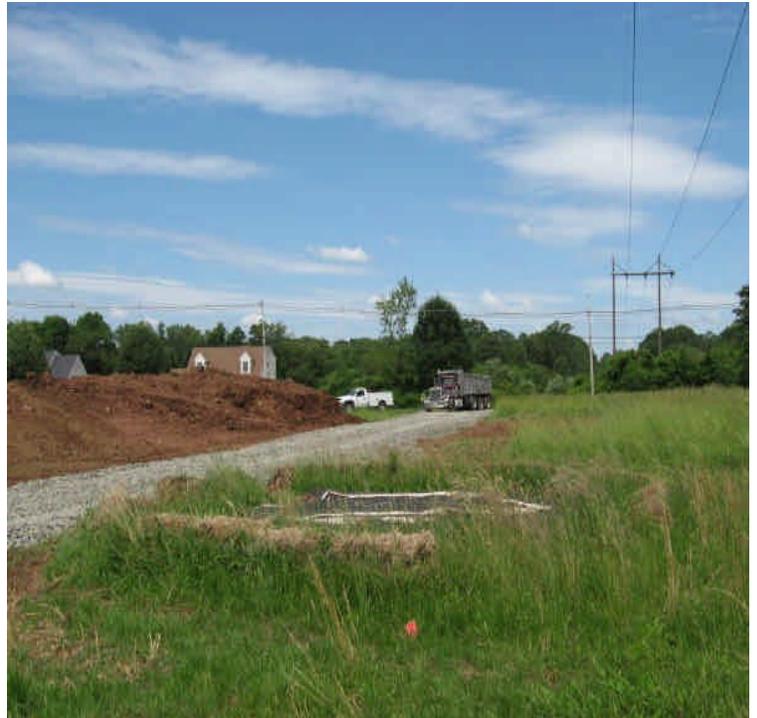
New access road and pad sites being installed off Pond Hill Road.

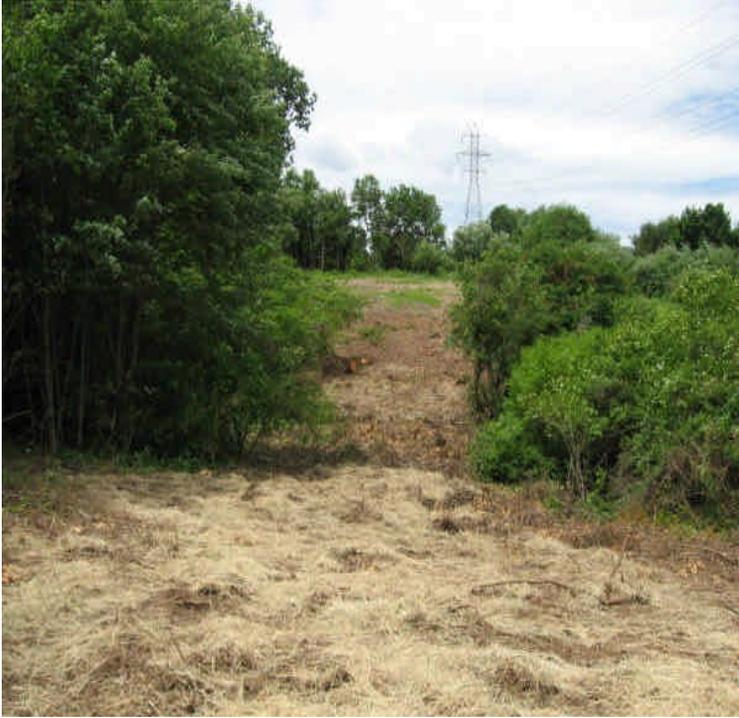
Hay and seed added to slopes in the ROW off Merritt Parkway. Ruts were noted here last week.

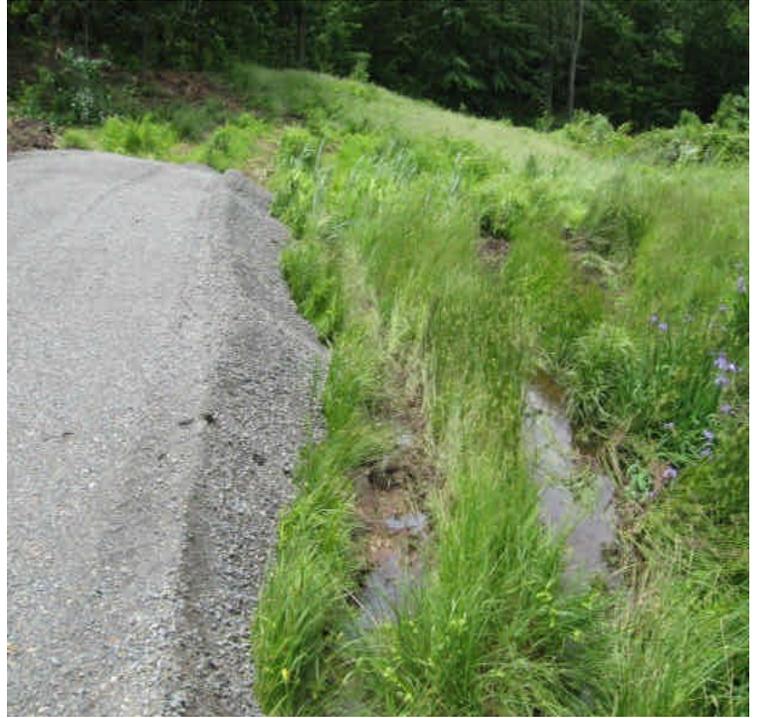
New pad within wetland, within apple orchard. Add controls as needed to protect the undisturbed area of wetlands. Avoid storing equipment on pad within the wetlands.

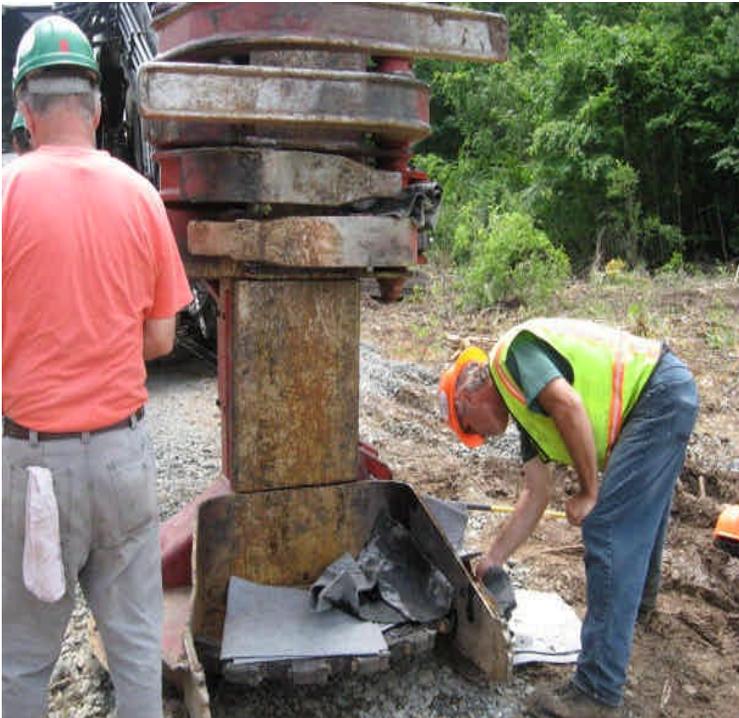
Leaking equipment off Tuttle Ave. Controls used to clean equipment. Contaminated soils were removed once equipment was repaired.

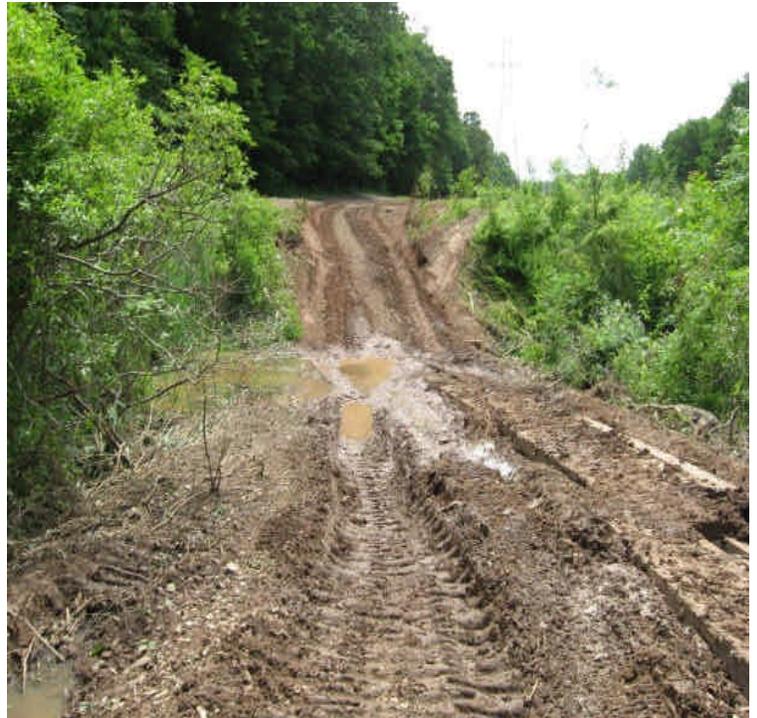
Turbid water and deep ruts off Tuttle Ave. Controls and appropriate crossing measures are needed at wetlands. Ruts should be graded to original contours and stabilized.
