Docket No. 272 – Development and Management Plan Inspection

Segment 2a Inspection

Date: June 26, 2007

Location: Segment 2a – Beseck Switching Station to Cheshire/Hamden Town Line

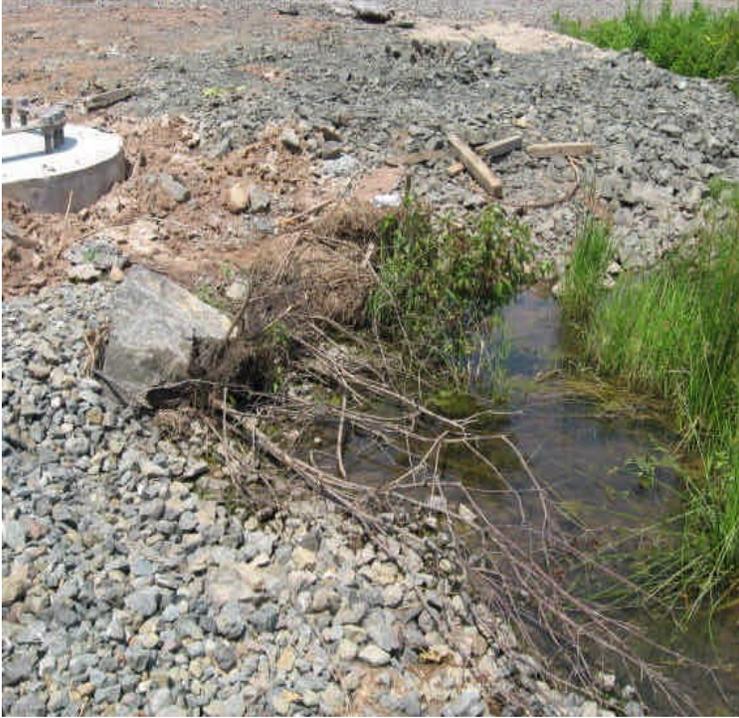
Foundation was placed in a small stream channel off Carpenter Lane. Create a new channel/or provide stream restoration to re-establish the hydrology.

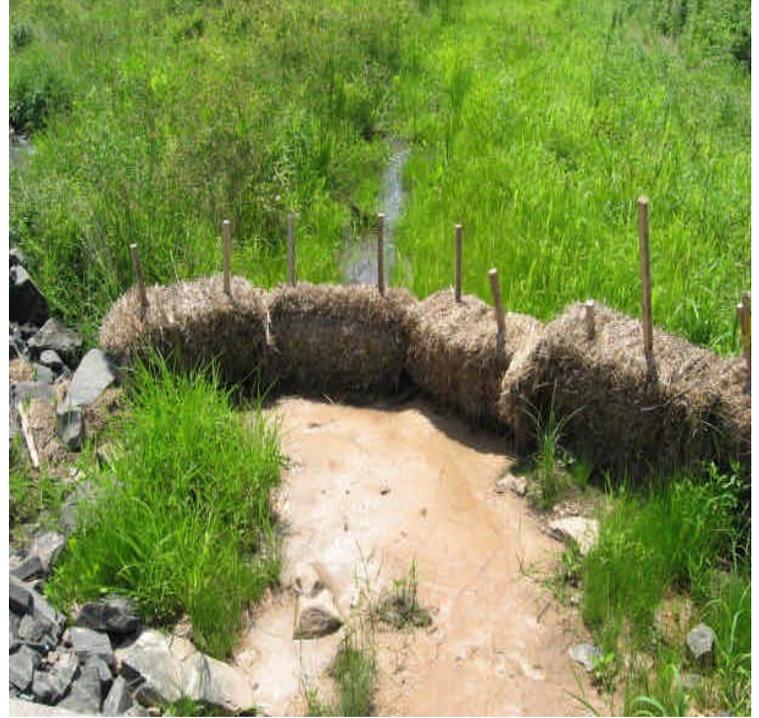
Sediment/turbid run-off was appropriately filtered by a haybale check-dam within wetlands off Carpenter Lane. Remove sediment when feasible to restore capacity.

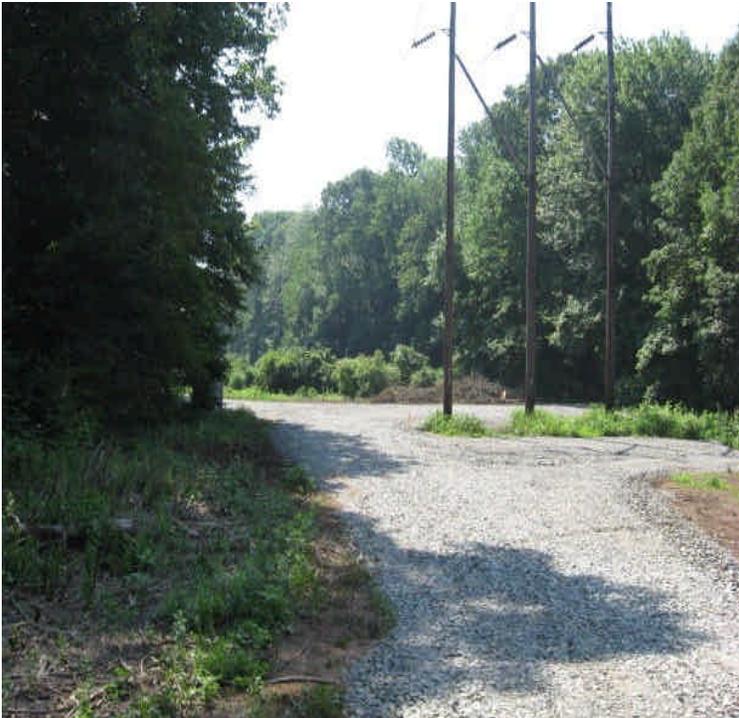
New stone access roads and pad installed off Docker Dr.

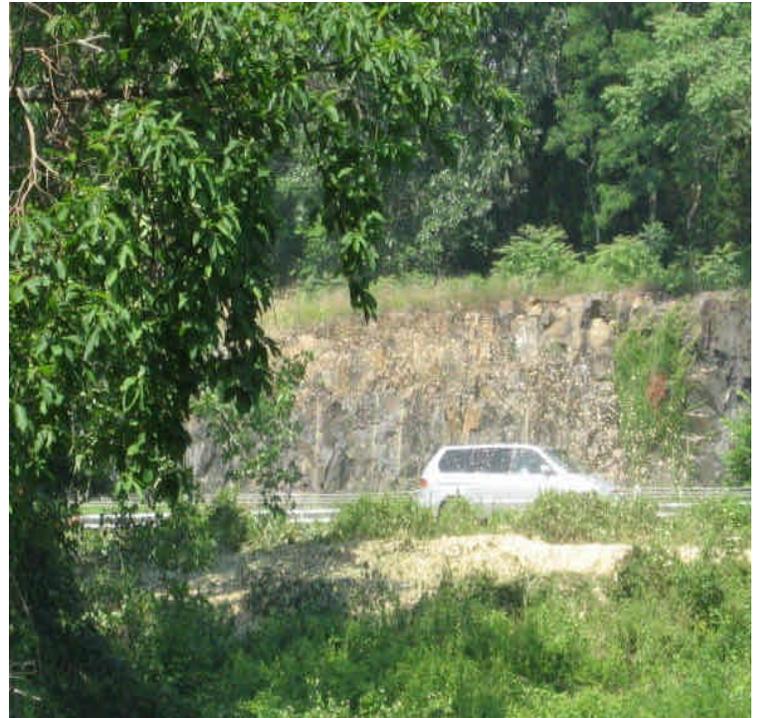
Clearing and mulching noted up to the Merritt Parkway (Rt 15).

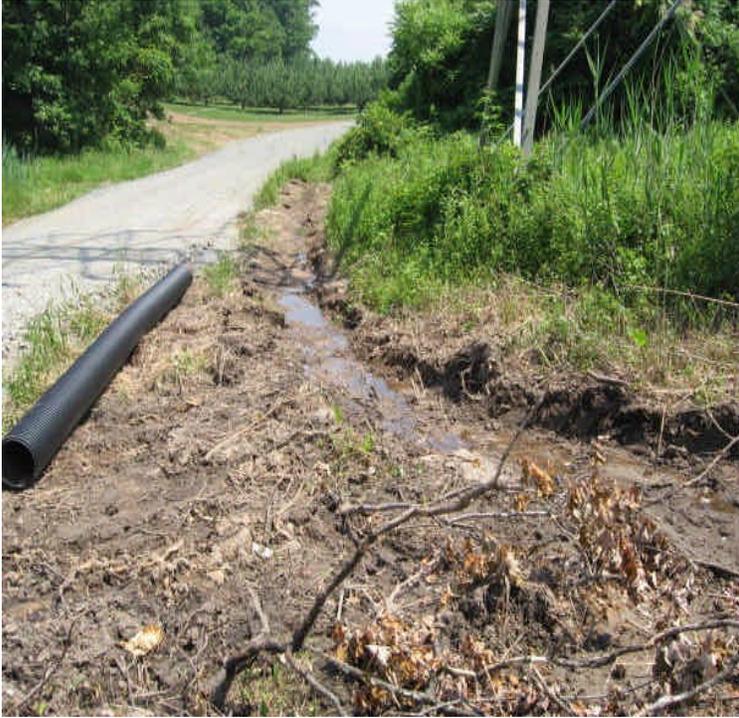
A drainage channel was dug within the apple orchard off Mansion Rd. A culvert appears to be necessary to reduce sedimentation.

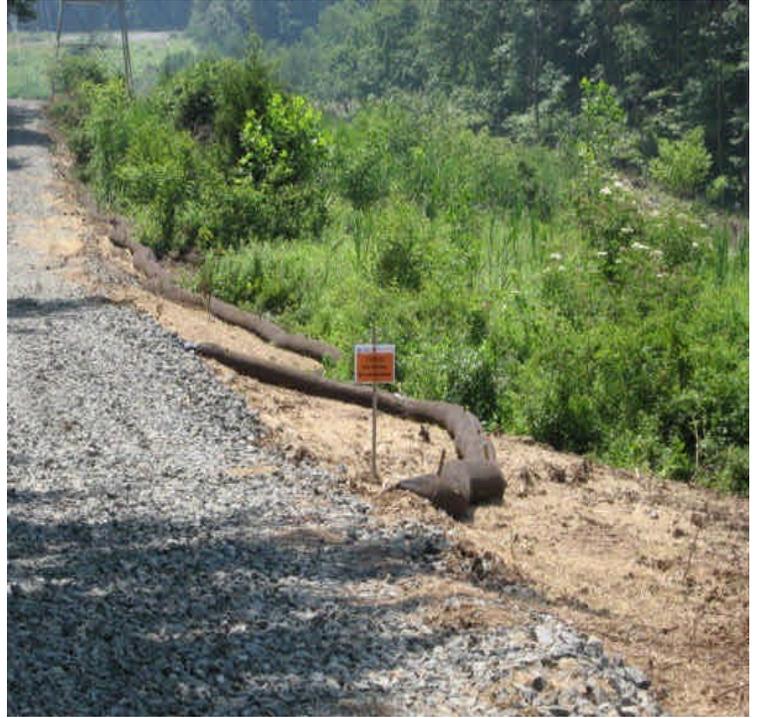
Access road has been installed off of Tuttle Ave. Filter socks, hay mulch and seed remain in place for control and stabilization.

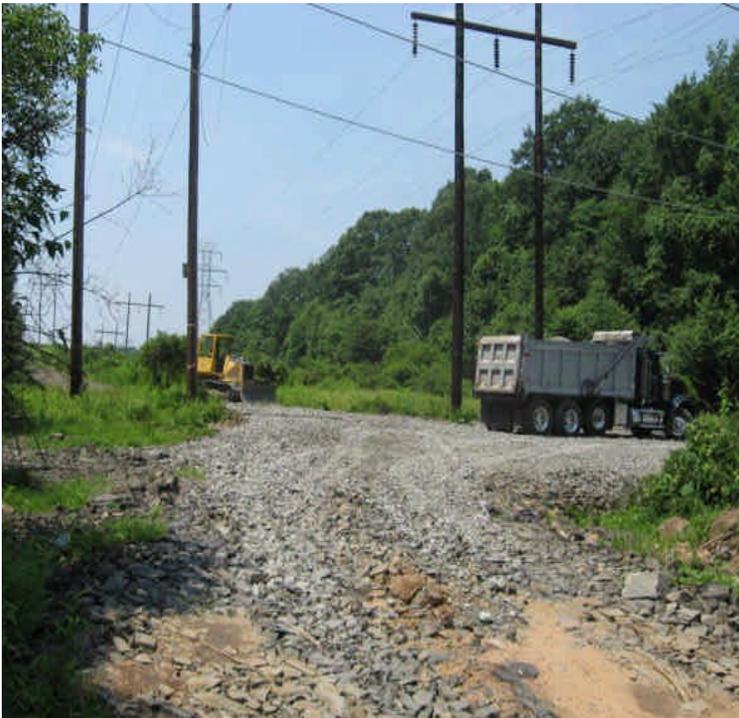
Stone was being added to the access road and pad sites off Old Farms Rd.

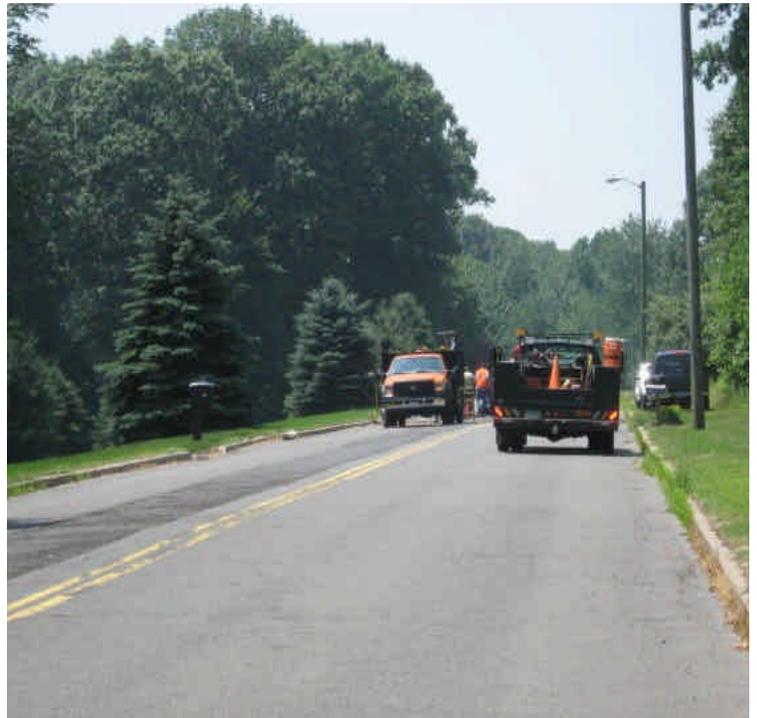
Crews were working along Old Farms Rd.
