Docket No. 272 – Development and Management Plan Inspection

Segment 3 Underground Line

Date: June 6, 2007 (evening inspection)

Location: East Devon Substation to the Housatonic River Crossing

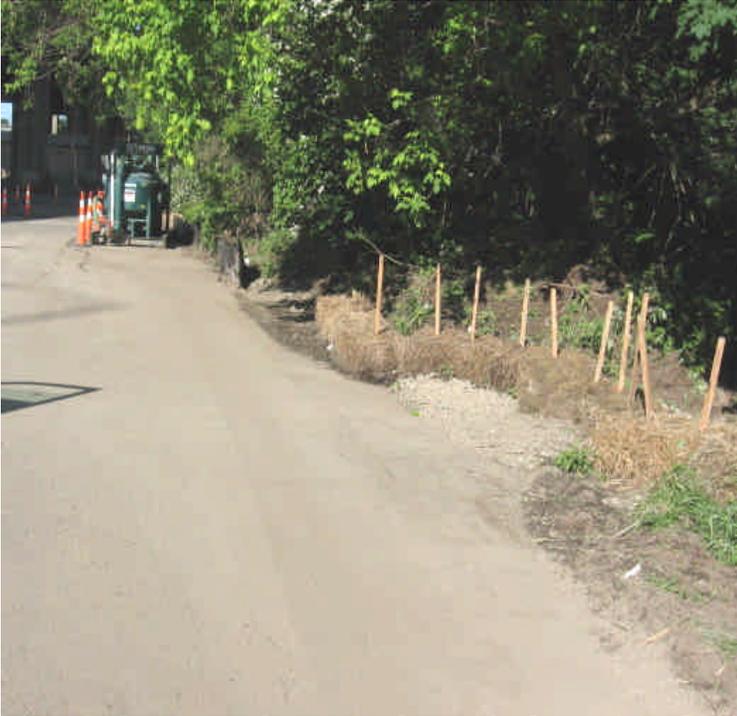
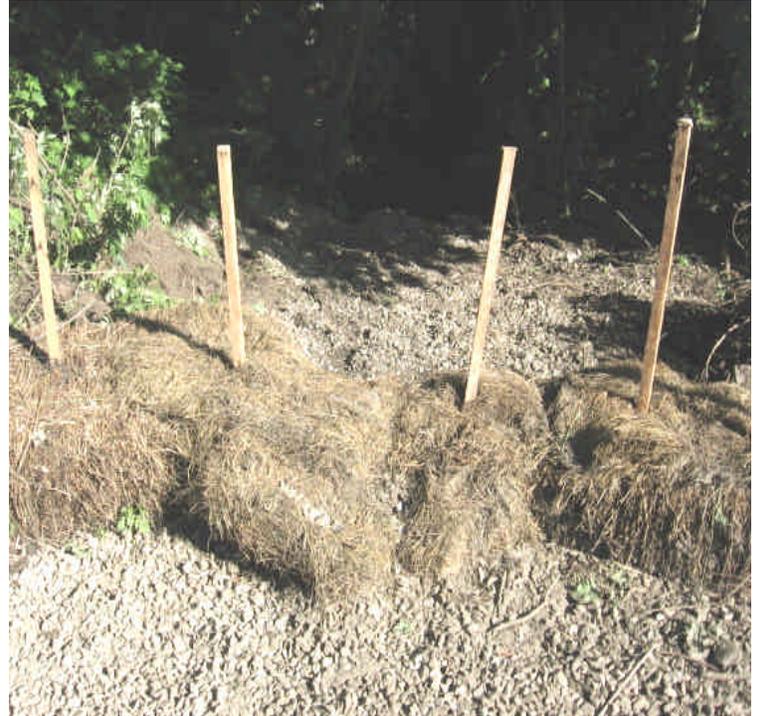
Both photos were taken near vault #1. Left: The remaining flowable fill has been adequately removed from the area. Right: Stone has been sufficiently removed from the swale and placed up gradient of the erosion control barrier.

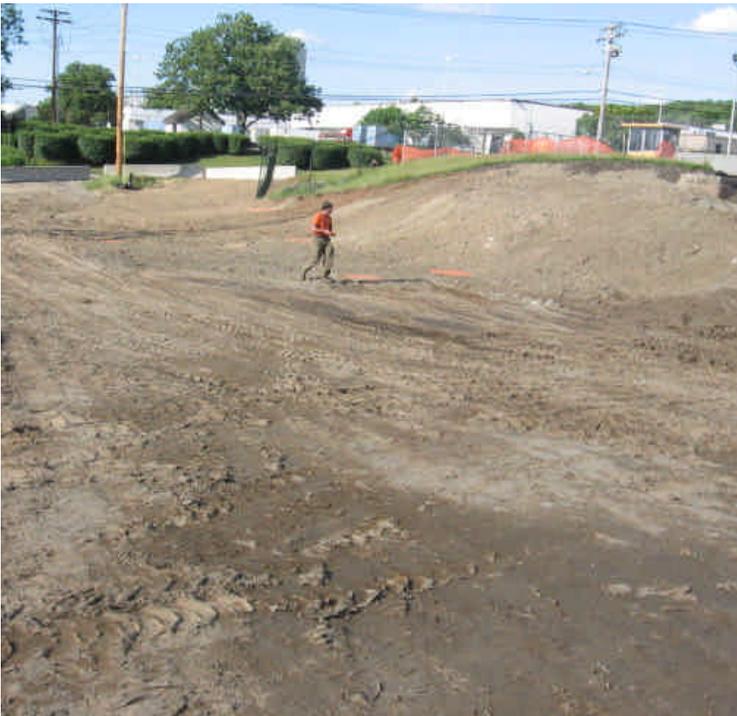
Work is complete near sta. #1080. Exposed soils, especially those along the slope, should be stabilized as soon as feasible.

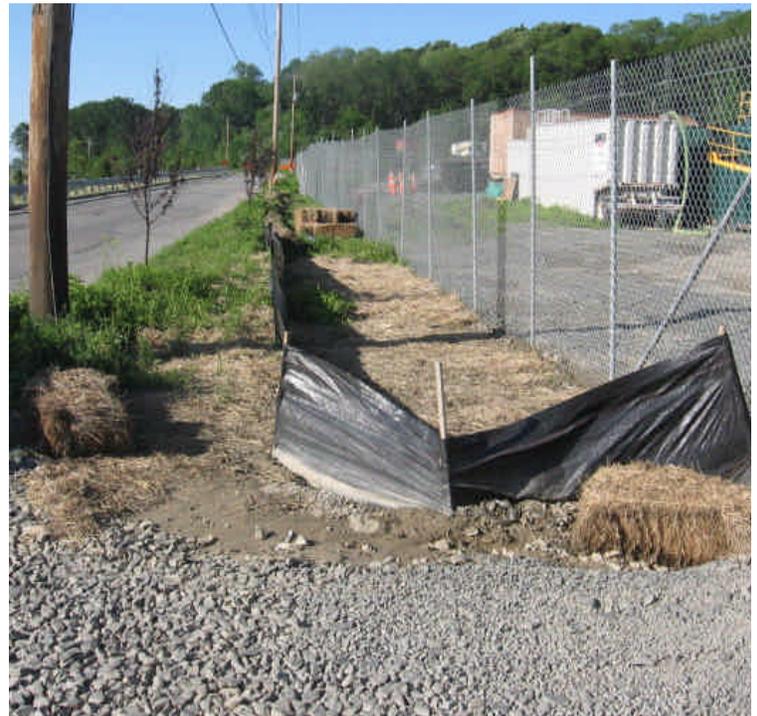
Exposed soil just outside of the lay-down yard fence has been temporarily stabilized with seed and hay mulch.
