Docket No. 272 – Development and Management Plan Inspection

Segment 3 Underground Line

Date: June 29, 2007

Location: East Devon Substation to the Housatonic River Crossing

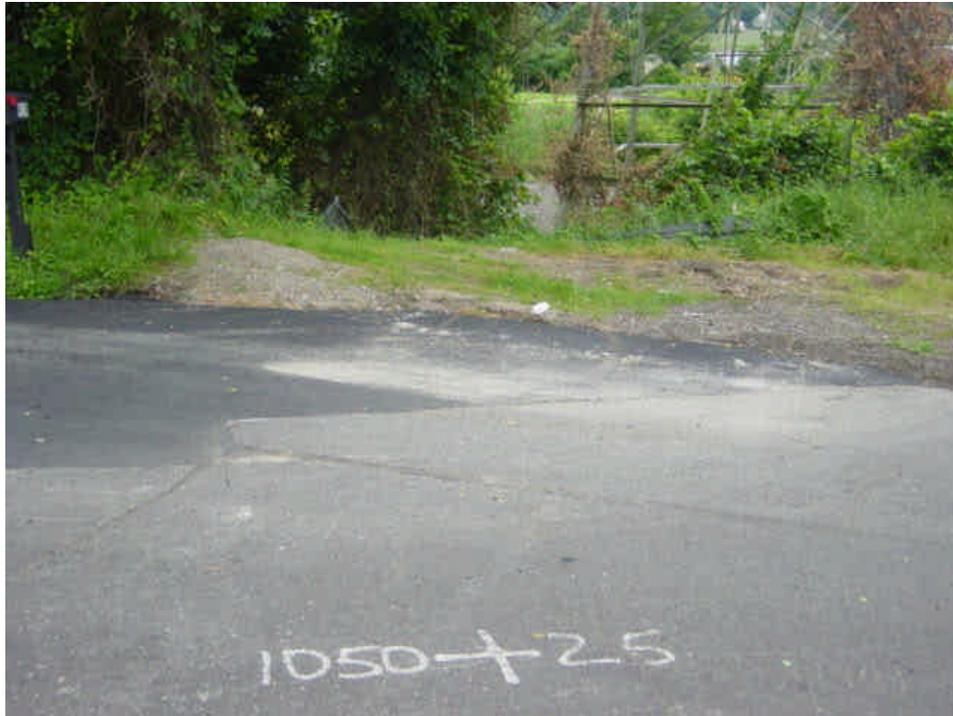
A small section of silt fence near sta. #1050 is in need of repair due to steel plates previously stockpiled here.

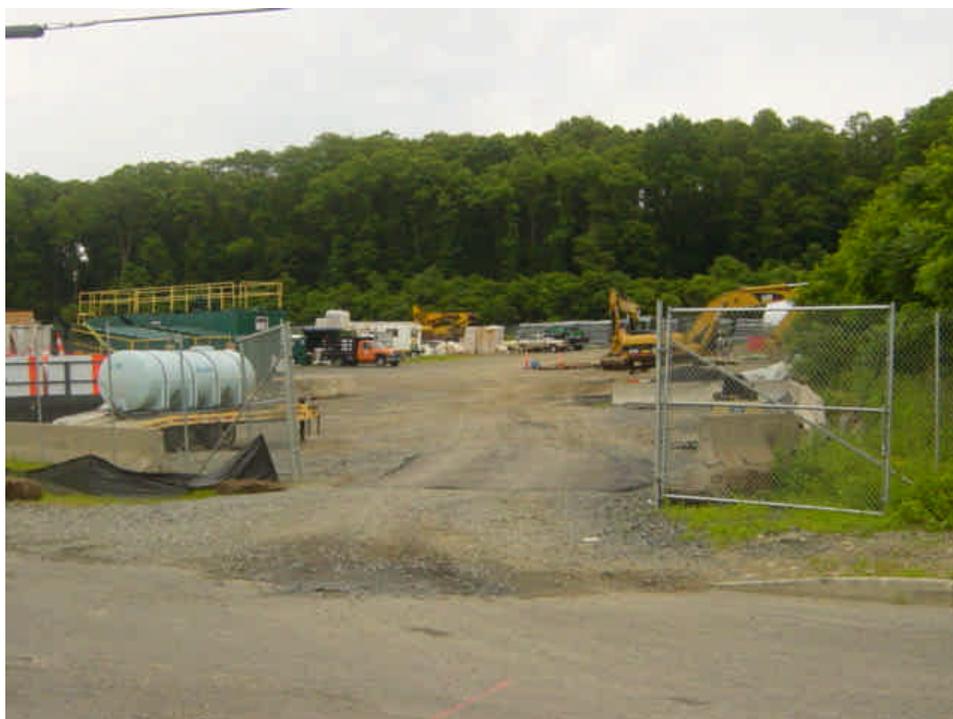
A minor amount of tracking was observed at the Shelland Street lay-down yard. The stone entrance pad should be refreshed as necessary to minimize sediment migration.
