Docket No. 272 – Development and Management Plan Inspection

Segment 4b Underground Line

Date: June 6, 2007 (evening inspection)

Location: Fairfield/Westport Town Line to Westport Avenue in Norwalk

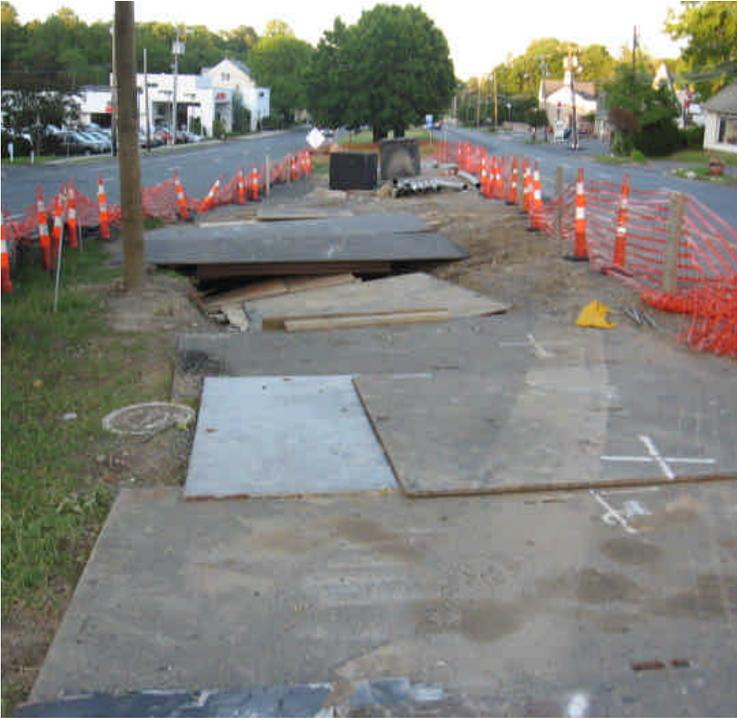
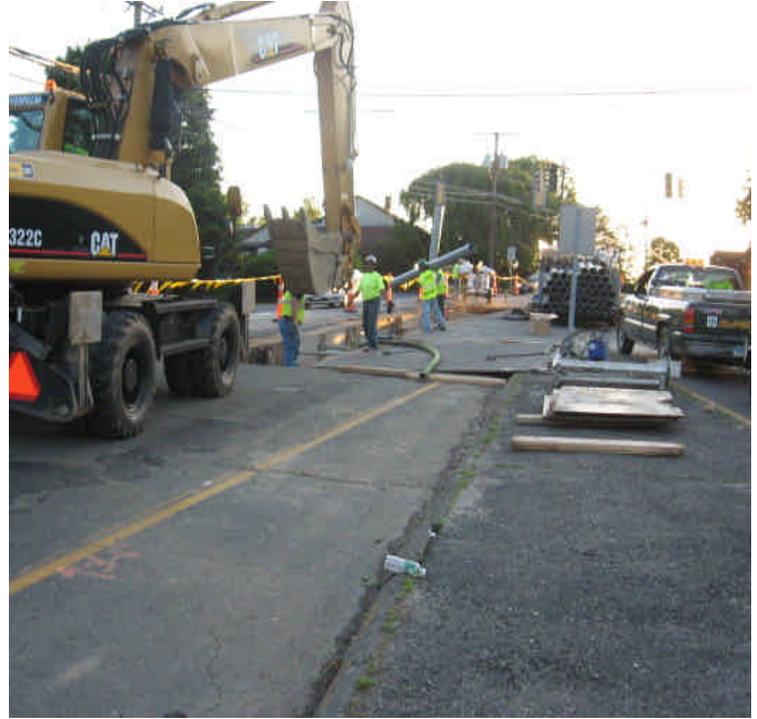
Both photographs are of the trenching location/activities at sta. #311 to #318. All catch basins were protected, no issues were observed.

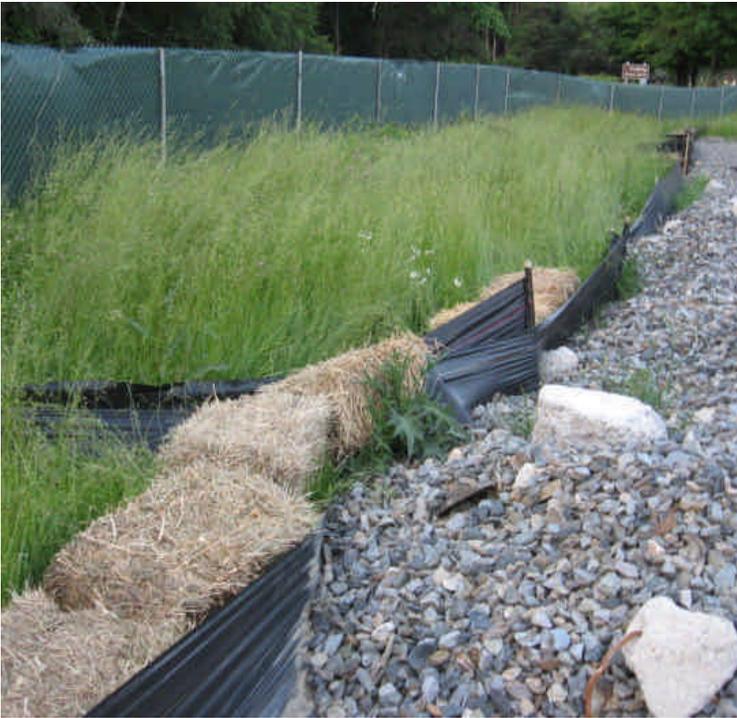
Both photographs are of the Sherwood Island lay-down yard. Left: Erosion controls have been re-established where necessary. Right: During BSC's inspection, a truck was observed watering down yard to prevent airborne dust migration.
