Docket No. 272 – Development and Management Plan Inspection

Segment 4b Underground Line

Date: June 21, 2007

Location: Fairfield/Westport Town Line to Westport Avenue in Norwalk

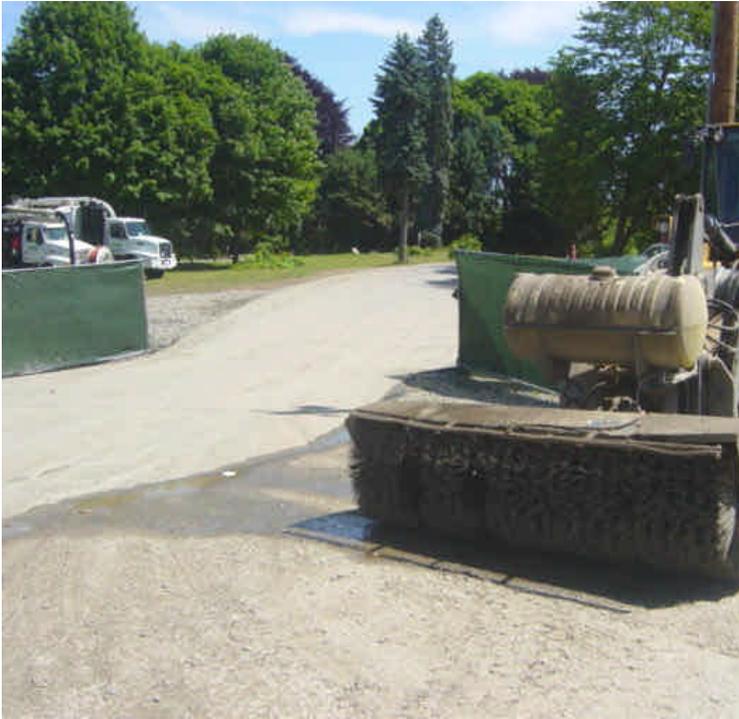
Continue to monitor for sediment tracking from the lay-down yard at the Sherwood Island State Park. Multiple pieces of equipment were observed being stored outside of the fenced perimeter of the yard. Store all equipment appropriately.

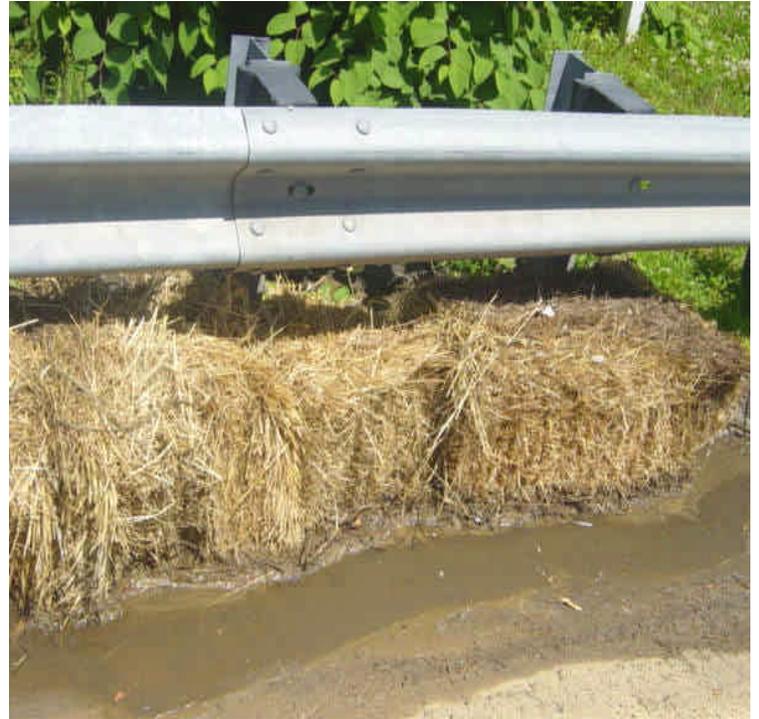
A haybale barrier was placed to protect a drainage swale near sta. #168. Muddy runoff from other activities (non-project related) was noted around the swale.

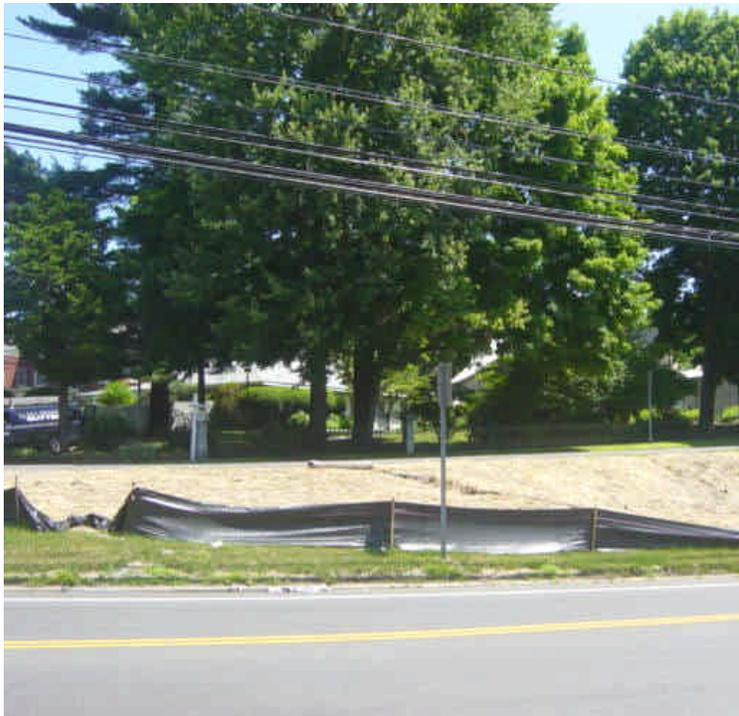
Photo of the gully/washout that has formed over vault #5. A silt sock has been placed at the top of the gully in an effort to prevent further erosion. A section of silt fence is still in disrepair. Stabilize the area as soon as feasible.

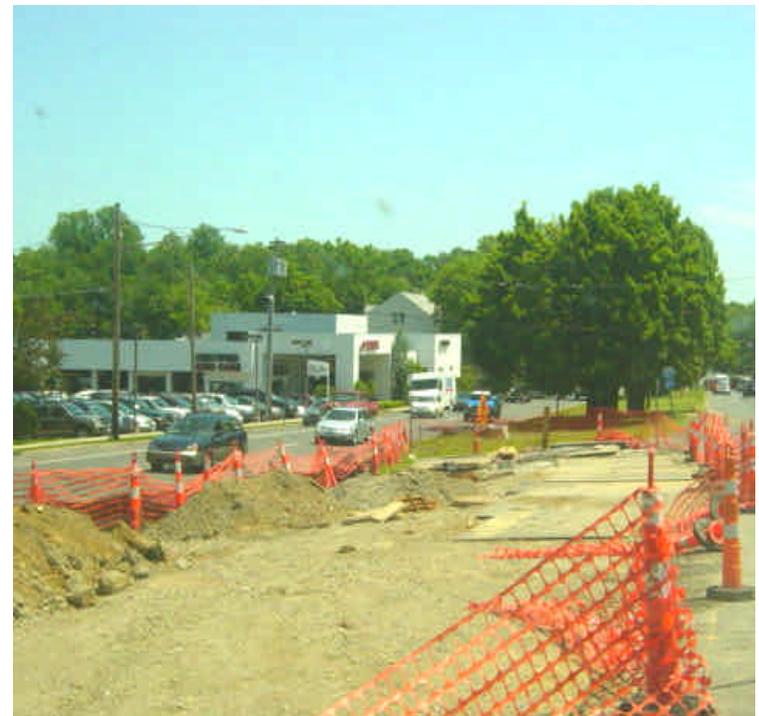
Vault #19 remains open and is temporarily covered with steel plates. Silt fence has been installed along the downgradient side of the work area.
