Docket No. 272 – Development and Management Plan Inspection

Beseck Switching Station Inspection

Date: March 6, 2007

Location: Beseck Switching Station

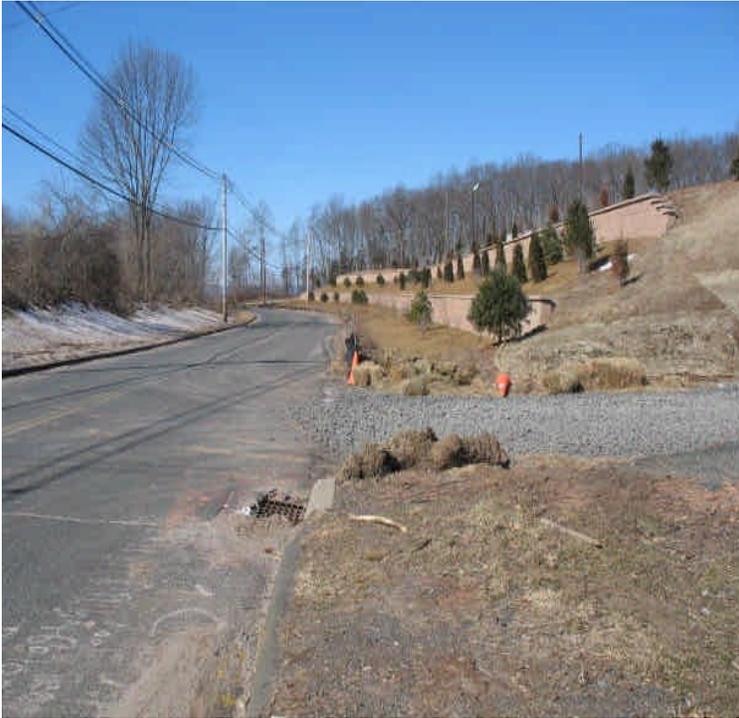
Site entrance/exit off Carpenter Lane is at final grade; haybales at the entrance are degraded and should be replaced. This was going to occur shortly. No run-off was noted at the time.

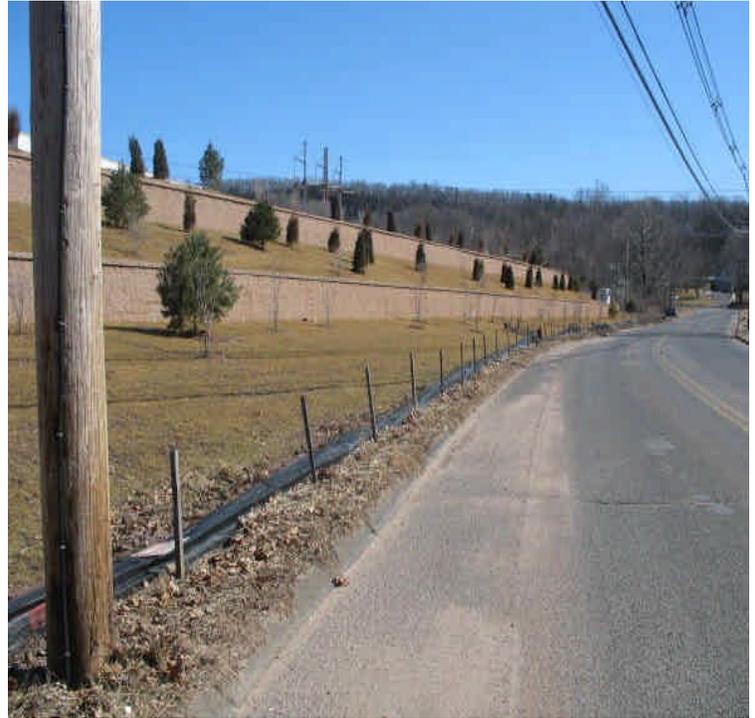
View of Carpenter Lane and retaining walls. Some slight sedimentation (as well as sand from town sanders) was noted along the gutters. Catch basins controls could use maintenance.

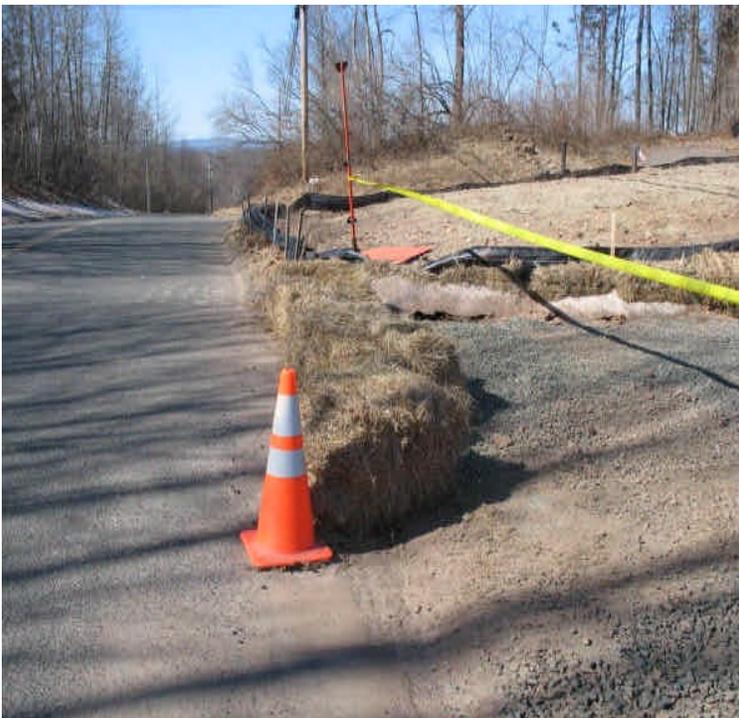
Haybales were placed across the closed site entrance (west side) in an effort to reduce turbid run-off from the site. Extend the haybales to encompass the access.

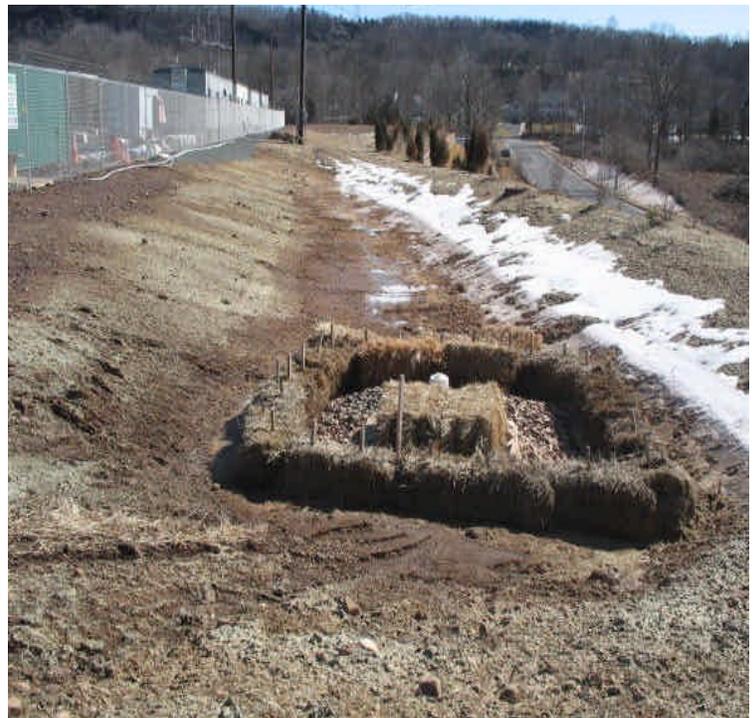
Haybales and controls remain in place at the inlet of the detention basin. Run-off appears to be contained effectively.

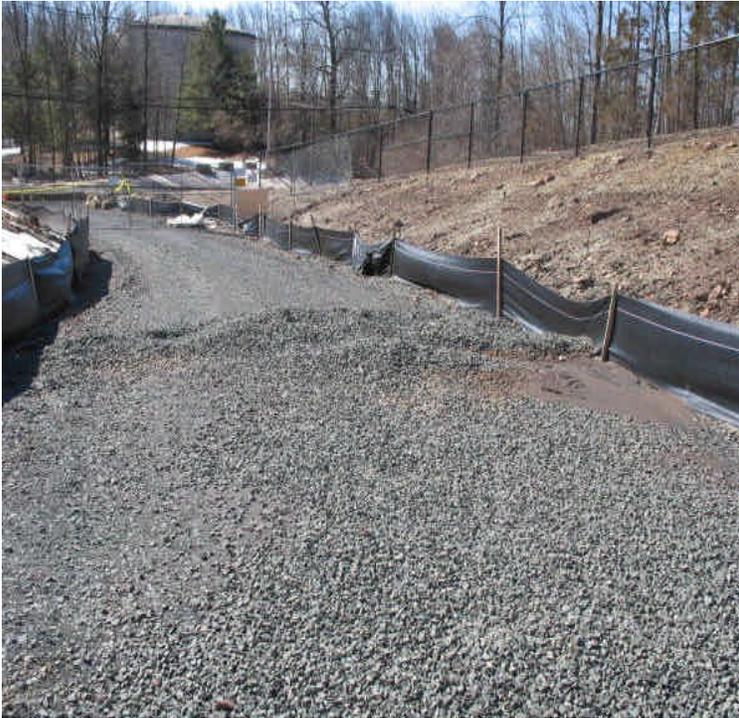
Another view of the closed site entrance. The recently installed water bar appears to be effective as sediment accumulation was noted at the edge of the stone.

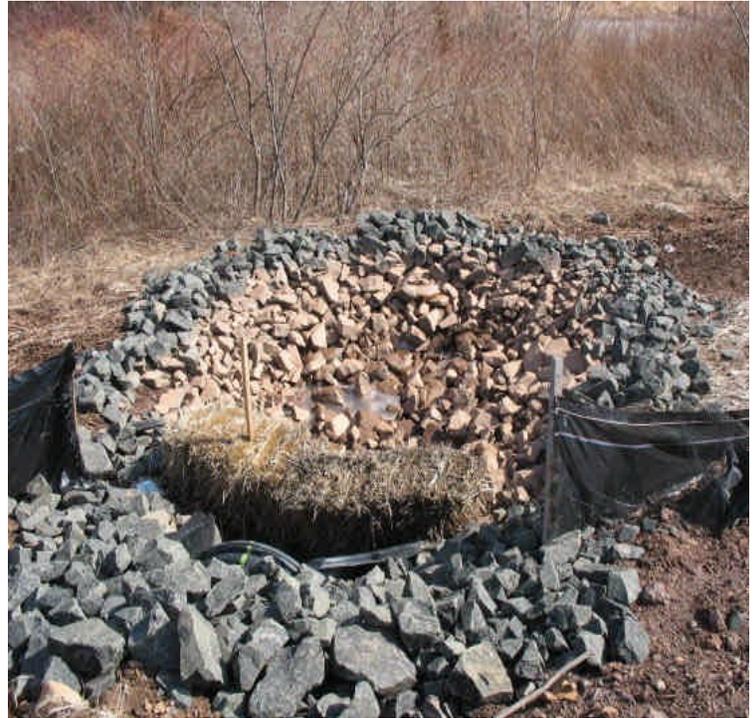
View of the culvert under the new access road. Turbid water has filtered out of the trap and sediment appears contained.

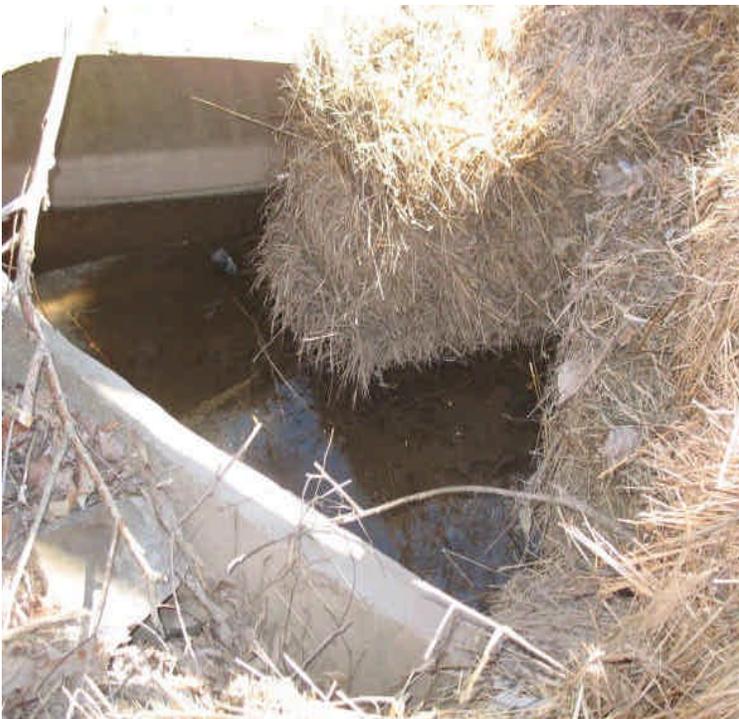
Storm drain outlet across Carpenter Lane has clear water flowing through the haybales. The majority of ice cover in the culvert and wetlands had melted. Efforts on site appears to have retained sediment.

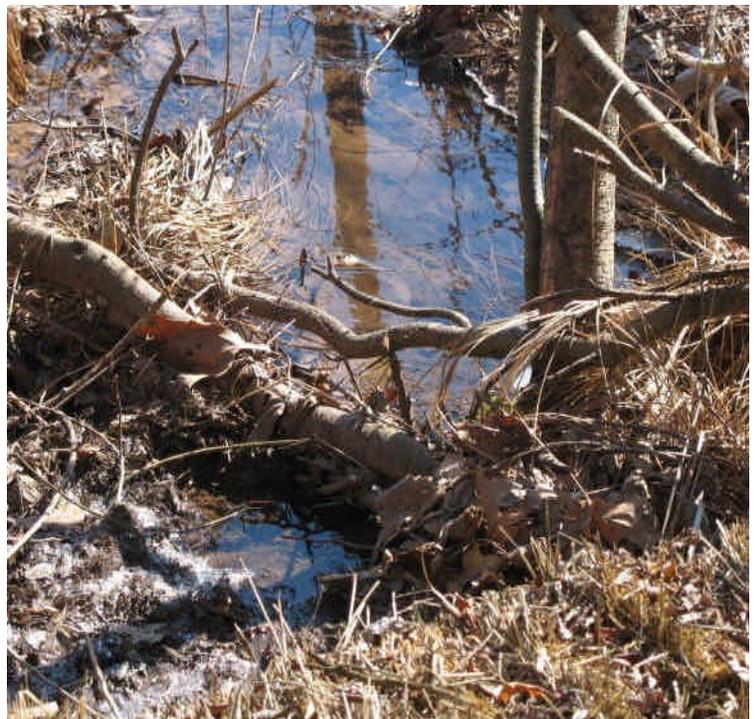
Clear water was observed leaving the haybales and entering the wetlands. Evaluate whether the amount of sediment accumulation justifies the minor disturbance needed to remove it, once the water subsides.
