**Docket No. 272 – Development and Management Plan Inspection**

**Beseck Switching Station Inspection**

**Date:** March 20, 2007

**Location:** Beseck Switching Station

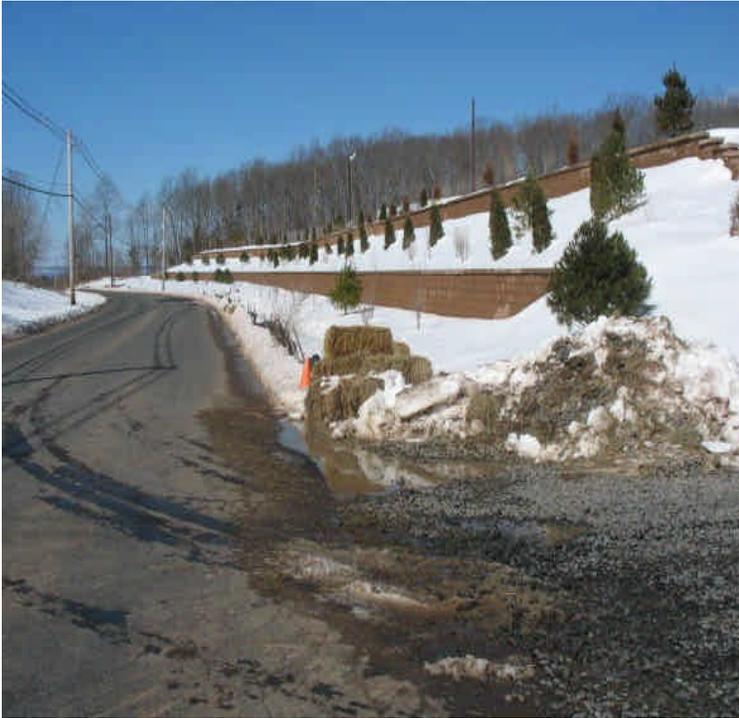
Site entrance/exit off Carpenter Lane is at final grade; haybales at the exit are degraded and should be replaced. This was going to occur shortly. Turbid run-off was noted during the inspection due to snow.

<b>Haybales at the edge of the site exit are degraded. 3/6-3/20/07</b>	<b>Replace haybales before the next rain or potential run-off event. Contractors stated haybales would be replaced shortly. 3/6-3/20/07</b>	<b>Needs attention. Contractors stated a shipment of haybales was on its way.</b>
	<b>Some turbid run-off was still noted from the site exit despite the efforts</b>	<b>Small stone check dams are also suggested along Carpenter Ln. to help</b>	<b>Needs evaluation.</b>

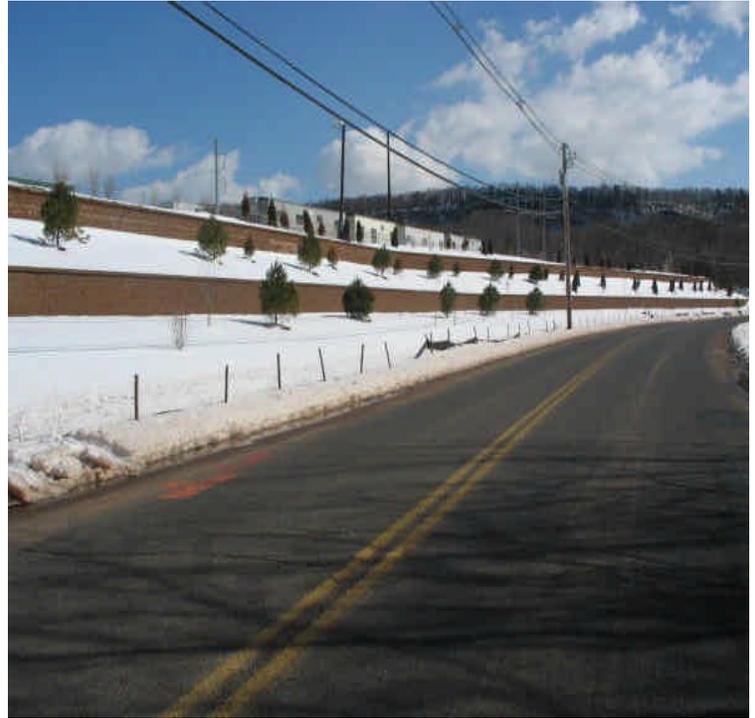
View of Carpenter Lane and retaining walls. Some slight sedimentation (as well as sand from town sanders) was noted along the gutters. Catch basins controls need maintenance.

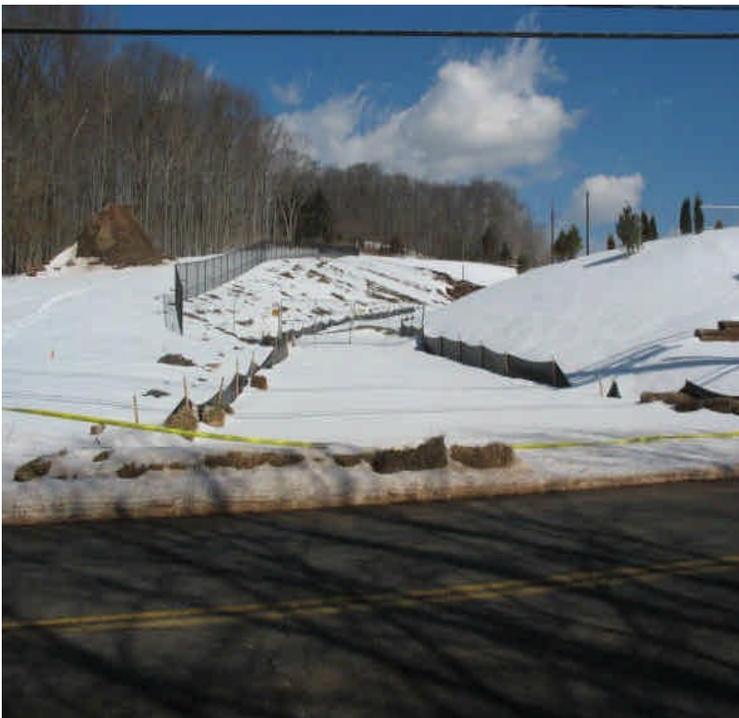
Haybales were placed across a portion of the site entrance (west side) in an effort to reduce turbid run-off from the site.

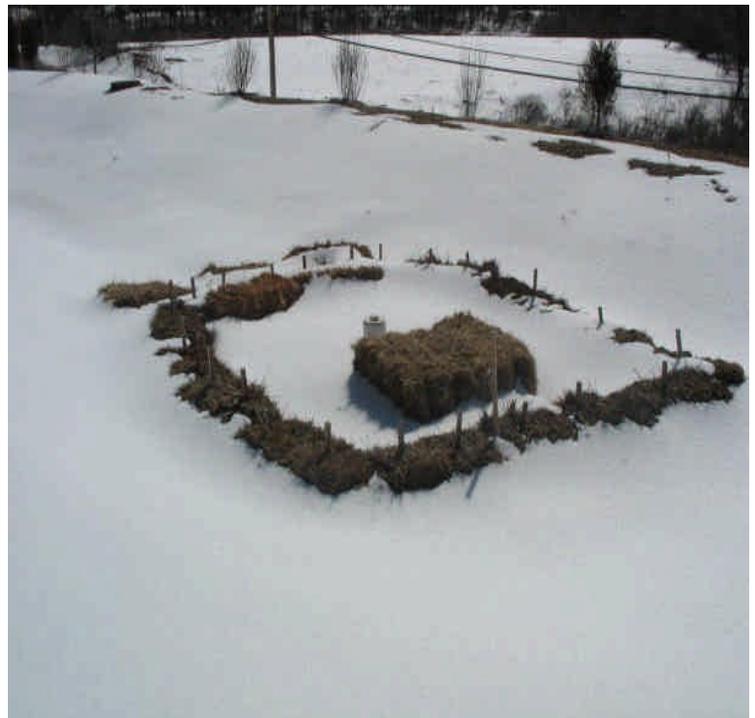
Haybales and controls remain in place at the inlet of the detention basin. Sediment from run-off was contained effectively the last few weeks.

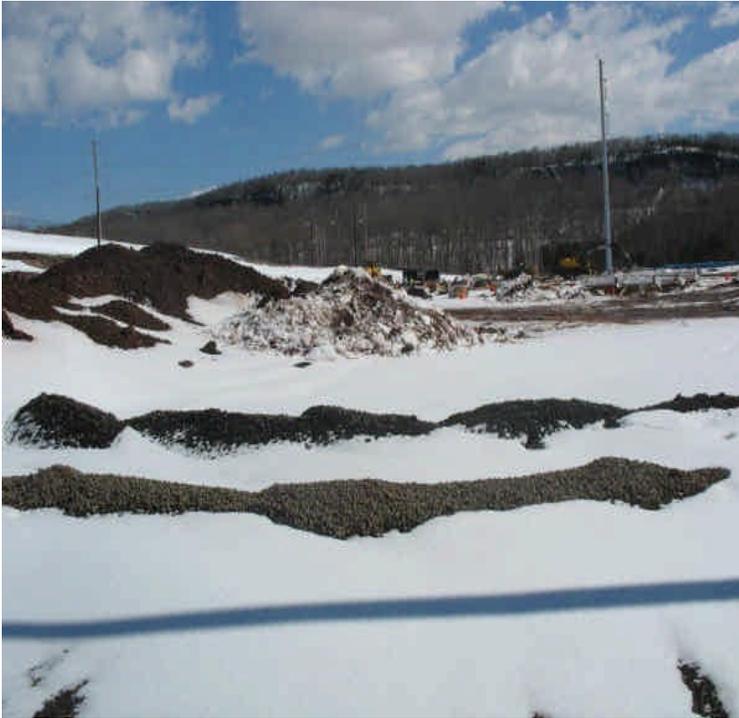
**View of stone water bars installed across the top of the closed site entrance.**

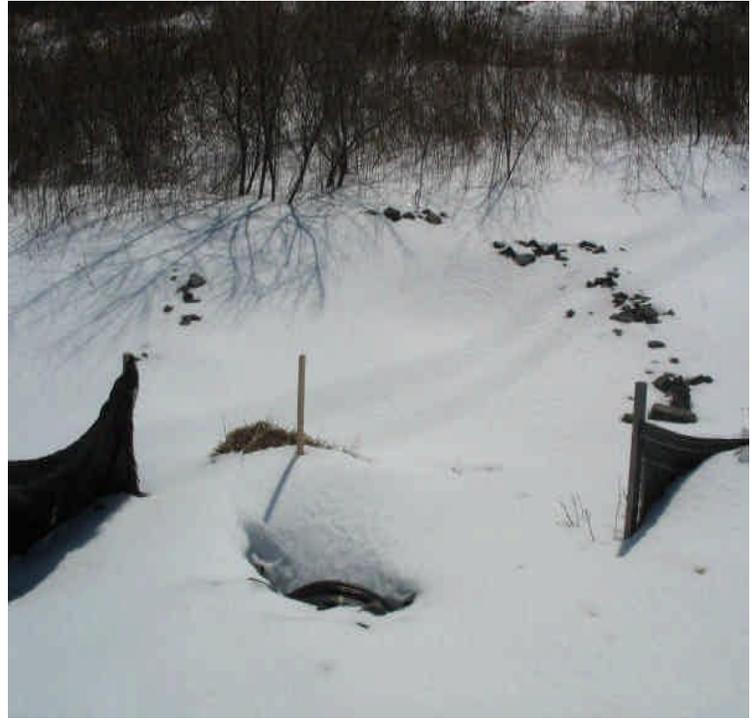
**View of the snow covered culvert and trap under the access road to the ROW.**

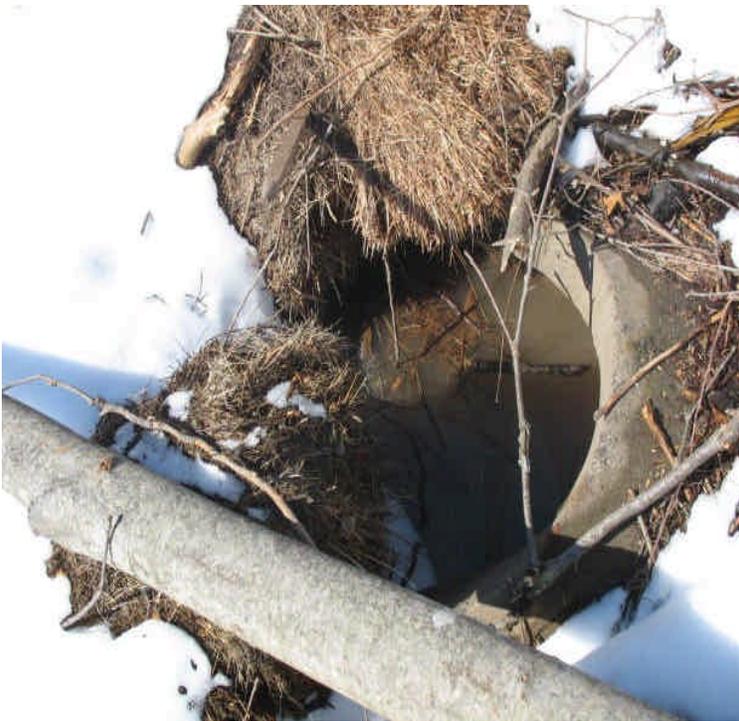
**Storm drain outlet across Carpenter Lane has slightly turbid water flowing through the haybales. The ice/snow cover in the culvert and wetlands makes observations difficult.**

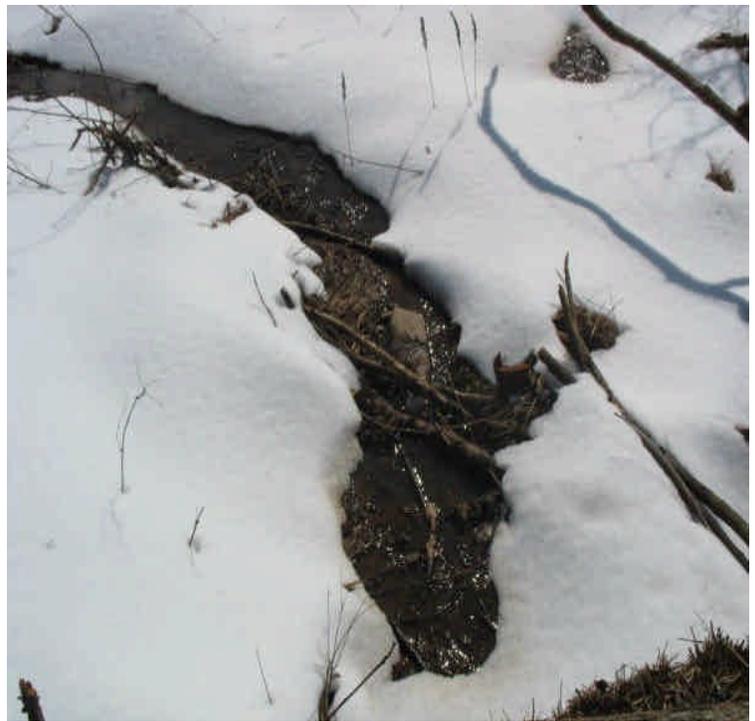
**Slightly turbid water was observed leaving the haybales and entering the wetlands. Evaluate whether the amount of sediment accumulation justifies the minor disturbance needed to remove it, once the water subsides. Timber harvesting/clearing within the wetlands for 2A was complete.**
