Docket No. 272 – Development and Management Plan Inspection

Segment 1a Inspection

Date: March 12, 2007

Location: Segment 1a – Scovill Rock Switching Station to Chestnut Junction, Oxbow Junction to Beseck Switching Station (excluding Royal Oak Bypass), and Black Pond Junction to Beseck Switching Station

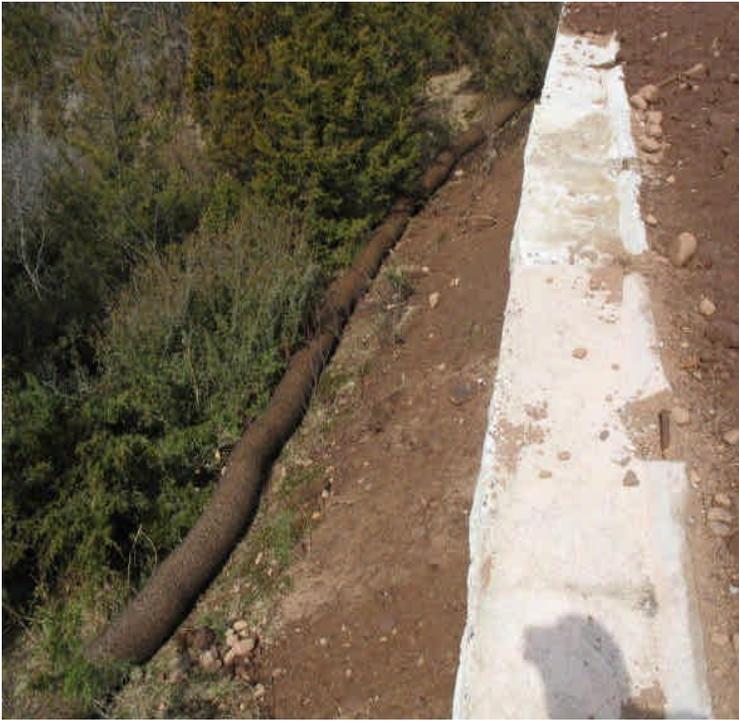
Retaining wall in place along a steep slope at a new pad site in the vicinity of the transfer station off Cherry Hill Rd. Filter socks were added at the base of slope for control.

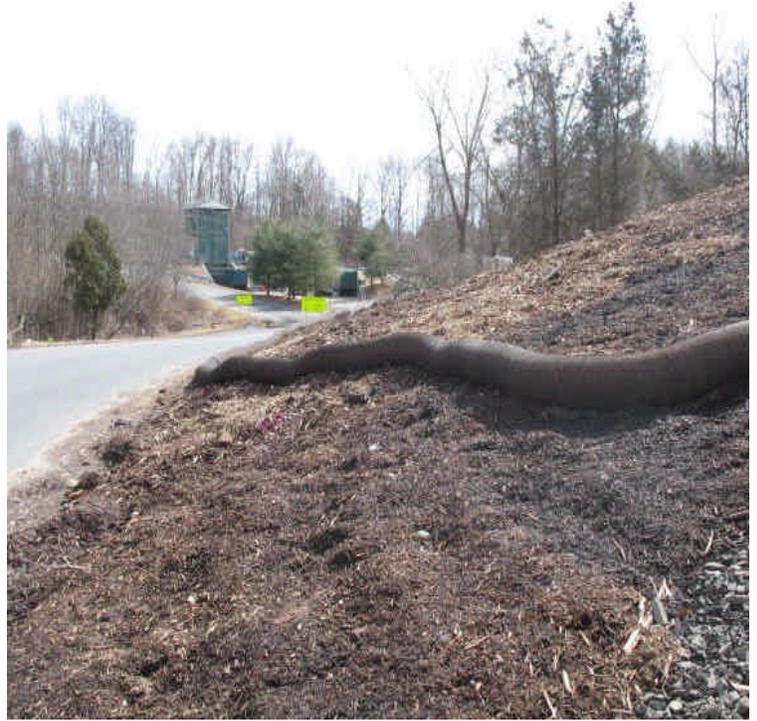
Filter socks were added along the pad and access road slope in the vicinity of the transfer station off Cherry Hill Rd. Ensure that controls are adequate to slow erosion.

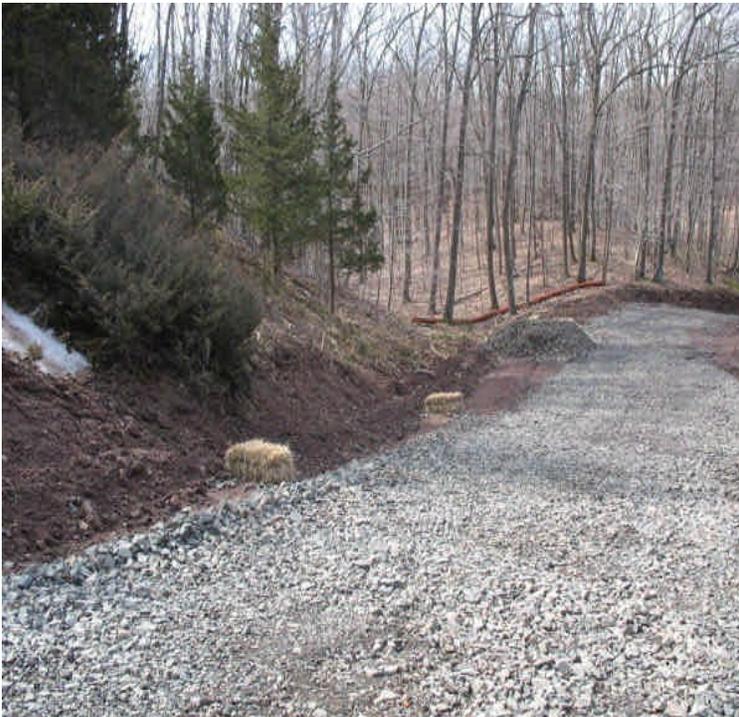
View of access road leading to the culvert area off Black Walnut Dr. Check dams (haybales and stone) were in place along the access road. Drainage ditches/waterbars leading to haybales were installed to direct and filter turbid run-off along the access road.

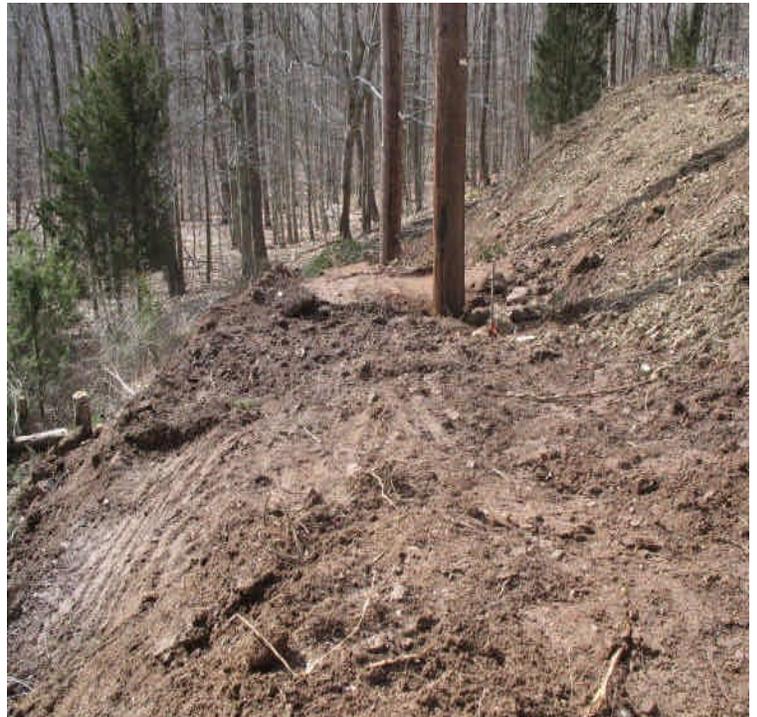
Pad site installed off Black Walnut Dr. upgradient of Ball Brook. Mulch was placed on the slope but additional controls may be needed due to potential for run-off here.

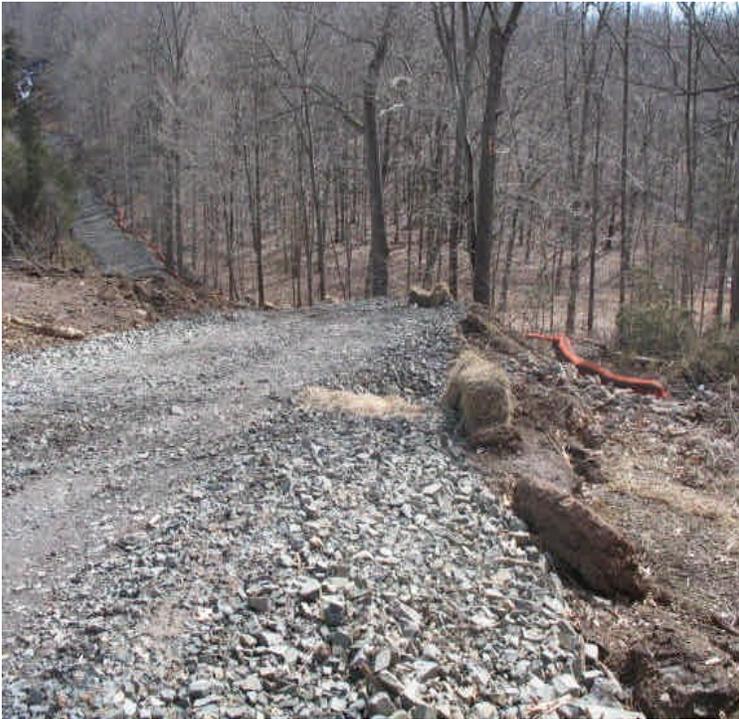
Haybales and water bars are in place along the access road off Black Walnut Dr. This access was installed to reach structure locations to the east. This avoids crossing Ball Brook and associated habitat.

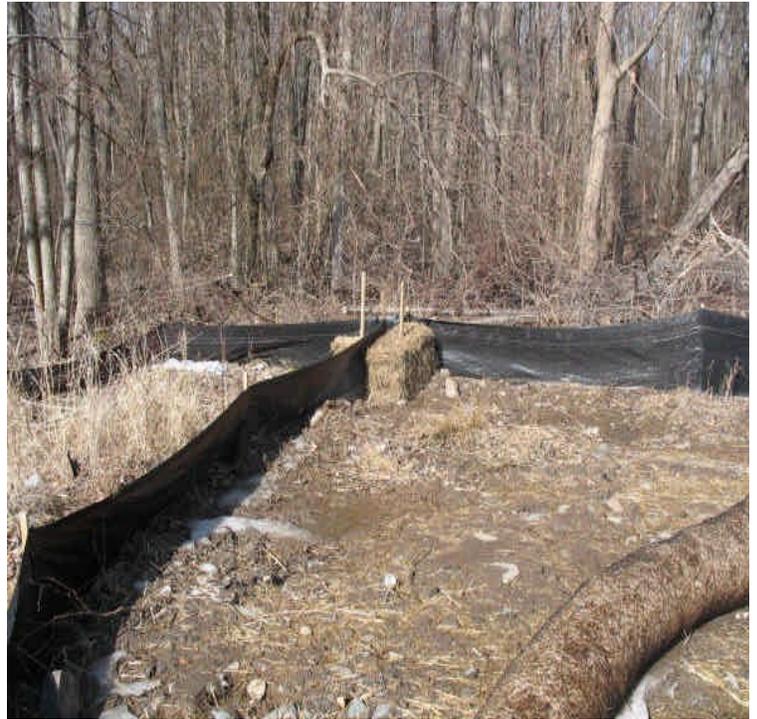
Silt fence, fiber rolls, and hay mulch are in place as a buffer for wetlands around the perimeter of the contractor receiving yard. Fallen sections of silt fence were supported with haybales.

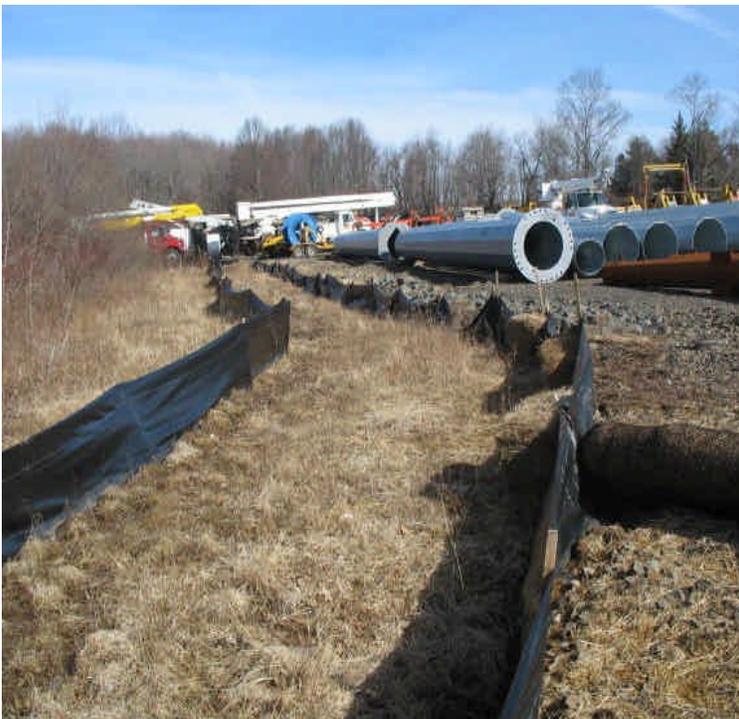
Additional controls remain in place adjacent to wetlands to filter/contain turbid run-off leaving the site.

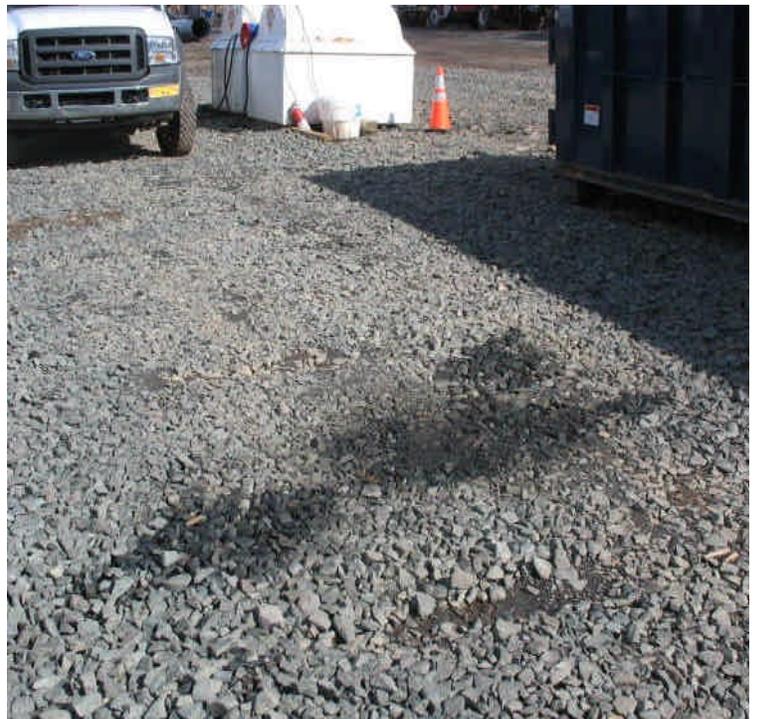
The fuel storage tanks remain in place on the stone spill pad and nozzles are contained. Larger drip stains were noted; spill contained to the stone.

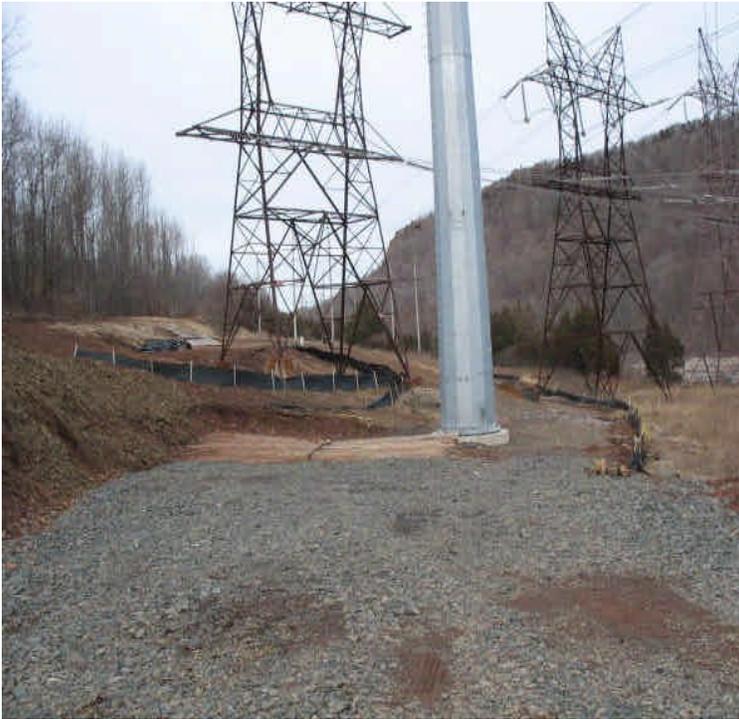
Controls remain stable off Black Pond following installation of the monopole.

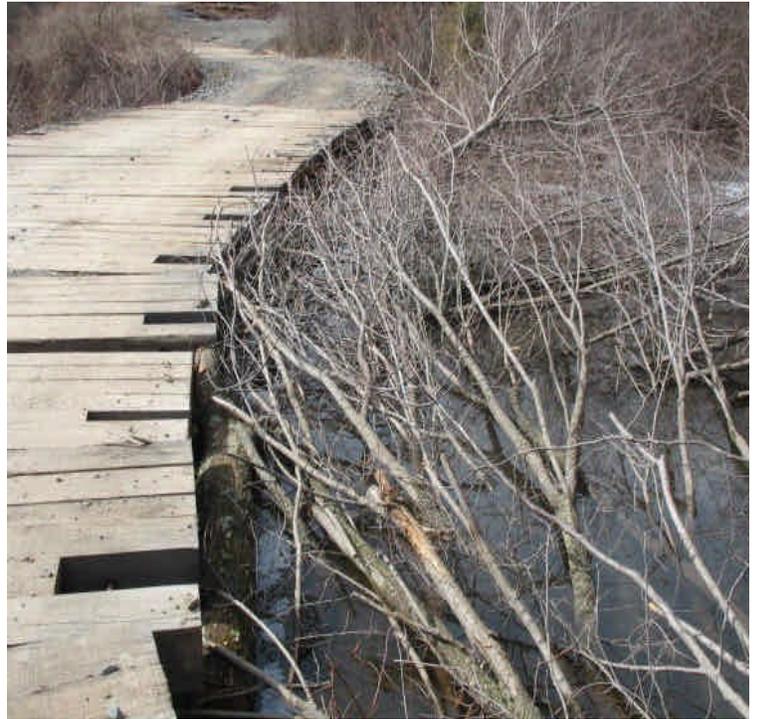
Wetland crossing off Powder Hill Road. No sediment or turbidity was observed coming from the stone crossing.

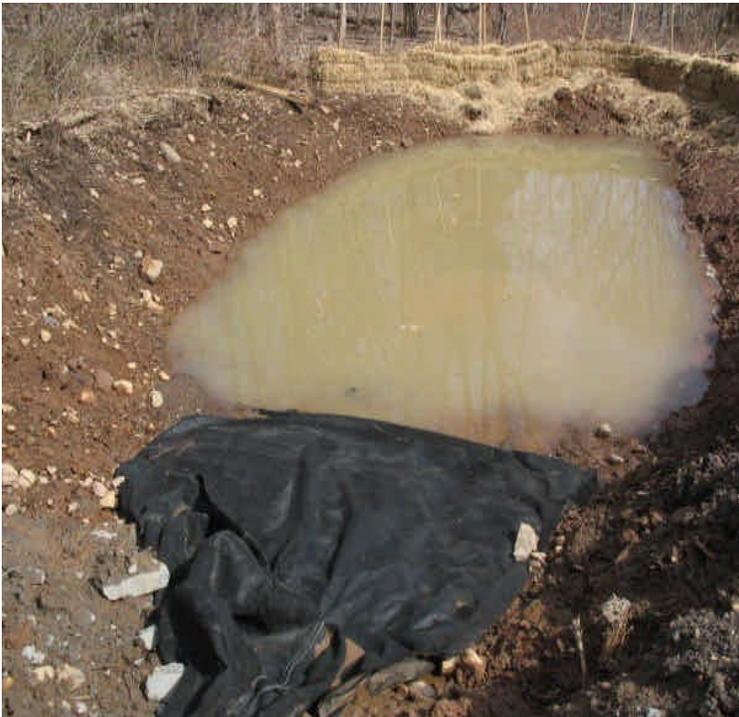
View of water and slurry from dewatering the foundation excavations off Powder Hill Rd. This appears contained to the basin.

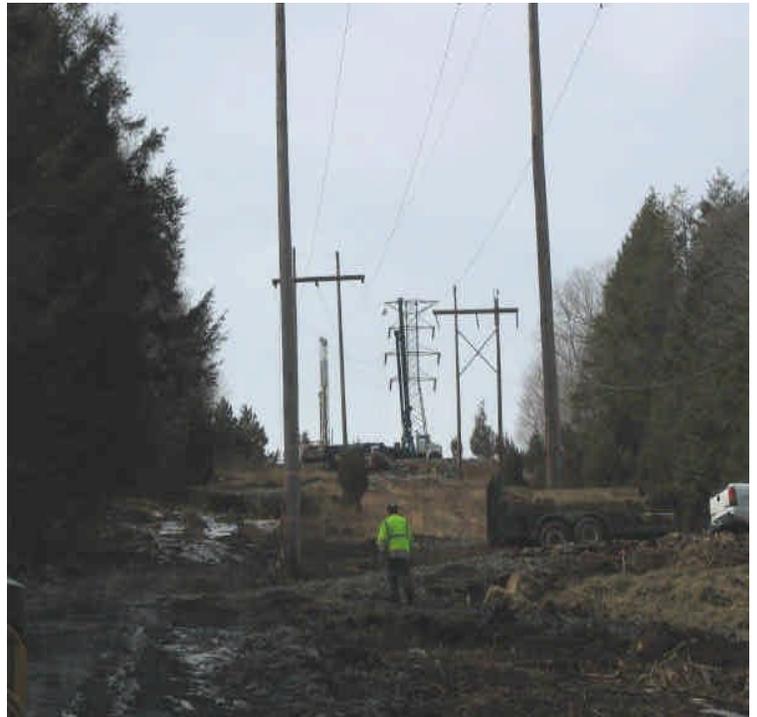
Drainage ditch/water bars and haybales were being repaired along the slope off Powder Hill Rd.

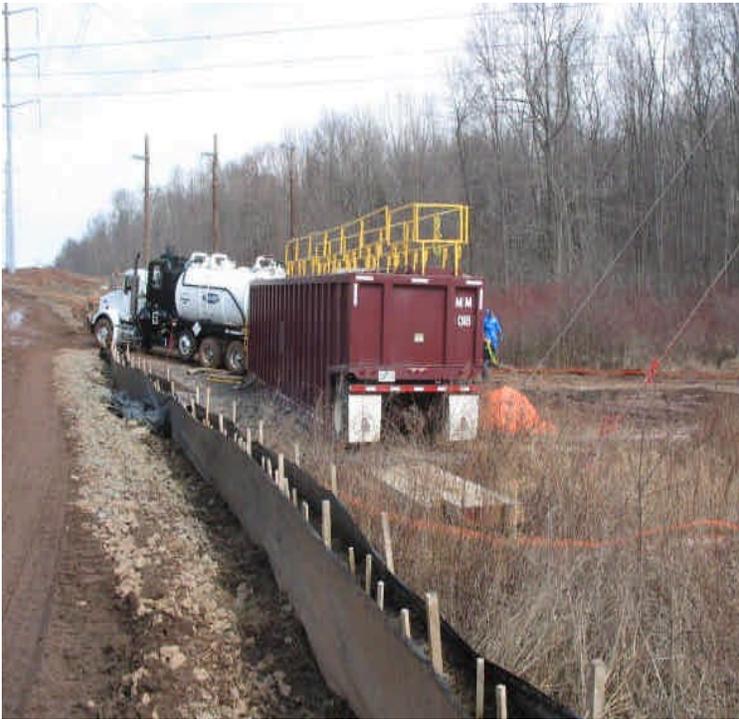
Dewatering tank and vac truck along the ROW east of Beseck SS. Slurry was being removed from the foundation and transported to a containment basin. Controls were in place along the wetland edge.

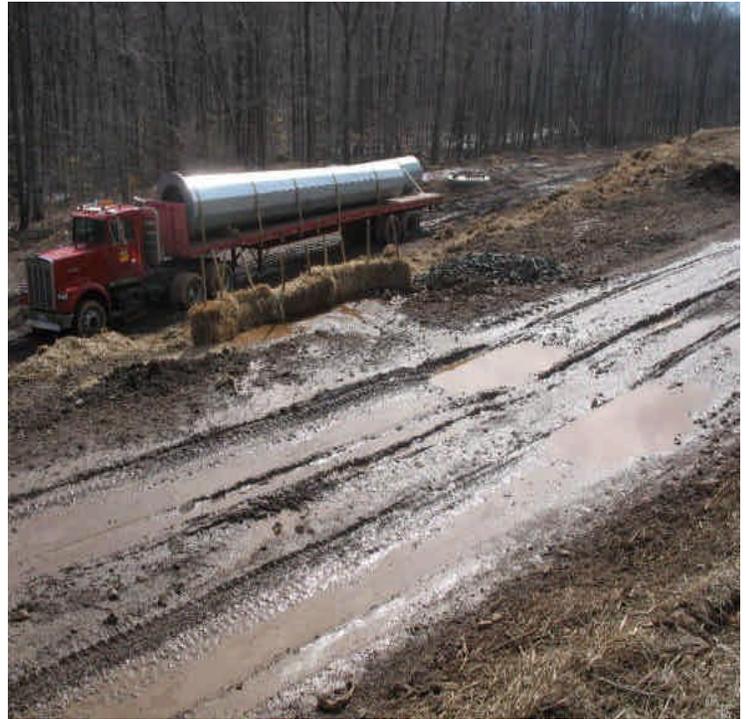
Turbid run-off and mud cover the surface of the access road north of Beseck SS. Consider stabilizing the access road with stone. Remove sediment accumulation from controls as needed.

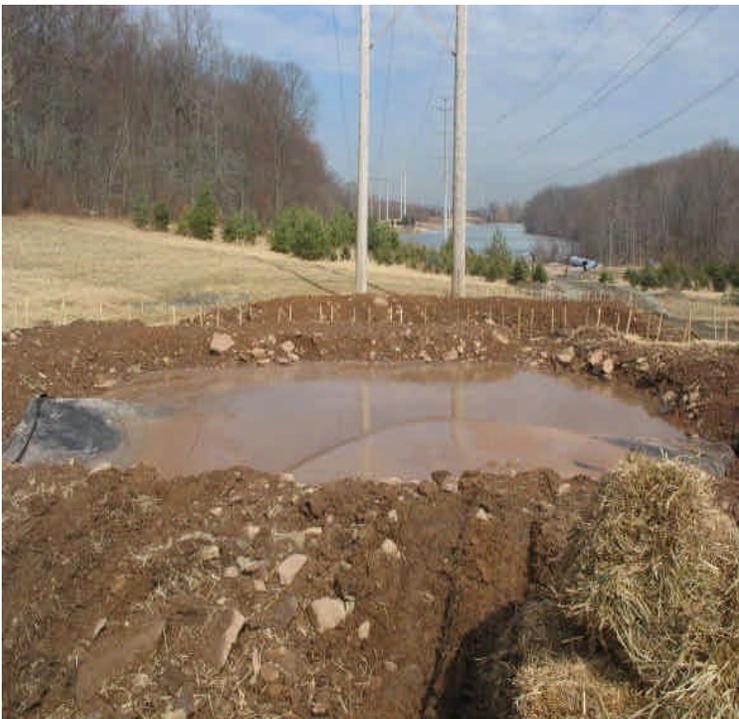
An active dewatering pit with filter bags remains in place north of Beseck SS.

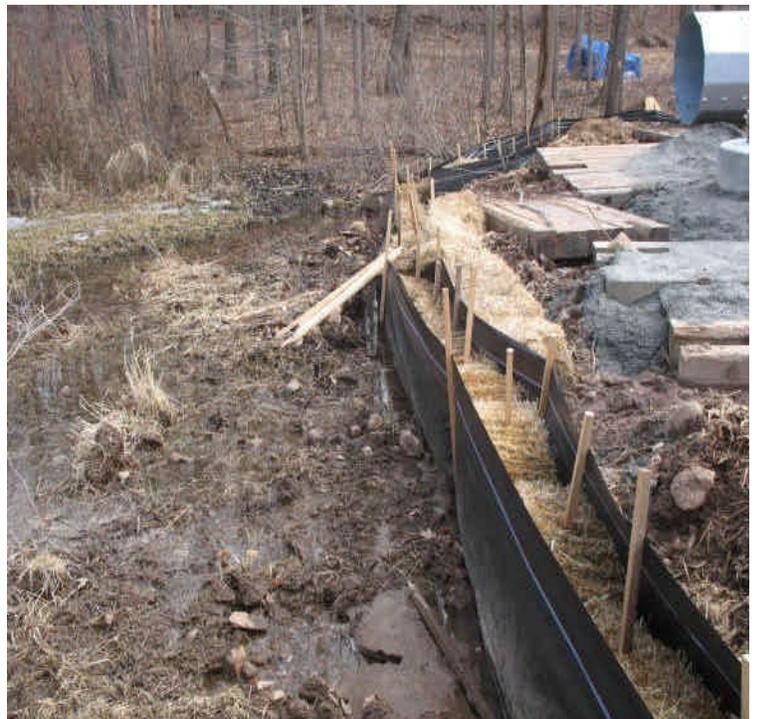
North of Beseck SS: Controls remain in place after the foundation adjacent to the pond was drilled. Ensure that sediment is adequately contained or stabilized beyond the controls.

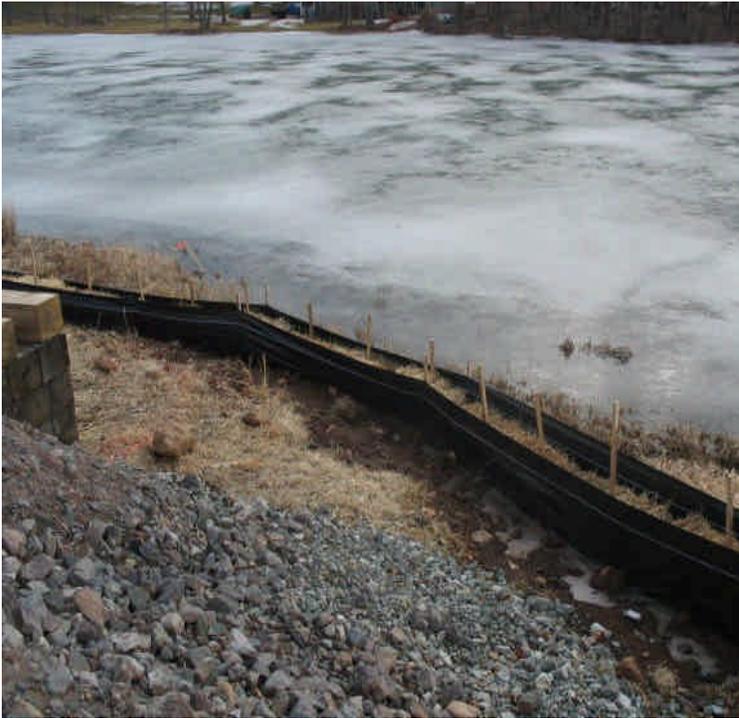
Controls installed along the pond north of Beseck SS to E. Meriden SS off Fleming Rd.

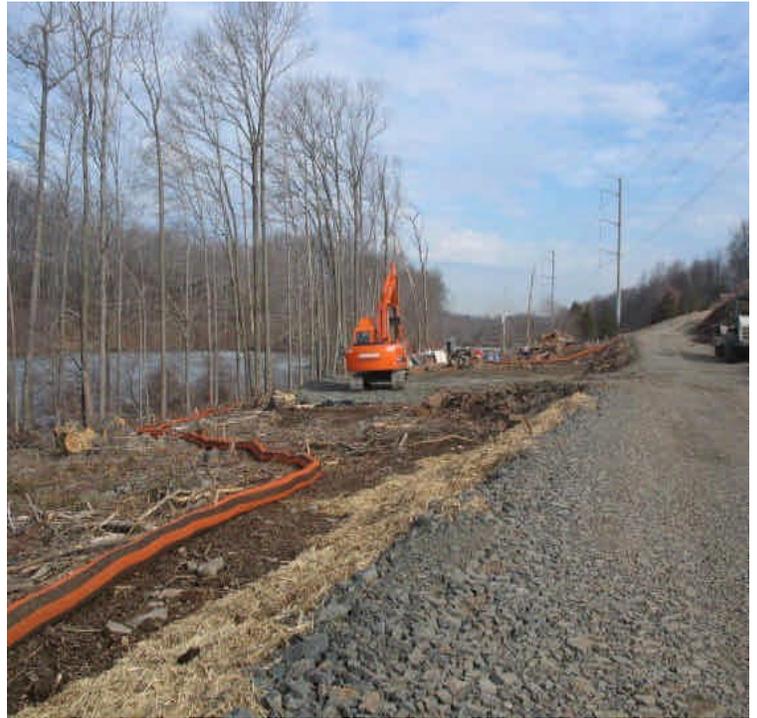
Additional view of the controls along a pond E. Meriden SS to Black Pond. New pad site construction was underway. Continue to monitor to ensure that controls are adequate to control run-off.

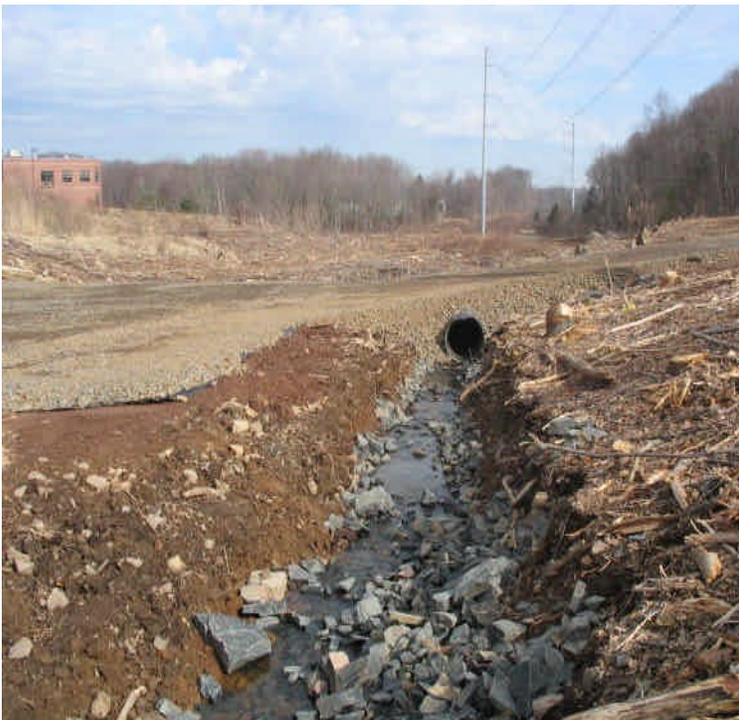
View of the stream flow diverted through the culvert and riprap channel in the ROW between E. Meriden SS to Black Pond. Water in the channel was mainly clear with some suspended sediment.

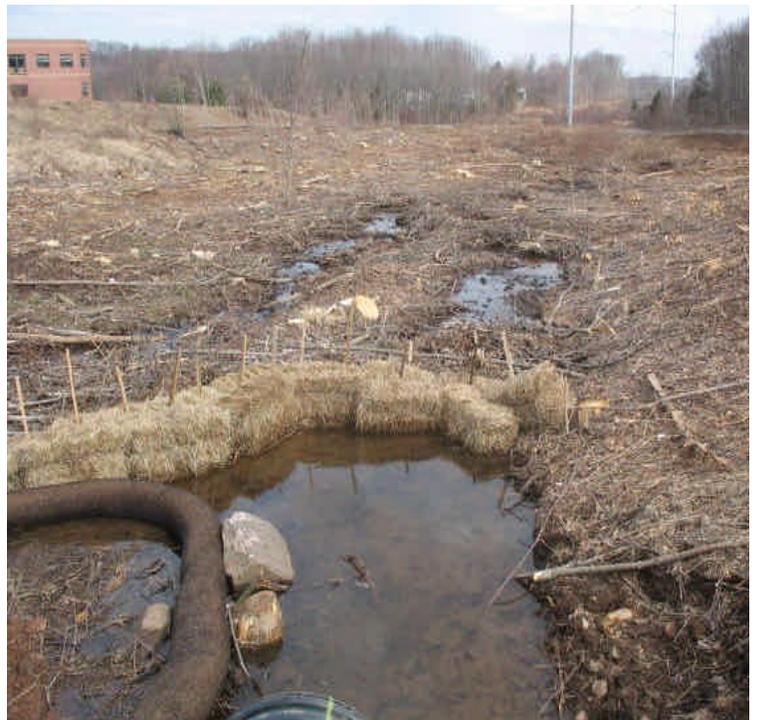
New controls were installed downgradient along the diverted stream channel. Controls appear to be filtering all sediment before it leaves the construction area.
